Vantage Mobility International

Field instructions upgrading VMIQ for Powerkneel™ current increase

Document Number: TS-WI-0256

VMIQ FIRMWARE UPGRADE TO PREVENT POWERKNEEL™ OVERCURRENT

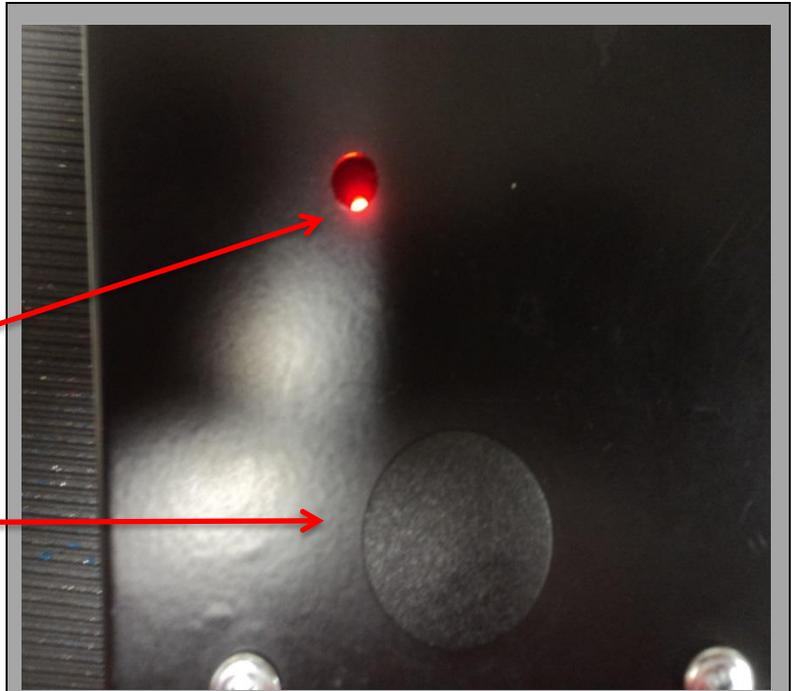
1. Locate and remove the plastic snap cover on top of the VMIQ housing to expose the reset button and the USB connection.

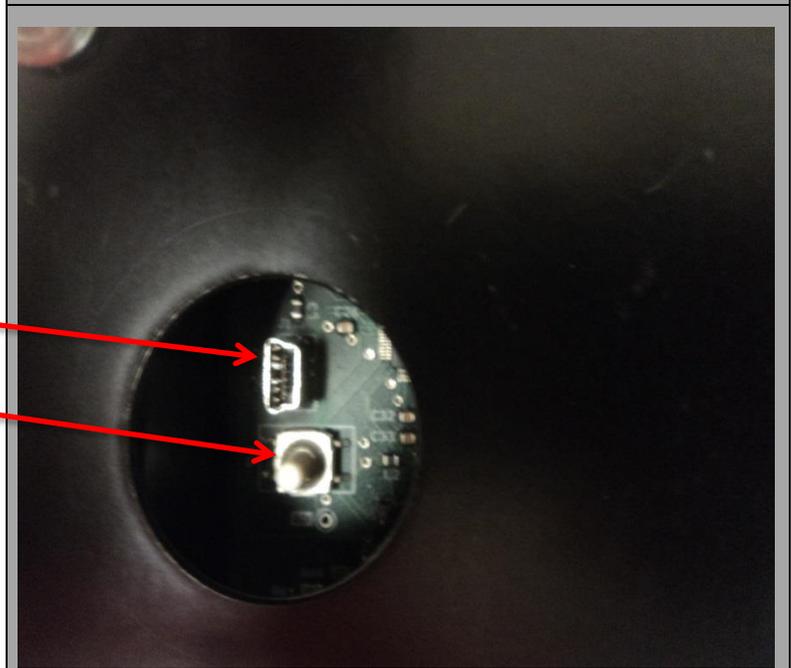
2. Connect computer to USB port using the Mini USB Cable.

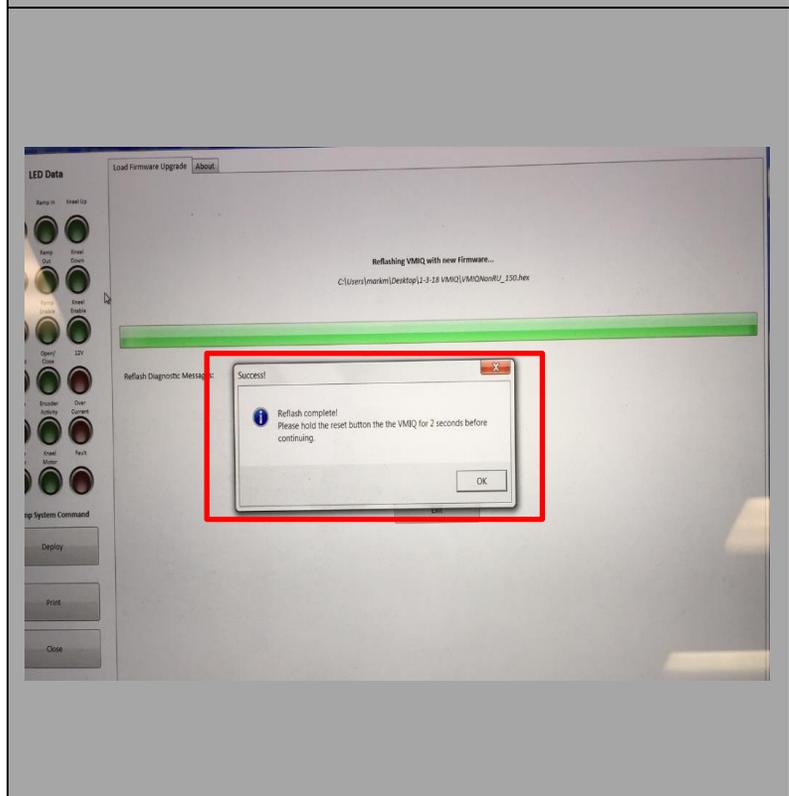
IF the bar does not turn COMPLETELY green and /or this screen does not pop up documenting the file has fully transferred (Reflash Complete), disconnect the tool from the VMIQ and restart the process.

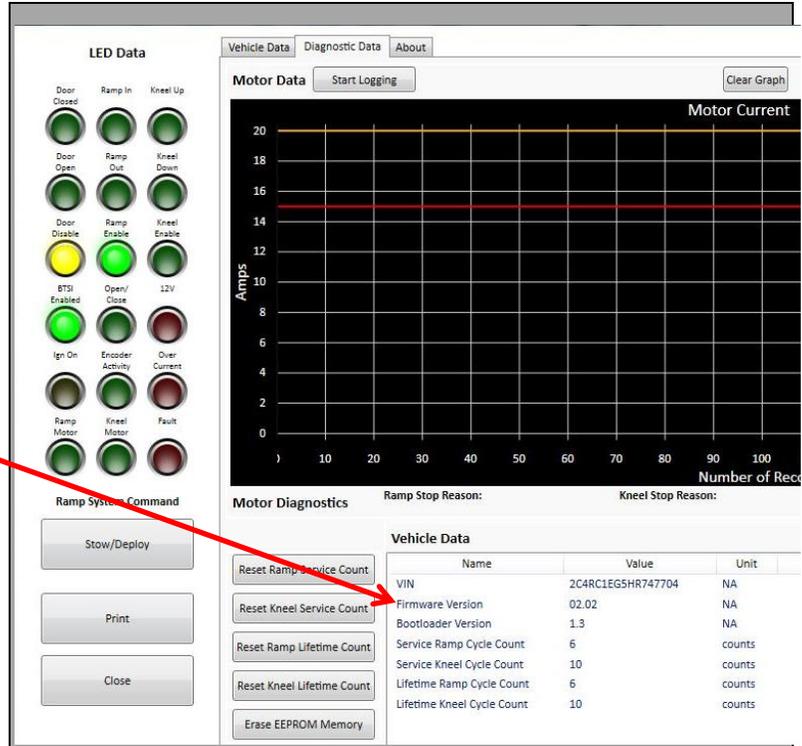
- To connect to the van and *confirm* the firmware version click on “Connect to VMIQ in Vehicle”. Click on the Diagnostic Data tab to confirm that the firmware you have loaded is correct.

Chrysler Pacifica should be version 2.0.2.

Honda and Toyota should be version 1.5.
