February 27, 2018

08343 Version 2

## 2016–17 Pilot: Judder from the Torque Converter Lock-Up Clutch (Snapshot Upload Required)

### AFFECTED VEHICLES

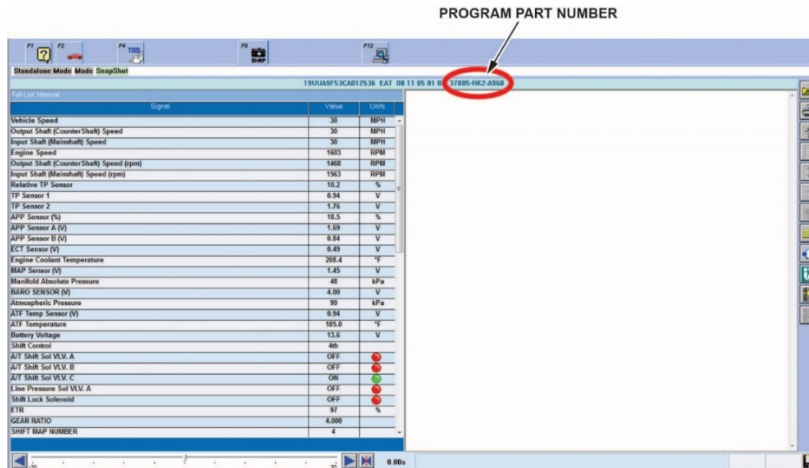
1. Connect the i-HDS, and go to the A/T Data List. Check to see if the software has been updated by comparing the program P/N against the table below.

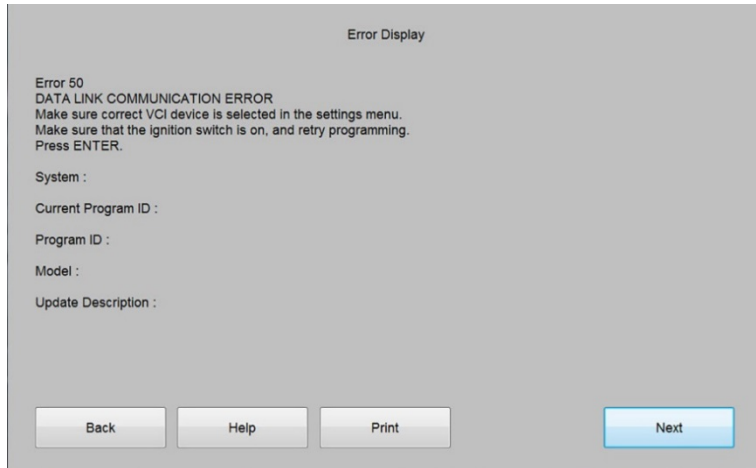
- You can't update the vehicle using the MVCI as a standalone tool.
- **Do not** use the MongoosePro VCI tool.
- Make sure the 12 volt battery is fully charged before starting an update.
- Connect a fully charged jumper battery to the vehicle and leave it connected during the entire procedure to maintain steady voltage.
- Never turn the ignition to OFF or ACCESSORY during the update. If there is a problem with the update, leave the ignition turned to ON.
- To prevent PCM damage, do not operate anything electrical (headlights, audio system, brakes, A/C, power windows, door locks, etc.) during the update.
- If you see the following Error Display, check that you are using the correct tool (MVCI or DST-i) with the i-HDS.

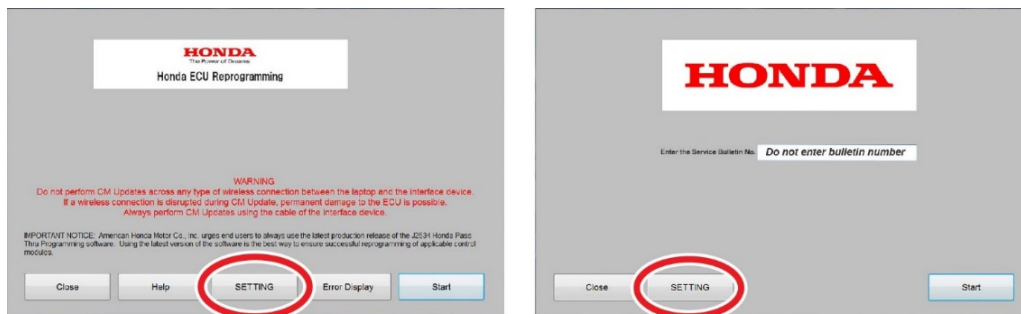
To change this, click on either of the SETTING selection buttons at the bottom of the J2534 initial screens as shown.

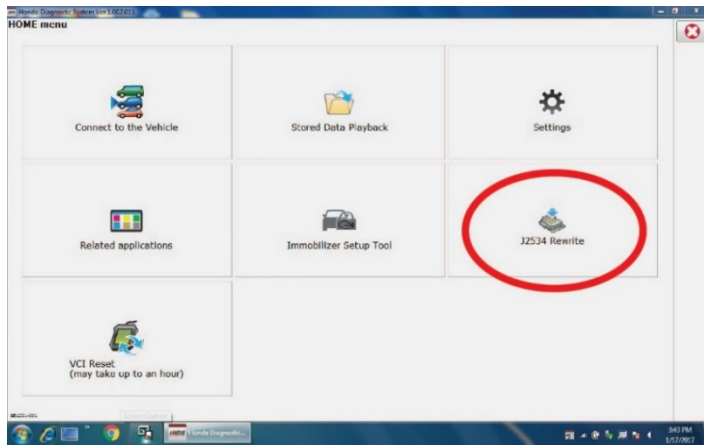
2. Select **J2534 Rewrite**.

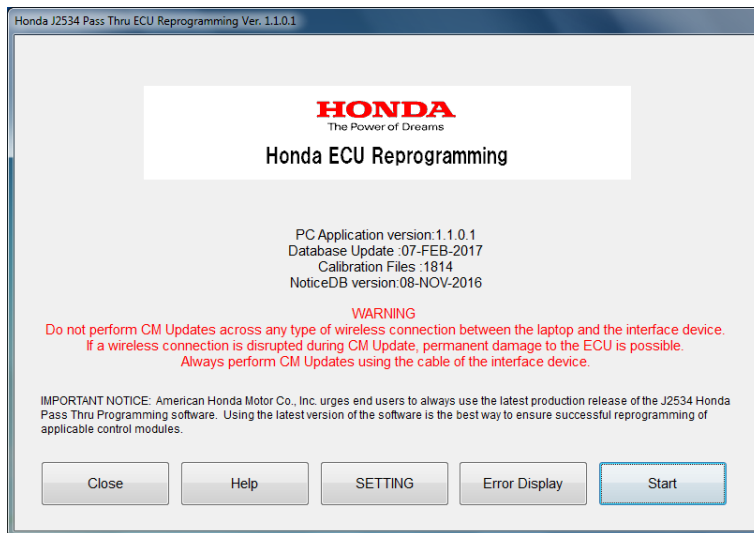
3. Confirm the software is the same **or later** as listed in SOFTWARE INFORMATION.

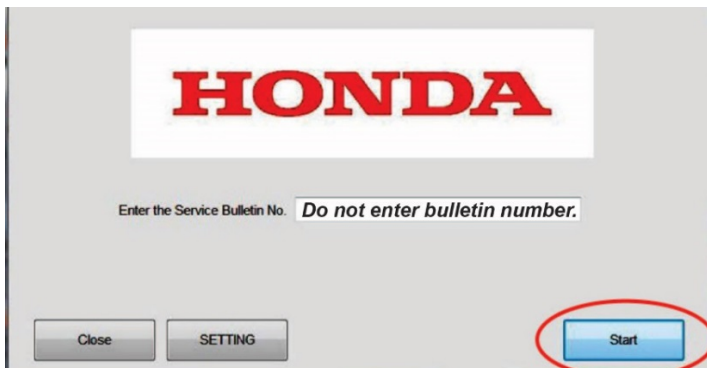
4. Select **Start**, then follow the screen prompts.

- **Don't enter a bulletin number.**
