| <b>HYUNDAI</b><br><b>Technical Service Bulletin</b> | GROUP<br><b>BODY</b> | NUMBER<br><b>18-BD-001</b> |
| <b>SUBJECT:</b> SONATA (LFA) PANORAMIC SUNROOF REAR SEAL REPLACEMENT | | |

**Description:** This bulletin provides the repair procedure to eliminate panoramic sunroof creaking noise originating from the panoramic moving glass seal.

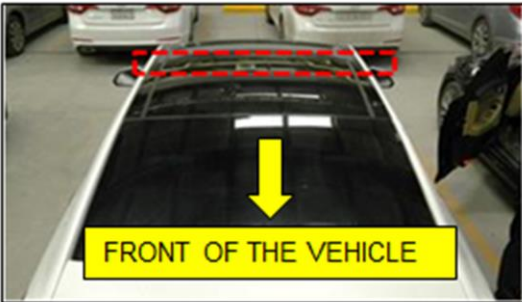
| 1. | <p><b>Condition:</b> Noise from panoramic sunroof area while driving. (“ticking” or “popping” noise)</p> | |

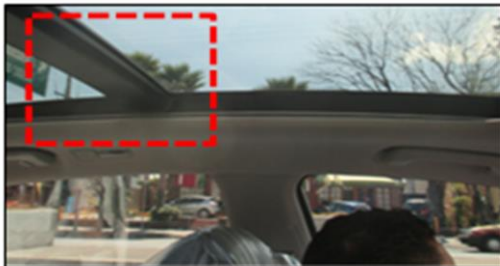
| 2. | <p><b>Location:</b> Noise can be heard at the center or rear of the panoramic sunroof glass.</p> | |

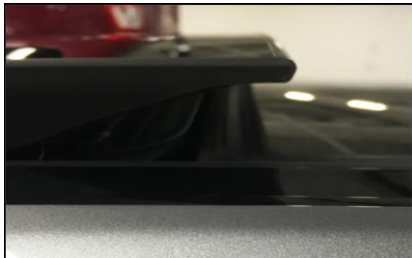
| 3. | <p><b>Confirmation:</b> Noise can be confirmed by tilting the sunroof glass up while driving.<br/>-&gt;If noise does not occur when moving glass is tilted up, the TSB does not apply.</p> | <div style="display: flex; justify-content: space-around;"> </div> <div style="text-align: center; margin-top: 5px;"> <span style="background-color: #4a7ebb; color: white; padding: 2px 5px;">Tilt Sunroof</span> </div> |
