| <b>Title (customer effect)</b> | Mack Chassis - Equipped With Bendix Fusion, With Or Without Lane Departure Warning ( LDWS ) - Diagnostic Trouble Code ( DTC ) SPN 516103 FMI 19, Bendix Code 167 With Possible "Lane Departure Warning Malfunction" Message - US17 And Newer |

Mack Chassis equipped With Bendix Fusion may display DTC / Fault code SPN 516103 FMI 19 on Premium Tech Tool ( PTT ) or J-Pro, and code 167 in Bendix ACOM software.

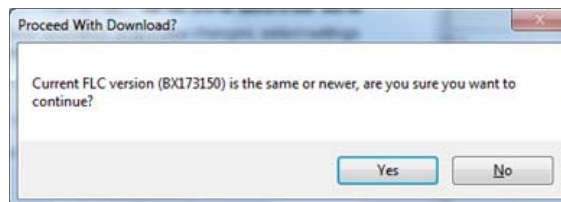
**NOTE:** If the error message shown below appears, the module software does not need to be updated.
