Transportation Tie-Down Best Practices

Service Category Suspension

Section Front Suspension

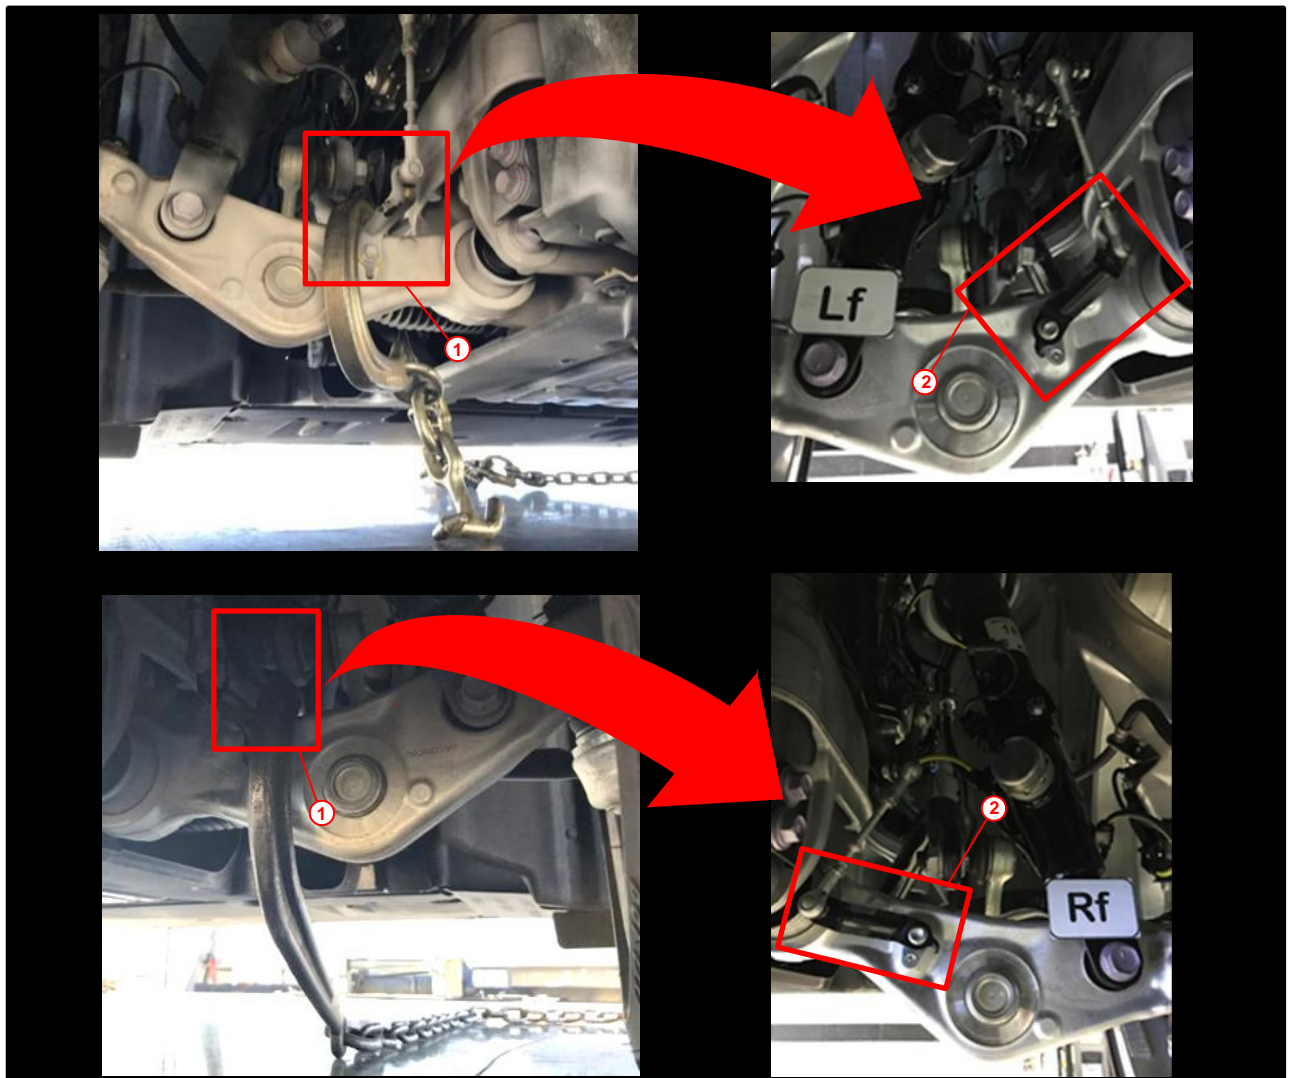
Figure 1.

Incorrect towing methods may cause the vehicle to exhibit a bent front height adjustment sensor bracket. This condition may cause headlight misalignment when auto adjusting based on the vehicle height position, and in some cases, will set a Diagnostic Trouble Code (DTC).

- If the vehicle is NOT towed correctly, the front height adjustment sensor bracket may be vulnerable to damage due to the layout of the front suspension.
- When shipping a vehicle, some third-party towing companies that use flatbed trucks do NOT follow the recommendations found in the Owner's Manual to secure the vehicle.
For example, some towing companies may secure the vehicle with metal hooks around the front lower control arms as a mount point. The front height adjustment sensor bracket is fixed to the lower control arm, and using this method risks bending the bracket if the strap or chain contacts this bracket under load.

| 1 | Incorrect Tie-Down Method/Location |
| 2 | Damage Caused by Metal Hook |

Toyota Motor North America (TMNA) recommends that dealers ensure towing companies are aware of proper hook and tie-down points and the risks if not performed properly. Customers should be educated in situations when non-dealer roadside assistance is used. If the vehicle has a damaged front height adjustment sensor bracket after being towed by a third-party towing company, please advise the dealer service department immediately, as the towing company may be responsible for damages.

1. Refer to the applicable Owner's Manual for the vehicle hook location to load on a flatbed:
 - [2018 LC 500/LC 500h Owner's Manual](#)
 - [2018 LS 500 Owner's Manual](#)
 - [2018 LS 500h Owner's Manual](#)
2. If the procedure in the Owner's Manual CANNOT be performed, request for additional information and support when necessary to load the vehicle.

Do NOT use metal hooks on suspension components for recovery.
