Abnormal Squeak Noise From Rear Suspension Over Uneven Roads

Service Category Suspension

Section Rear Suspension

YEAR(S)	MODEL(S)	ADDITIONAL INFORMATION
2014 - 2018	Highlander, Highlander HV

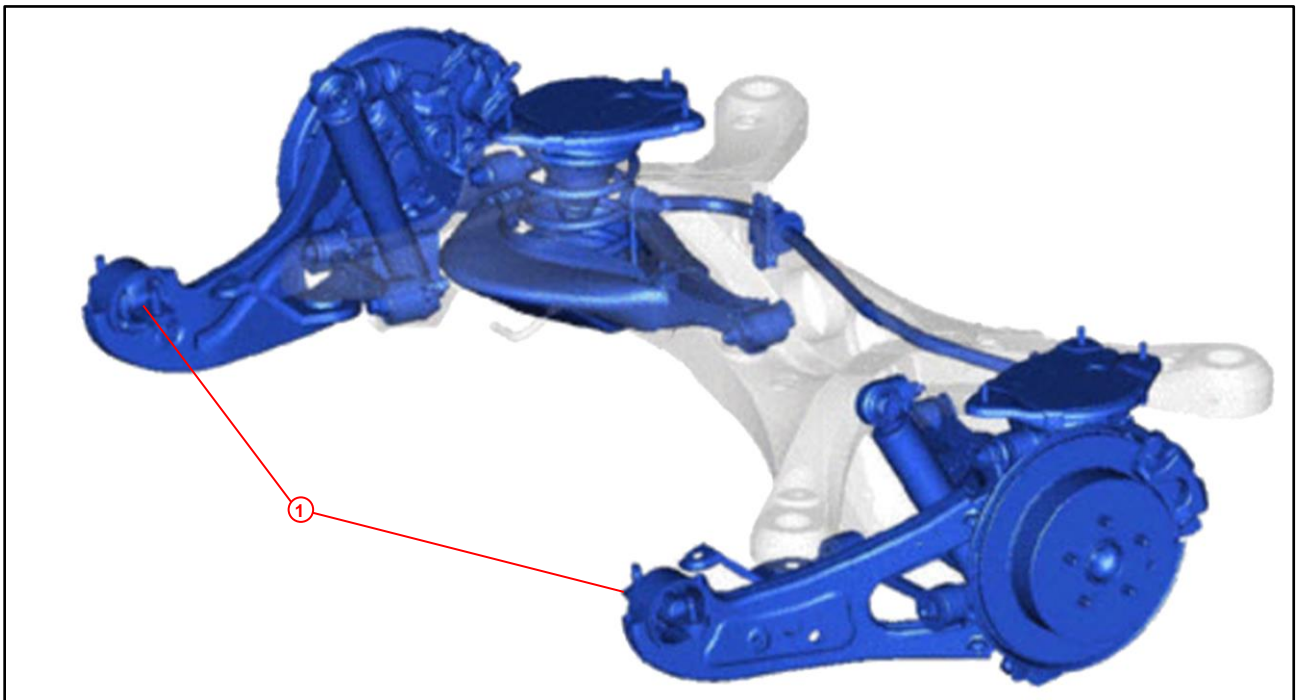
Figure 1.

Some 2014 – 2018 model year Highlander and Highlander HV vehicles may exhibit an abnormal squeak noise from the rear suspension. This condition may be more noticeable in colder, ambient temperatures and may occur when traveling over uneven roads or when the vehicle comes to a complete stop. The abnormal noise may be caused by the rear trailing arm bushing. An updated rear trailing arm assembly is available. Follow the Repair Procedure below to address this condition.

1	Rear Trailing Arm Bushing
----------	----------------------------------

3. Replace BOTH rear trailing arm assemblies even if ONLY one side is emitting the squeak noise.

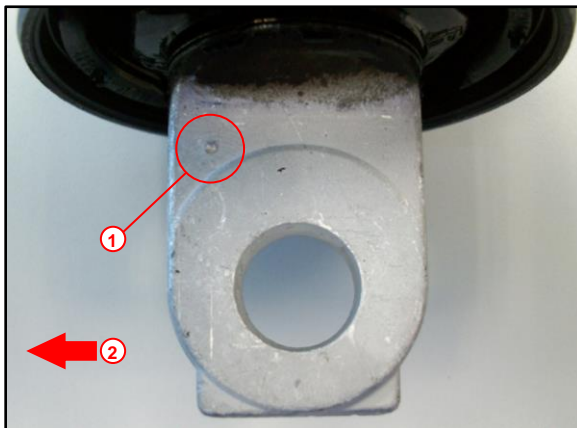
Figure 2. LH Side

1	Identification Mark
2	Front

2. BEFORE installing NEW parts, confirm the identification mark as shown. If this mark is NOT present, the part is incorrect and SHOULD NOT BE INSTALLED.

The identification mark on the NEW part faces the outside of the vehicle.

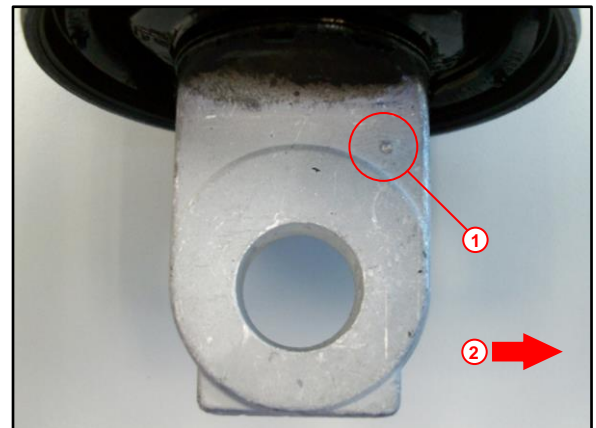
Figure 3. RH Side

1	Identification Mark
2	Front

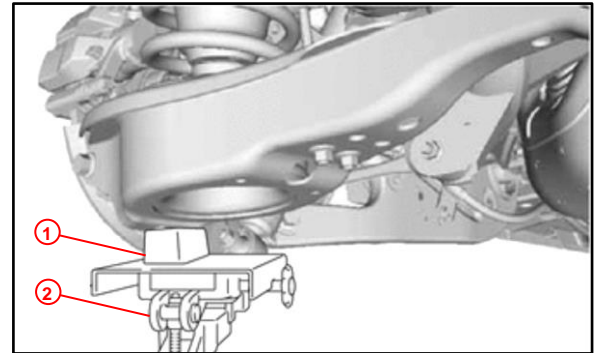
Figure 4.

1	Wooden Block
2	Jack

- 2014 – 2018 Highlander:
Suspension – Rear Suspension – “Rear Suspension: Rear Trailing Arm: [Removal / Installation](#)”
- 2014 – 2018 Highlander HV:
Suspension – Rear Suspension – “Rear Suspension: Rear Trailing Arm: [Removal / Installation](#)”
