**PREVOST**

## WARRANTY BULLETIN

**WB17-16**

| SUBJECT : | C15 & C58 CONNECTOR BYPASS | | |

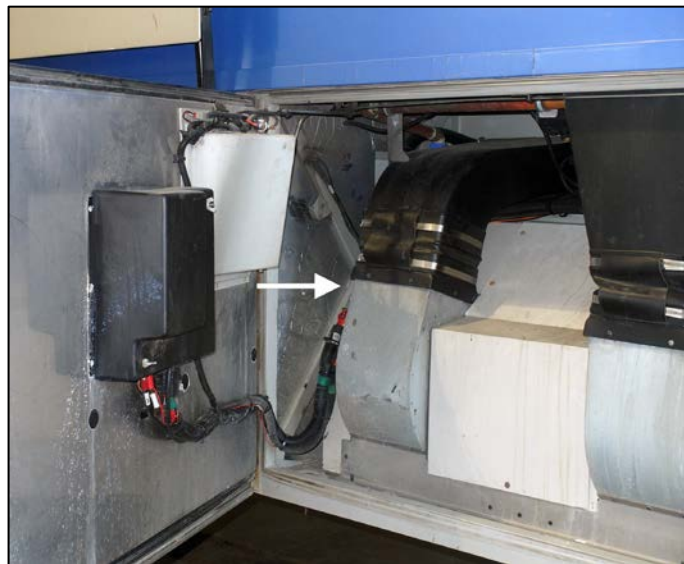
**Figure 13: C15 General Location**

A1. Locate connector C15 in the evaporator compartment.

A2. Harness and connector is attached along the left side of the evaporator fan enclosure.(Figure 13)

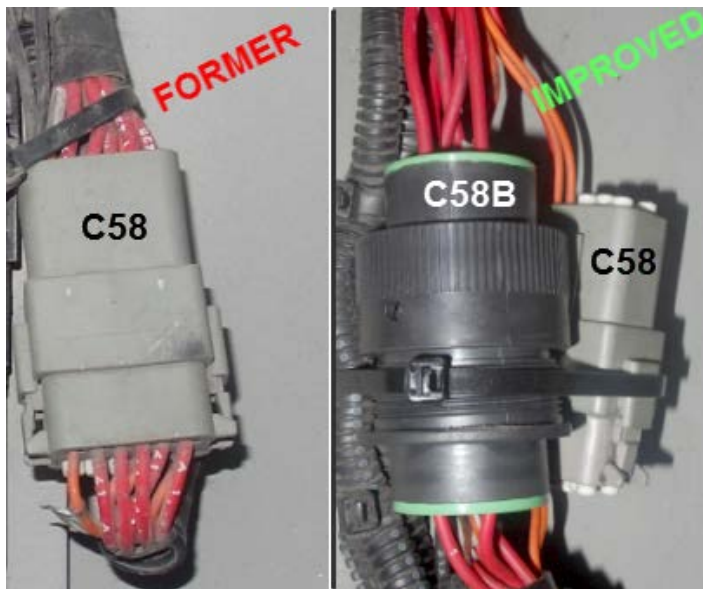
Figure 18 : C58 ARRANGEMENT "FORMER" AND "IMPROVED"

Visually confirm an *improved* connector (Figure 18) is already installed in this location.

This confirms the improvement is already implemented on this vehicle.

If the *former* connector is present alone, proceed to part "B", disregarding vehicle number.

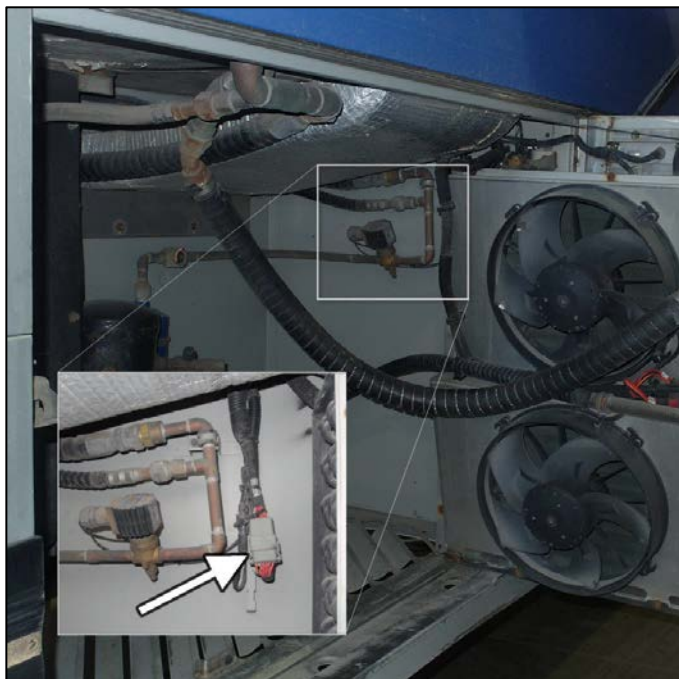
Figure 19: C58 location

B1. Locate connector C58 in the condenser compartment.

B2. Harness is located along the top of the right (front) wall of the condenser compartment. (Figure 19,Figure 20)
