Technical product information

Topic	Engine oil in charge air coolers
Market area	Bentley: worldwide (2WBE),Hongkong-Macau (5HK)
Brand	Bentley
Transaction No.	2050222/1
Level	EH
Status	Approval
Release date

Bentayga W12

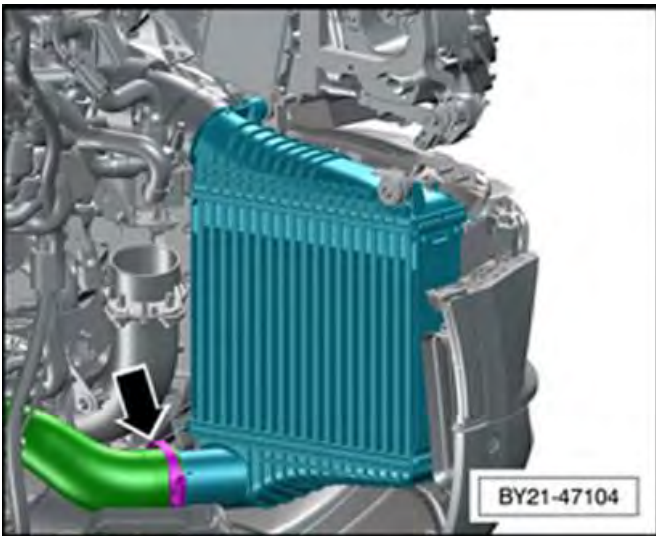
Liquid gugging noise evident from engine charge air intakes system - Excessive oil discovered in charge air coolers

A specific level of oil residue is expected in a charge air cooler. Currently the level of oil being seen in some Bentayga charge air coolers is excessive. Investigations are taking place to identify the cause

There is no requirement to change parts

Any oil found in the charge coolers should be drained off, any remaining oil residue should be cleaned from the charge coolers and hoses, the vehicle should then be returned to the customer.
