SERVICE BULLETIN

Reference number:	SB-01-1054	Issued: 02 February, 2018
Subject:	DB11 Rear Windscreen Leaks	
Model(s):	DB11 Coupe	
VIN Range:	L00120 to L01993	
Applicable to:	All Dealers	
Distribute to:	After Sales Manager Executive Manager Service Manager Sales Manager	Warranty Staff Technician(s) Parts Staff

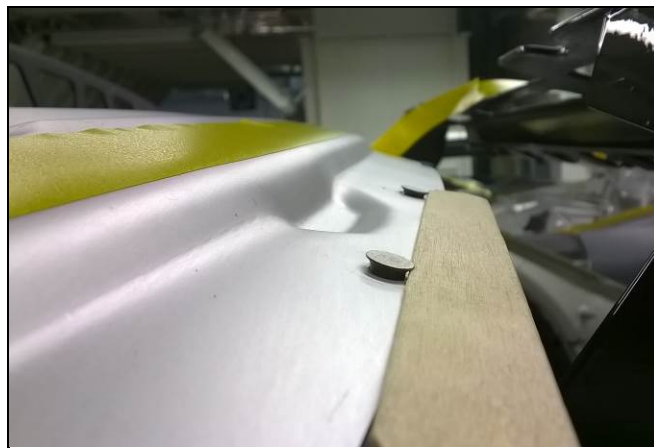
Figure 1

Aston Martin has found that some DB11 vehicles have had water leaks through the windscreen. The primary cause of the problem is that some of the rivets in the body structure were not installed flush. This can cause a failure in the sealant bond for the windscreen.

When the windscreen seal has this defect, water can leak on to the parcel shelf and/or on to adjacent areas of the vehicle interior. If there is an indication of a leak, do the workshop procedure that follows.

This workshop procedure has two parts. If the windscreen continues to leak when Part A is complete, you must do Part B.
