## SERVICE BULLETIN

Reference number:	SB-11-1007	Issued: 27 February, 2018
Subject:	DB11 Bracket for the Paddle-Shift Assembly	
Model(s):	DB11 V12	
VIN Range:	Up to 18.5MY vehicles	
Applicable to:	All Dealers	
Distribute to:	After Sales Manager Executive Manager Service Manager Sales Manager	Warranty Staff Technician(s) Parts Staff

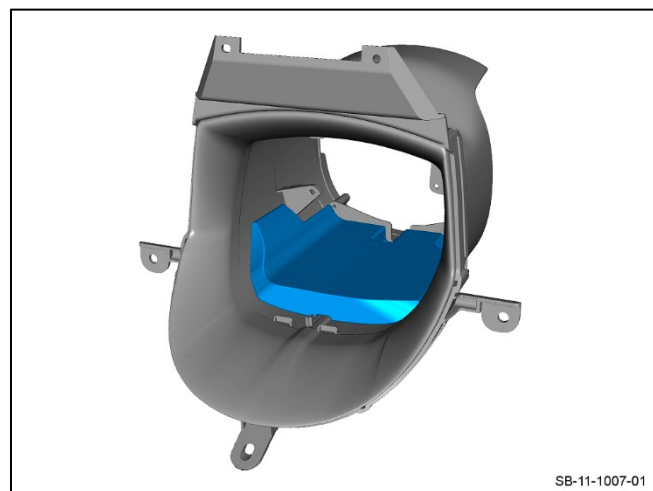
Figure 1

If a Customer complains of too much flexibility in the paddle-shift assembly, do the workshop procedure that follows to correct the problem. The movement in the paddle-shift assembly is caused by flexibility in the steering column cowl and in the SCCM rear bracket.

**Note:** *The old steering-column cowl has a foam part (refer to Figure 1). The new steering column cowl does not need a foam part. When you remove the old steering column cowl, do not install the foam to the new steering column cowl.*

New parts have been introduced to replace the initial parts and correct the problem. These are the SCCM rear bracket, the paddle shift to SCCM fixing bracket, and the steering column cowl.
