GROUP Body	MODEL 2018MY Stinger (CK) 3.3T-GDI
	NUMBER PS544	DATE February 2018

SUBJECT: FRONT BUMPER TOW HOOK CAP

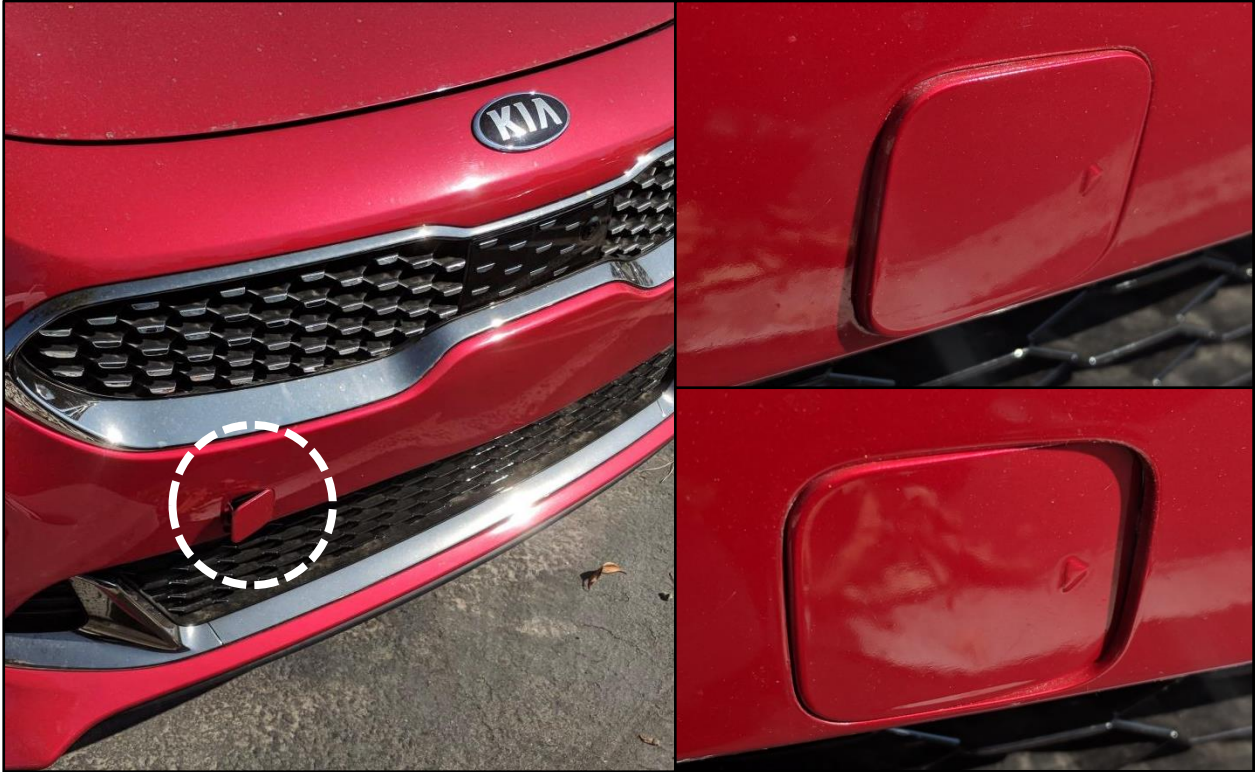
INCORRECT SAMPLES:
Tow Hook Cap not properly inserted and not flush with front bumper cover.
