MODEL  
2018MY  
Stinger (CK)

NUMBER  
178 (Rev 1, 1/30/2018)

## TECHNICAL SERVICE BULLETIN

SUBJECT: SERVICE ACTION: RATTLE NOISE  
FROM TAILGATE (SA322)

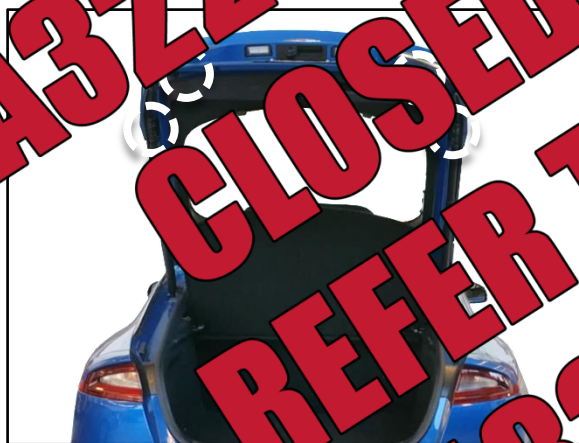
This bulletin provides the procedure to adjust the overslam bumper and install a guide bumper mounting kit on some 2018MY Stinger (CK) vehicles produced from September 21, 2017 through January 4, 2018, which may exhibit rattle noise while driving, especially over bumps. Follow the procedure outlined in this bulletin to adjust the overslam bumpers and install a guide bumper mounting kit. Before conducting the procedure, verify that the vehicle is included in the list of affected VINs.
