GROUP BOD	MODEL 2018MY Stinger (CK)
	NUMBER 178A	DATE February 2018
TECHNICAL SERVICE BULLETIN		
SUBJECT: SERVICE ACTION: RATTLE NOISE FROM TAILGATE (SA322A)

This issue number is SA322A.

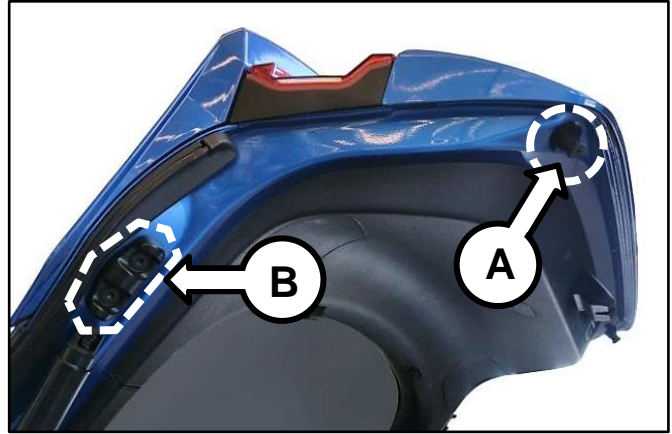
1. Open the tailgate. Locate both tailgate overslam bumpers (A) and guide bumpers (B) on both sides (left side shown in photo).

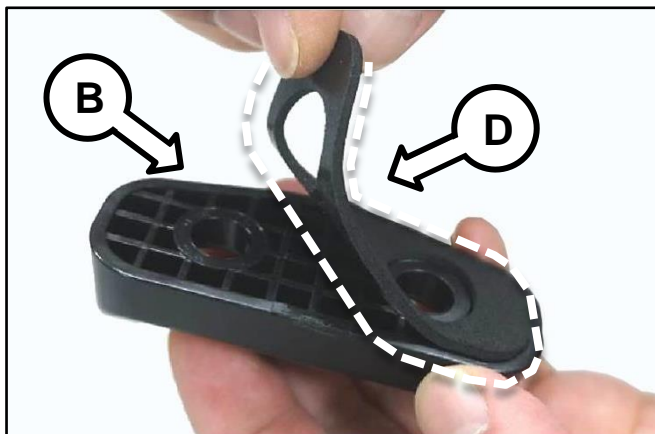
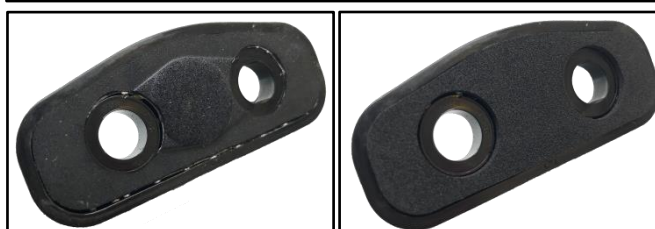
Old Pad

New Pad

4. Remove the old pad (D) and carefully center and apply the new improved thicker pad onto the guide bumper (B).

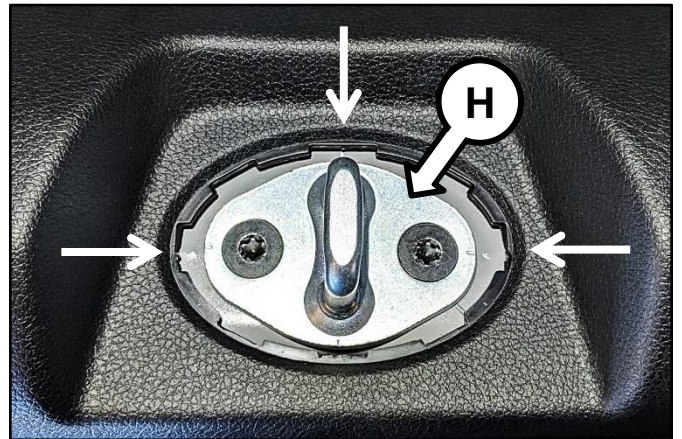
8. Check the alignment marks on both the body and the striker (H). The markers must be aligned to match. If so, replace striker cover to complete the inspection. Road test vehicle on rough road to confirm no rattle noise is present.

If striker marks are not aligned, proceed to the next step to adjust.

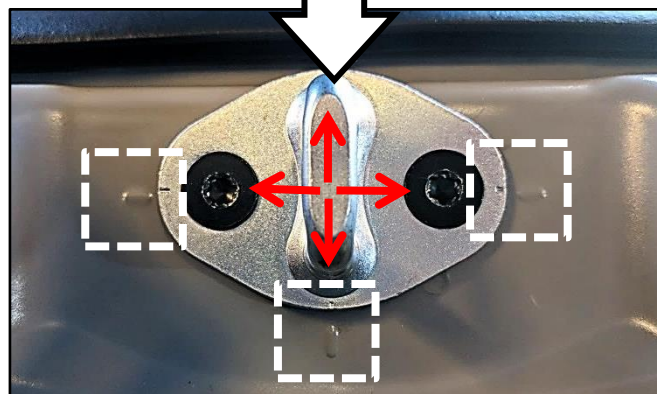
Alignment marks for reference. Striker may be moved in any direction.
