GROUP CHA	MODEL 2011-2014MY Optima (QF)
NUMBER 060 (Rev 1, 2/23/2018)	DATE January 2016

TECHNICAL SERVICE BULLETIN

SUBJECT: ECU UPGRADE – STEERING LOGIC IMPROVEMENT

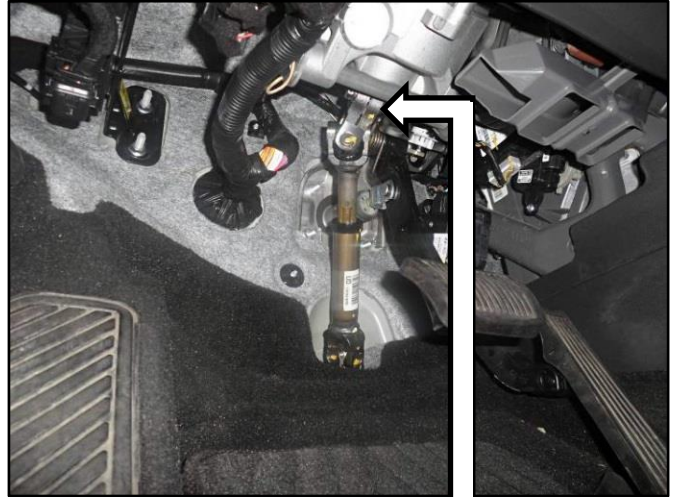
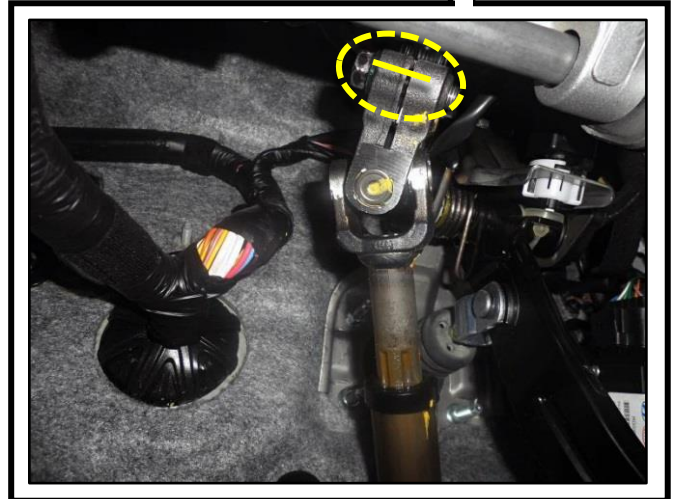
1. Remove the top bolt from the universal joint. **NOTE: place a mark across the universal joint to make reinstallation easier.**

After disconnecting the universal joint, do NOT turn the steering wheel more than 270° to prevent damage to the clock spring.

Tightening torque:
21.7 – 25.7lb.ft (29.4 – 34.3N.m)

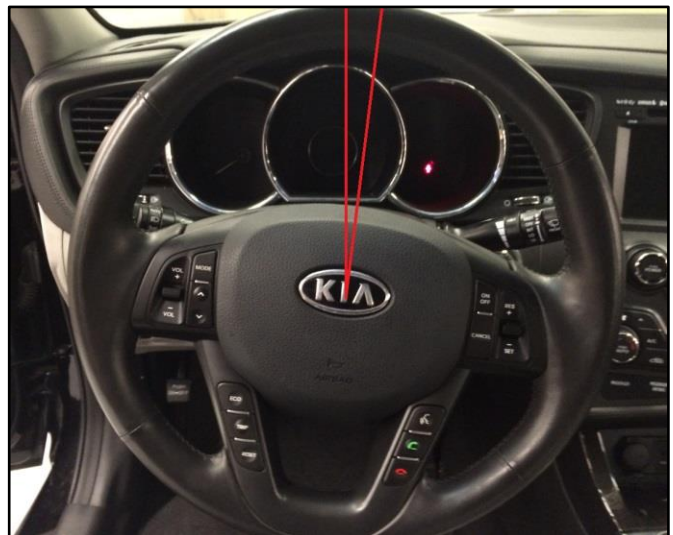
2. Prior to starting the MDPS effort measurement test (page 3), position the steering wheel slightly to the right, as shown, with the Steering Angle Sensor (SAS) in the positive range. **NOTE: attempting to start the steering effort test with the SAS in the negative range will trigger an error message and prevent the test from running.**

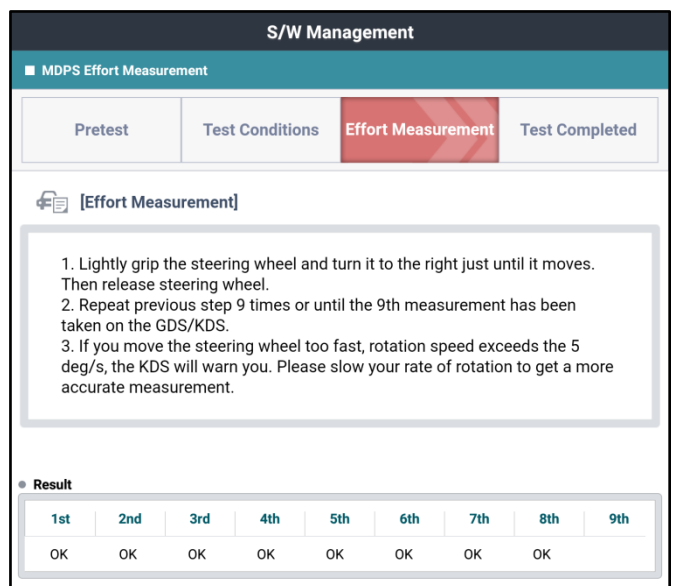
If the five (5) Deg/Sec. rotation speed is exceeded, a message, as shown below, will display.

Steering wheel rotation speed is fast.

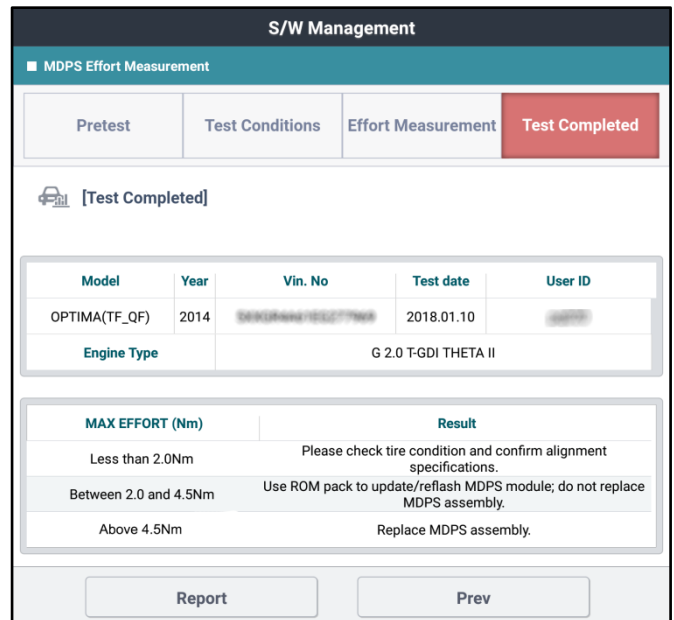
14. Refer to the table below for the correct course of action after the 'Test Completed' screen is displayed. **NOTE: select Report to save the report for future reference.**

Item	Max. Effort	Remedy	Proceed to
Steering Effort Value	0 - 1.5 lb.ft (0 - 2.0 Nm)	No further action is required	N/A
	1.5 - 3.3 lb.ft (2.0 - 4.5 Nm)	ECU Upgrade	Page 7
	3.3 lb.ft (4.5Nm) or higher	Replace MDPS	Page 12

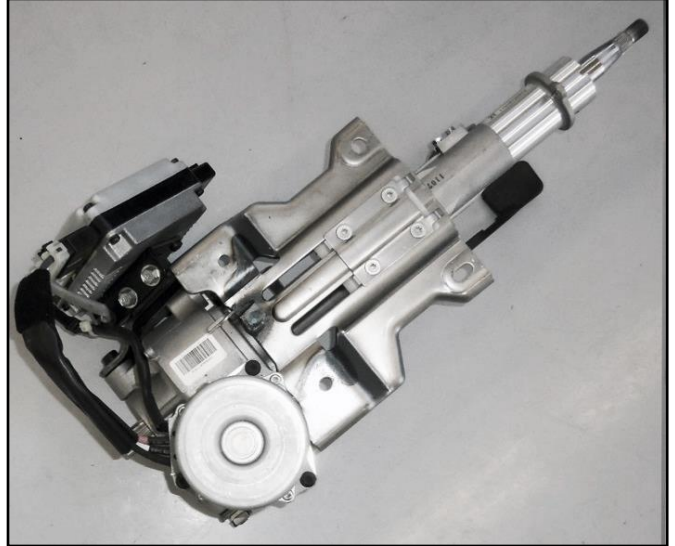
MDPS Replacement Procedure (for MDPS Effort Value greater than 3.3lb.ft/4.5N.m):

1. Replace the MDPS assembly by referring to the “Steering System → Electric Power Steering → Steering Column and Shaft → Repair procedures” chapter in the applicable Shop Manual on KGIS.
