MODEL
2017MY
Niro (DE HEV)

NUMBER
135 (Rev 1, 2/15/2018)

TECHNICAL SERVICE BULLETIN

SUBJECT: SERVICE ACTION: INSPECTION AND/OR
REPLACEMENT OF HYBRID DRIVE MOTOR (SA304)

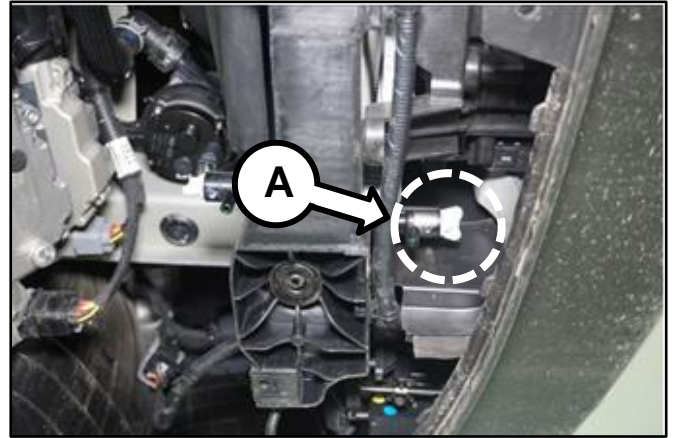
1. Drain the Hybrid motor coolant by referring to the “Hybrid motor system → Hybrid motor cooling system → Coolant → Repairing procedure” chapter in the applicable workshop manual. Hybrid motor coolant drain is located on the front side of the radiator (A).

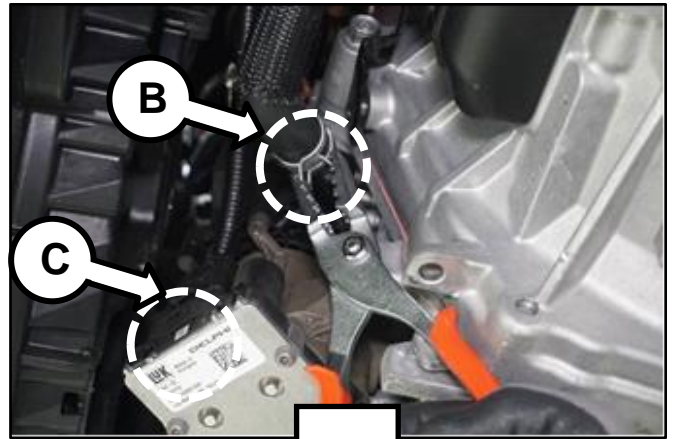
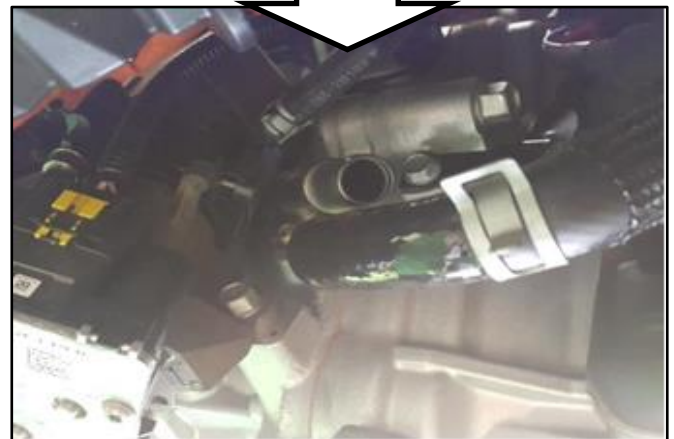
2. Remove the inlet hose by releasing the hybrid drive motor inlet hose clamp (B). Do not allow coolant onto the engine clutch actuator assembly, as this may damage the actuator (C).

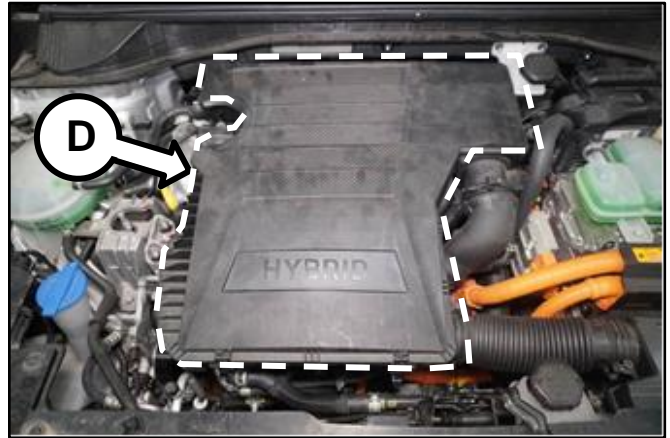
3. Lower the vehicle and remove the air cleaner (D).

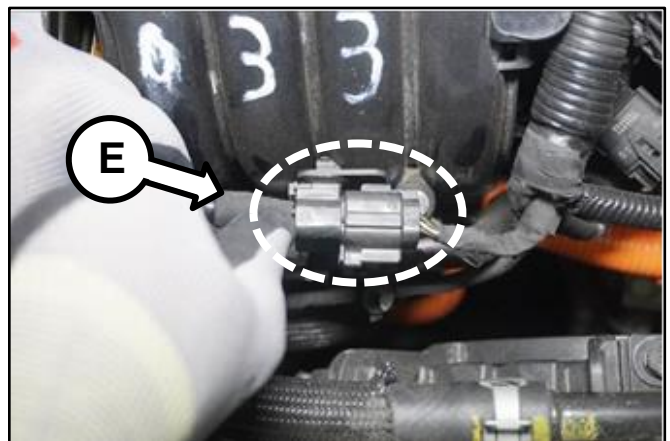
4. Remove the hybrid starter generator (HSG) temperature sensor connector (E).

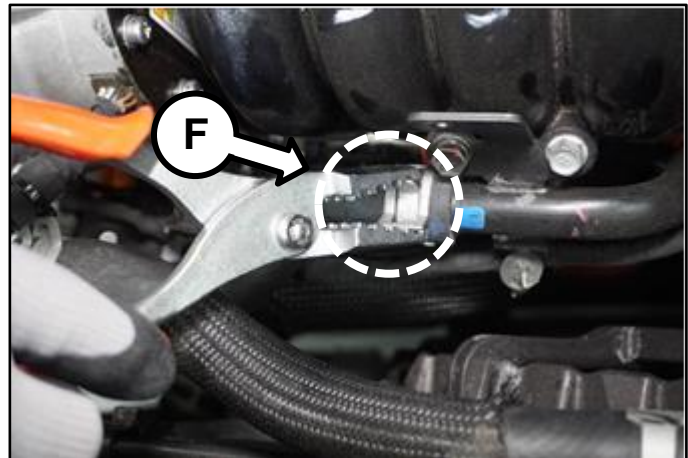
5. Release and move the HSG inlet hose clamp (F) and remove the HSG hose.

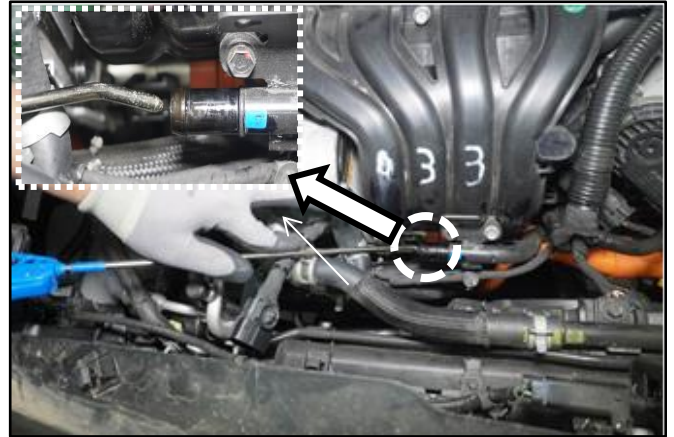
6. Drain the remaining traction motor coolant completely, by using an air gun as shown, into the drain pan left under the vehicle from step 2.

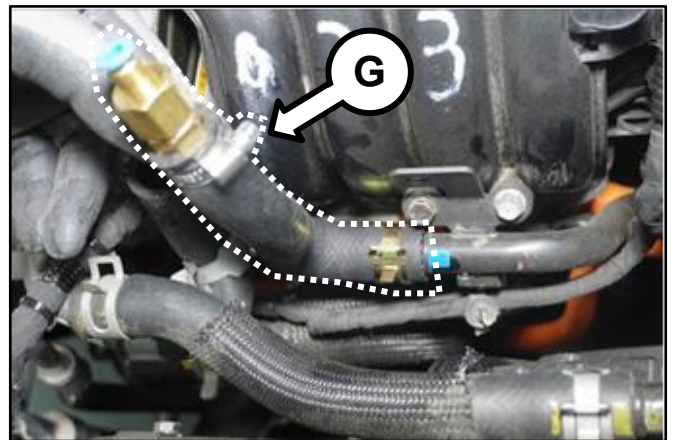
7. Connect the Pressure Test Adapter Hose (G) to the HSG inlet pipe.

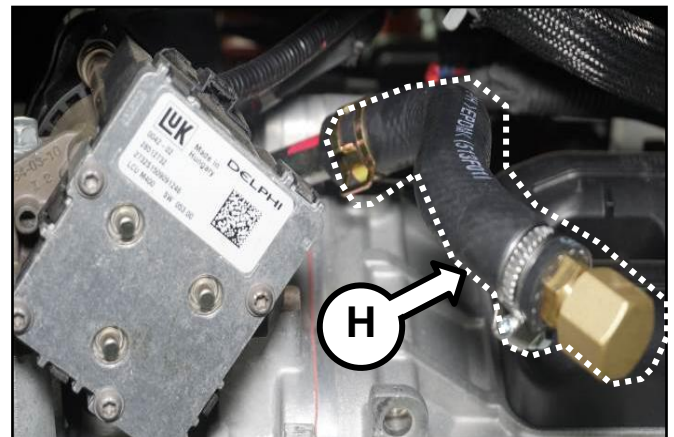
8. Raise the vehicle on a lift and connect the Capped Test Adapter Hose (H) to the hybrid drive motor inlet pipe.

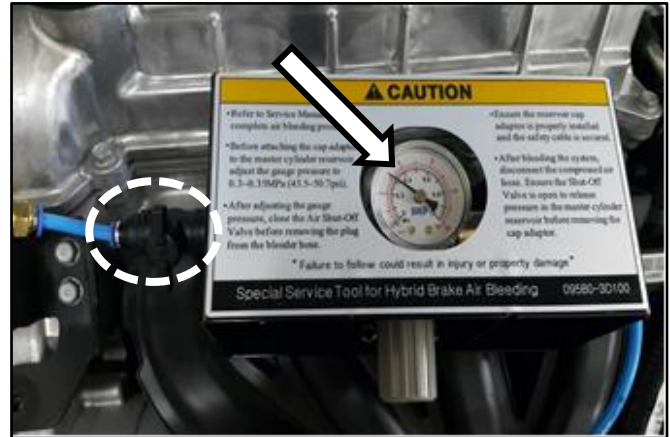
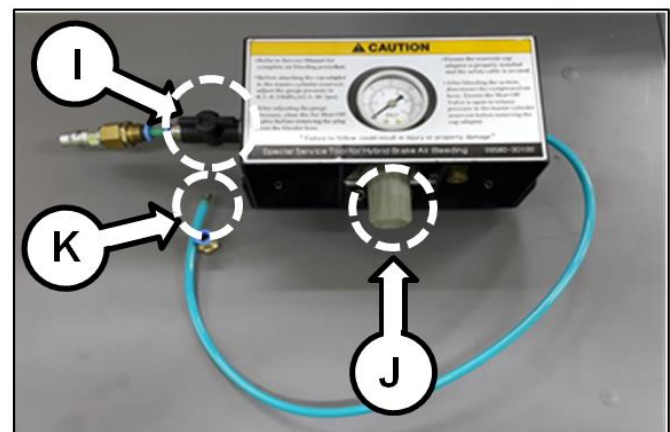
1. Close the valve (I), place the cap on the outlet hose (K), and install the air hose.
2. Open the valve (I).
3. Pull the pressure valve adjuster outwards (J) and adjust the pressure to 3 bars and push back in.
4. Close the valve (I) and remove the air hose. Pressure should remain at three (3) bars (confirm air bleeding tool is not leaking). If OK, proceed to step 7, if NG, then fix the leak before proceeding.
5. Open the valve (I) slowly and remove the pressure.
6. Close the valve (I).
7. Remove the cap (K) and install the air hose.
8. Install the output hose end into HSG inlet adaptor.
9. Attach the air hose and open the valve (I) and ensure 3 bars pressure.
10. Close valve (I), remove air hose and test for leaks.
 - Keep the pressure valve closed and monitor for one (1) minute and check to ensure the pressure remains at three (3) bars.

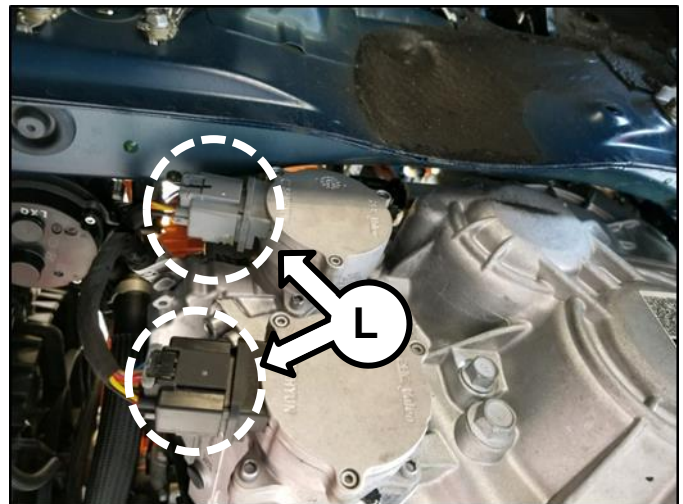
When removing/installing the traction motor/DCT assembly, the DCT clutch actuators/connectors can be damaged from interference with the LH frame rail. Avoid damage by carefully guiding the components past the rail during removal/installation.

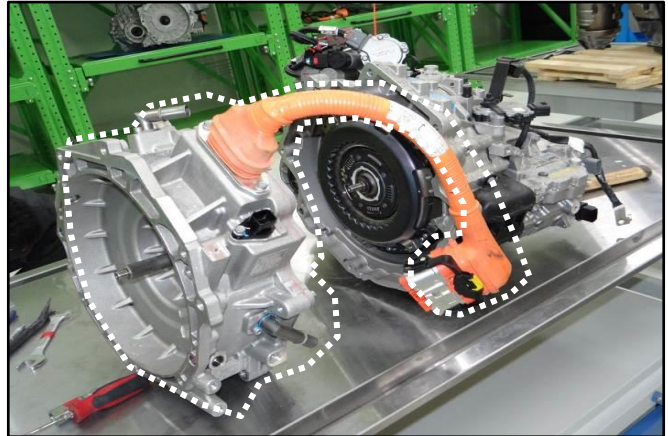
NOTE: When mating the traction motor/DCT assembly to the engine assembly, it may be necessary to rotate the crank pulley bolt to align the traction motor input splines with the engine's clutch.
