MODEL  
2018MY  
Stinger (CK)

NUMBER  
074

## TECHNICAL SERVICE BULLETIN

**SUBJECT:** SERVICE ACTION: THETA 2.0L TURBO ATF WARMER  
CONNECTOR REPLACEMENT (SA333)

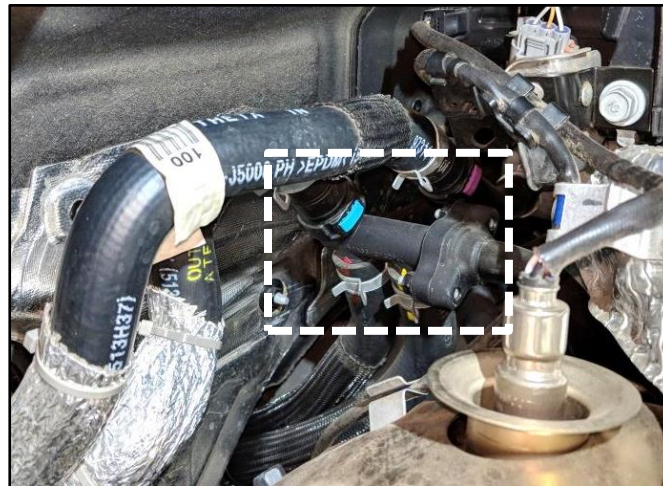
This bulletin provides the procedure to replace the Automatic Transmission Fluid (ATF) warmer connector on some 2018MY Stinger (CK) vehicles, equipped with the Theta 2.0L Turbo engine and produced from September 9, 2017 through January 4, 2018, which may exhibit a coolant fluid leakage between the ATF connector and engine side heater pipe. Follow the procedure outlined in this bulletin to replace the ATF warmer connector. Kia is requesting the completion of this Service Action on all affected vehicles in dealer stock, prior to delivery. Before conducting the procedure, verify that the vehicle is included in the list of affected VINs.
