142/17 ENU 4271

Noise Symptom - Creaking From Rear End Area: Checking rear spring strut for damage (SY 142/17)

Model Line: 911 Carrera/S/4/4S/GTS (991)

Subject: Rear supporting mount

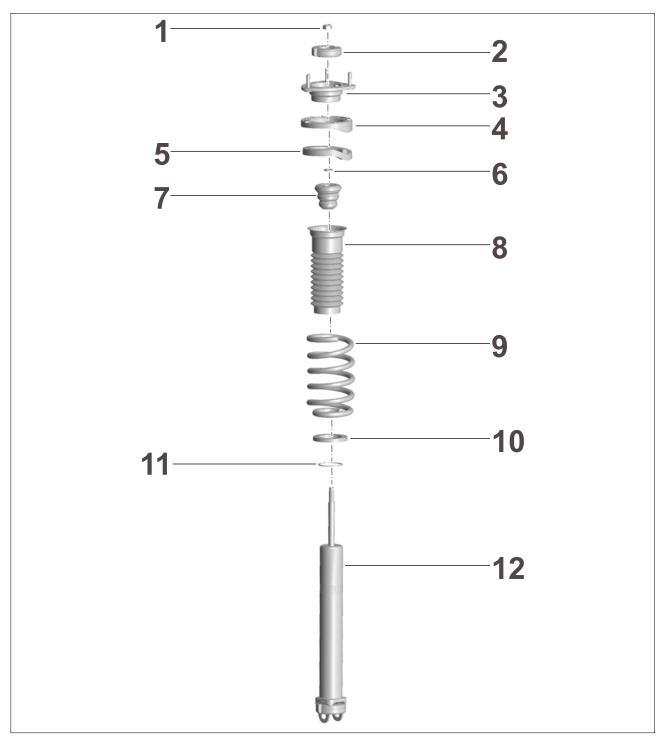
Overview of rear spring strut

Cause: The spring force of the coil spring may be outside of the tolerance range.

The increased transverse force as a result of this can overload the insert in the supporting mount.

The piston rod may no longer be guided in centrally and touches against the supporting mount housing.

2 Check insert (⇒ Overview of rear spring strut-2-), supporting mount (⇒ Overview of rear spring strut-3-), coil spring (⇒ Overview of rear spring strut-9-) and shock absorber (⇒ Overview of rear spring strut-12-) for damage.

3 If you find signs of damage, such as chafing or score marks, **replace** inserts (⇒ *Overview of rear spring strut* -2-), supporting mounts (⇒ *Overview of rear spring strut* -3-), coil springs (⇒ *Overview of rear spring strut* -9-) and shock absorbers (⇒ *Overview of rear spring strut* -12-) on the affected spring strut.

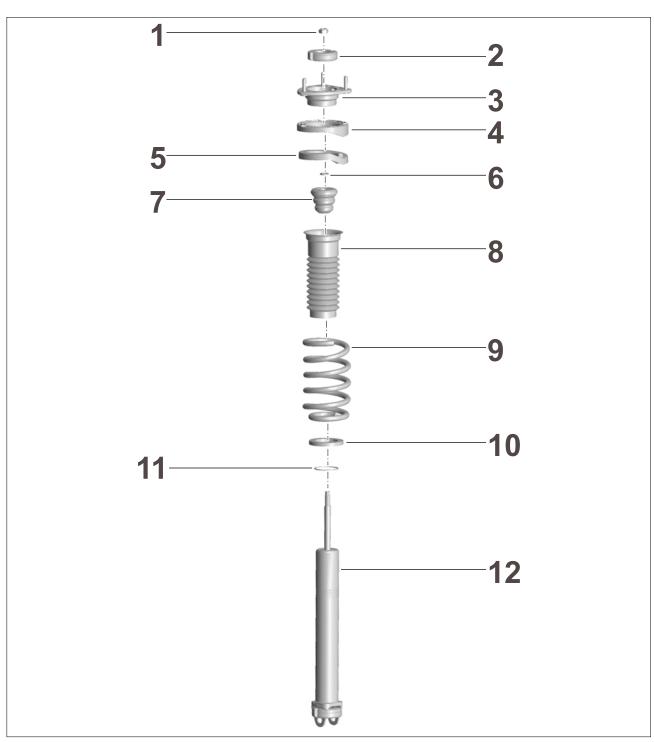
Overview of rear spring strut

If the insert shows no sign of damage on the outside, it may be damaged by the metal core on the inside.

3.1 Inserts (⇒ Overview of rear spring strut-2-), supporting mounts (⇒ Overview of rear spring strut-3-) and coil springs (⇒ Overview of rear spring strut-9-) must be replaced in pairs. ⇒ Workshop Manual '427137 Disassembling and assembling rear spring strut'

- Mileage: 15,500 miles (25,000 km)
- Age: 2 years
- 3.2 Shock absorbers (*⇒ Overview of rear spring strut-12-*) must be replaced in pairs, depending on mileage and age.
