Advanced Technical Information

Cayenne (92A)
1801 1945

Additional Coolant Pump Fault (POC4700) Causes MIL

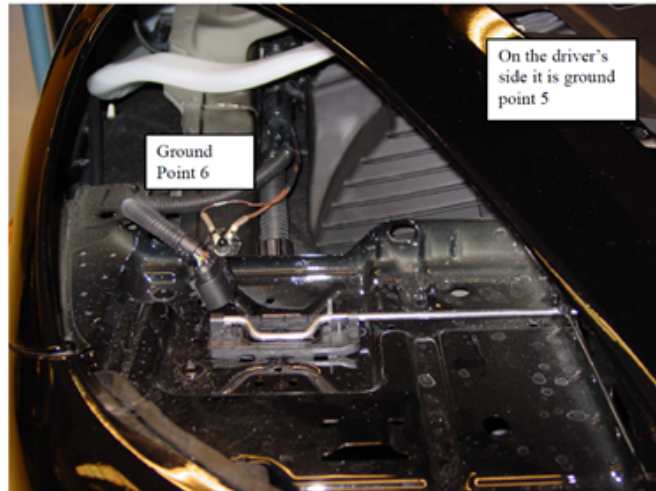
Figure 1 – Ground Pin 6B

- a) Corrosion on Ground Pin 6B (See figures 1 and 2.)
- b) Corrosion on the connector to the secondary low temperature coolant pump.
- c) A bad ground or otherwise unsound wiring.

Looking into right front wheel well through the headlamp area (Driver side similar)

The service recommendation is to check the ground, connector, and wiring for corrosion and circuit continuity. Repair the ground, connector, or wiring as needed. Sometimes, the ground bolt is painted and not adequately conductive. In this case, clean the ground bolt and eyelet using a wire brush and sandpaper.

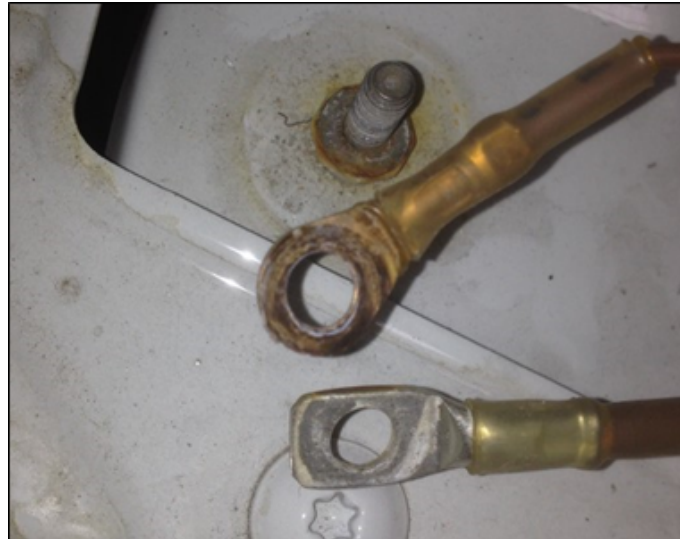
Figure 2 – Example of corrosion on ground point
