# TECHNICAL SERVICE BULLETIN

Technical Service Bulletin: 77-0622

Forest River is alerting you to an issue involving certain 2018 No Boundaries ("No Bo") NBT10.5, NBT10.6, NBT16.5, NBT16.7, NBT19.5 travel trailer recreational vehicles. Please see the information below which describes the issue and provides you with details on the steps you should take to have your vehicle repaired.

# NO BOUNDARIES ("NO BO") – WINTERIZATION REMEDY INSTRUCTIONS

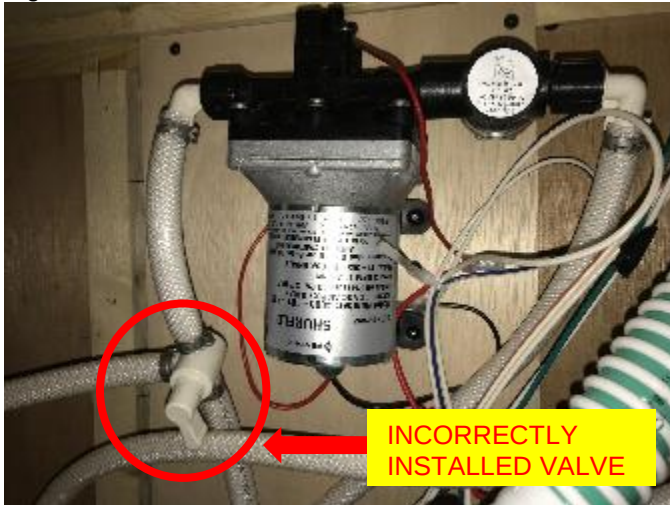
Figure 1

The manufacturing plant installed the winterization valve on the pressure side (vehicle side) of the water pump. The winterization valve should have been connected to the intake/suction side of the water pump. If the waterlines and water using components are not appropriately winterized from freezing, the components and waterlines may crack, break, etc. potentially voiding the component manufactures warranty.

Step 2: Inspect the 3-Way Valve location, if the Valve is on the Pressure Side of the water pump as shown in Figure 1, proceed to the remedy by ordering **KIT NUMBER: 60P15984A**;

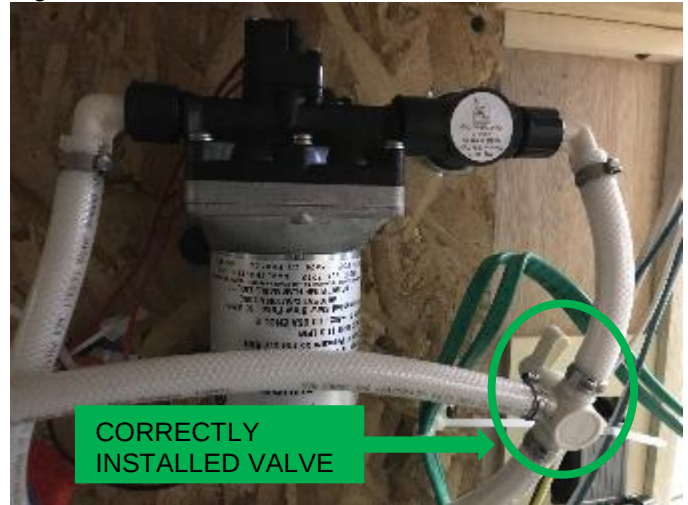
Step 3: If the Valve is installed according to Figure 2, do not proceed with the remedy. *Claim the Inspection Code.*

Remedy – Refer to Figure 2 for the Remedy if needed

- Step 1: Using a cutting tool such as a box cutter, cut the white water hose close to the valve then discard valve assembly;
- Step 2: Slide the provided hose clamps on each of the white hoses;
- Step 3: Insert the waterline coupler into each hose and secure tightly with the hose clamps on each side of the coupler;
- Step 4: Cut the white water line hose approximately 4 inches from the 90° elbow;
- Step 5: Slide the provided hose clamps on each of the white hoses;
- Step 6: Insert the provided pre-assembled valve into each hose with the handle pointing towards the white waterline to the pump

**Important note important: on the valve is the word "IN" ensure the valve handle is turned to cover this word**

Step 7: Secure the hose clamps onto the valve tightly

Step 8: Test the water system to ensure there are not any leaks
