SERVICE INFORMATION BULLETIN

APPLICABILITY: 2017-2018MY Impreza
2018MY Crosstrek

NUMBER: 07-129-18

SUBJECT: Inaccurate Tire Pressures
Displayed in Combination Meter

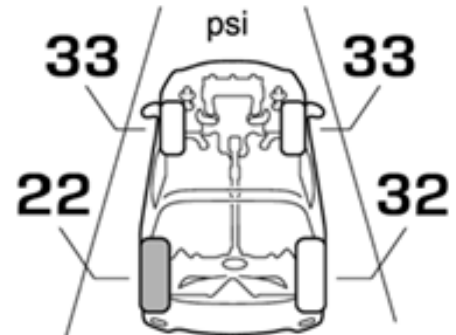
This bulletin announces availability of reprogramming files to optimize operation of the Tire Pressure Monitor System's (TPMS) real-time display function. Under certain high-altitude conditions, the tire pressure values displayed in the combination meter may not be accurate.

NOTE: The TPMS Real Time display is independent of the actual TPMS function. Should an actual low tire pressure condition occur, the TPMS indicator light will illuminate as expected.
