SERVICE INFORMATION BULLETIN

APPLICABILITY: 2015-2017MY Legacy and Outback
 2015-2016 Impreza
 2015-2017 Crosstrek
 2016-2018MY Forester
 2016-2018MY WRX

NUMBER: 15-205-16R
DATE: 11/21/16
REVISED: 01/03/18

SUBJECT: Reprogramming File Availability to Address Operational Concerns with “Gen 2” Fujitsu-TEN (F10) Navigation and 7” Display Audio Units

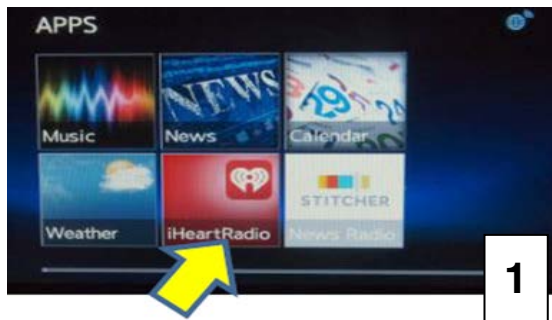
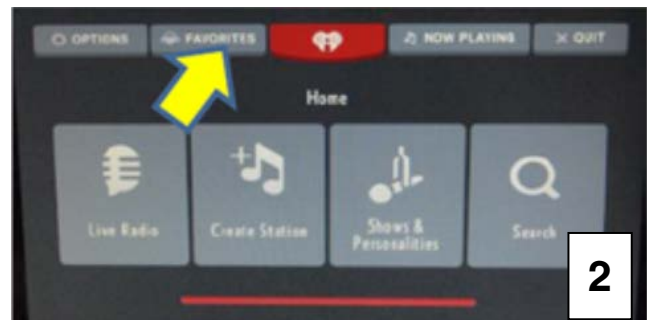
- **SXM channels higher than 256 cannot be selected using the voice command feature.**
- **Additional characters appear (in this example, question ??? marks) after entering an e-mail address and password using the software keyboard when attempting to log in to an iHeart radio account as shown in the screen shot sequence below.**

This bulletin announces new reprogramming file availability and the software installation procedure to address additional operational concerns received from the field and listed below involving “Gen 2” F10 Navigation and Display Audio units with 7” display. The procedure will involve downloading the applicable software update files then loading them onto **two** flash drives for audio unit installation. It is important to read through and understand this information completely before proceeding. These latest software updates contain new logic to address the following concerns:

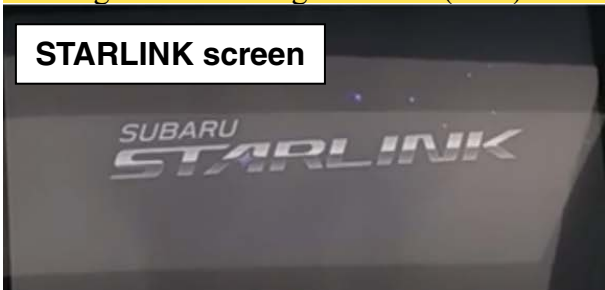
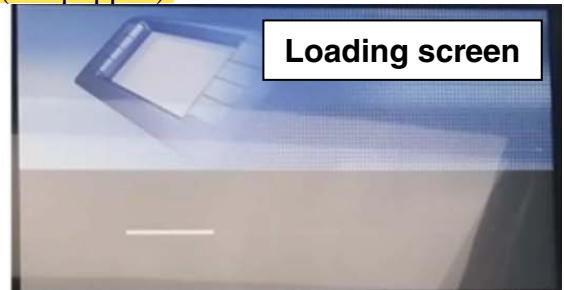
- The Navigation system re-boots from the Loading screen (not the STARLINK screen) when utilizing the remote engine starter (RES) feature (if equipped).

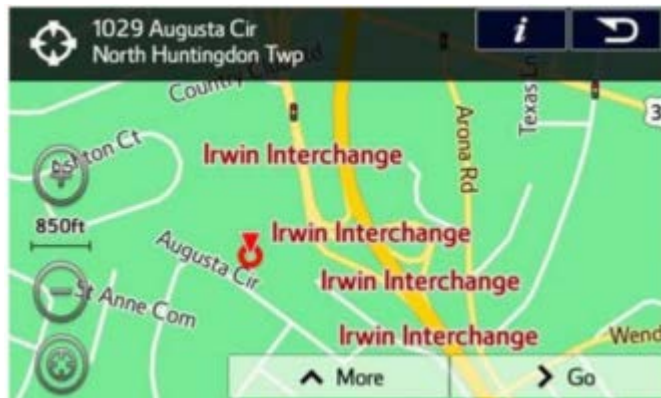
Symptom 6: Roads or interchanges have the same name displayed multiple times.

Change: Logic update to show only one road or interchange name at the same time.

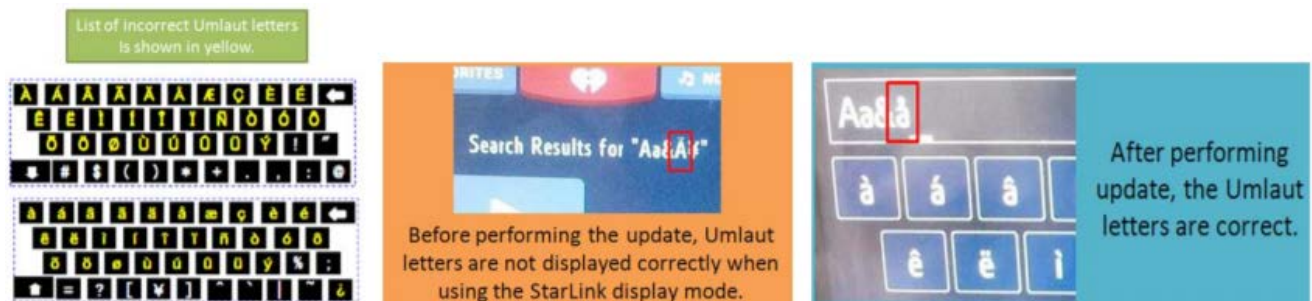
Symptom 11: Incorrect Umlaut characters are shown on STARLINK display.

Change: Logic change to allow proper display of Umlaut letters.

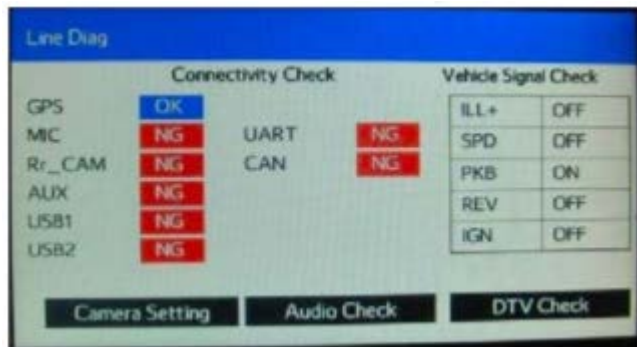
Symptom 14: “Line Diag” screen is intermittently displayed while driving.

Change: Logic change to prevent display of the “Line Diag” screen.

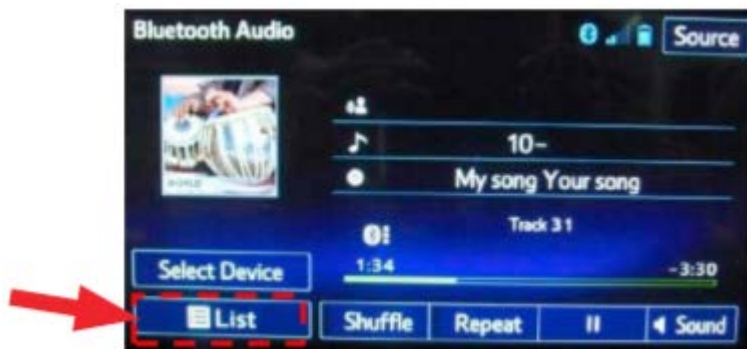
Symptom 15: “LIST” soft touch key is not displayed on Bluetooth Audio screen while using Bluetooth audio feature with an Apple device utilizing iOS8 software version.

Change: Logic change to enhance compatibility with iOS8 software.

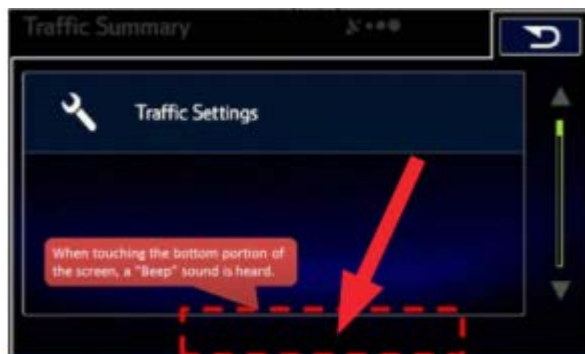
Symptom 16: “Beep” sound heard when touching the bottom of the display screen where no function soft touch keys are displayed.

Change: Logic change to eliminate beeping sound from inactive soft touch key screen areas.

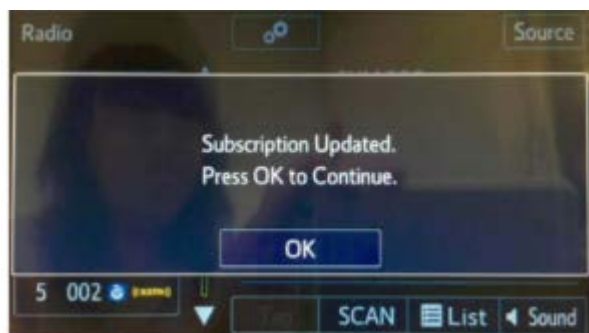
Symptom 17: SXM caution message screen is displayed in English even when French language operation settings are selected.

Change: Logic change to make all messages display in the selected operating language.

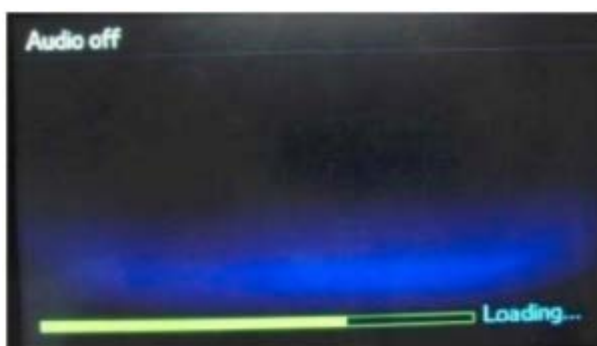
Loading Screen

- Repeated display of the “Loading” screen at initial unit start-up

Change: Logic updates included where applicable to address each of the following conditions:
