NEW 2018 Eclipse Cross

Vehicle Technical Info

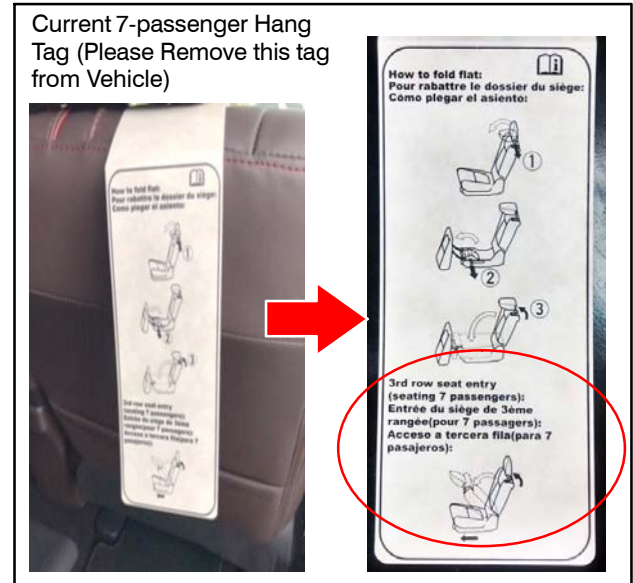
“Some early 2018 Outlander PHEV vehicles were shipped with a hang tag that describes third row seat operation, even though there is no third row seat. These hang tags were meant for 7-passenger Outlander vehicles, and were inadvertently placed in some Outlander PHEV models.

Dealers are asked to remove and discard these hang tags during PDI, and on any vehicles currently in dealer inventory. This will prevent any confusion and help ensure a high level of customer satisfaction with every vehicle sold. Please make sure that sales personnel demonstrate second row seat operation to the customer to their satisfaction.

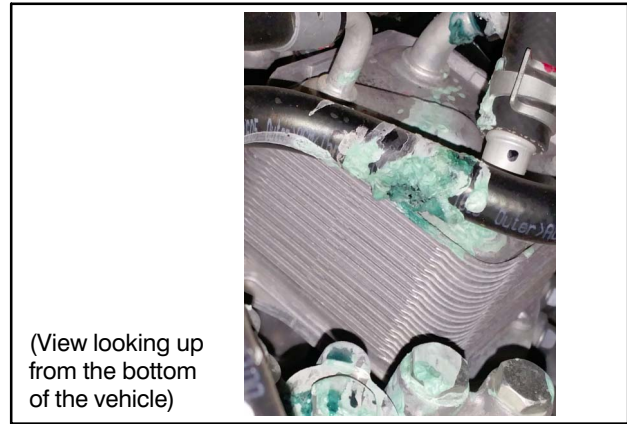
“Dealers have reported coolant leaking from the water hoses at the CVT8 fluid cooler (see photo below). Normal dealer repairs have been to replace the water hose and/or clamps on the affected area.

In order to investigate this condition further, MMNA is looking to collect 5 complete sets of CVT8 fluid coolers with the water hoses and clamps **undisturbed**. Please do not remove the water hose clamps indicated by the circled areas in the photo below (the other hoses are for the CVT8 oil, not coolant). This is important since MMC needs to perform a duplication test to confirm the area of leakage.

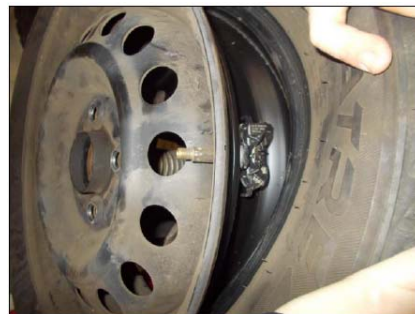
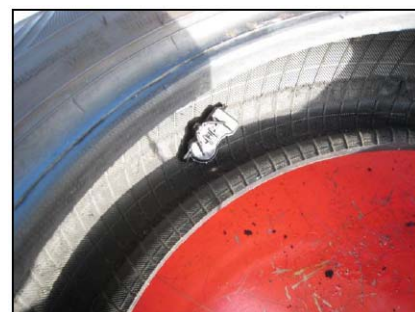
2. A photo of the TPMS transmitter and valve stem taken when the tire was dismounted at your dealership. The photo must show whether or not the sensor was attached to the wheel (valve stem) or loose inside the tire upon arrival. **GOOD** photos: Below are two examples of “Good” photos submitted to the PRC. In one case, the sensor was attached to the wheel, and the other shows it was loose in the tire.

GOOD EXAMPLES OF SUBMITTED PHOTOS
(showing location of sensor, attached and unattached)

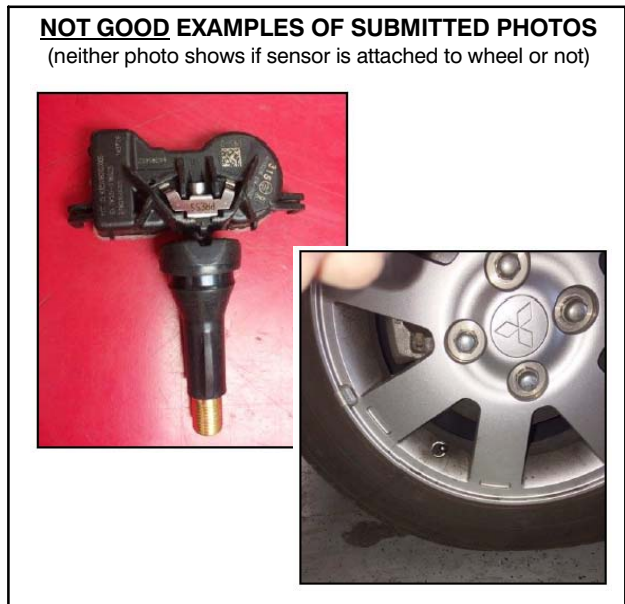
NOT GOOD photos: Below are two examples of “Not Good” or unacceptable photos submitted to the PRC.

A photo of the sensor by itself or of the outside of the wheel does NOT show where the sensor was in relation to the wheel and tire upon arrival at the dealership.

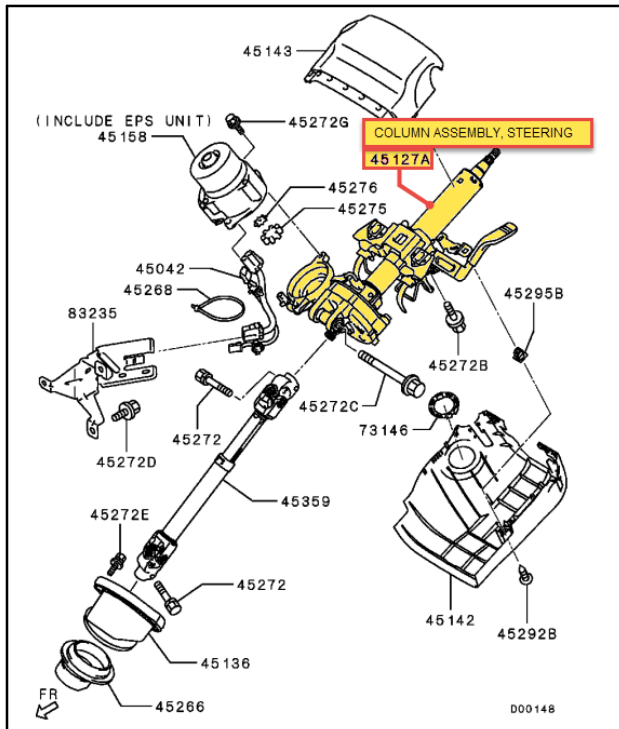
In case you find DTC C1512 in the Electric Power Steering (EPS), obtain and attach Freeze Frame Data (FFD) to the PRC, and perform all the checks in the diagnostic procedure of the Workshop Manual. If all checked items are found to be normal (CAN bus line, connectors C-145-1 and C-145, pins 21 - 24 [C-145-1], wiring harness inspection, voltage measurement at pins 22 & 24, data list check of items 1 & 2), then replace the steering column assembly **ONLY**. Please see highlighted part in the following diagram. There is no need to replace the steering motor.

NOTE: Make sure the vehicle did not have a prior accident involving the steering system.

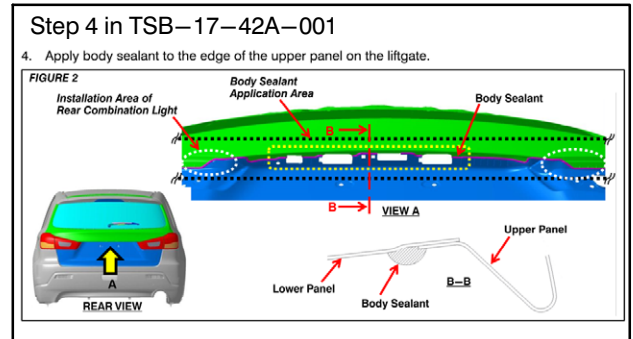
Service part liftgates, part numbers 5801B559 and 5801B862, do not require the application of seam sealer, shown in step 4 of TSB-17-42A-001. This hatch is built with a different material and does not require the sealer.

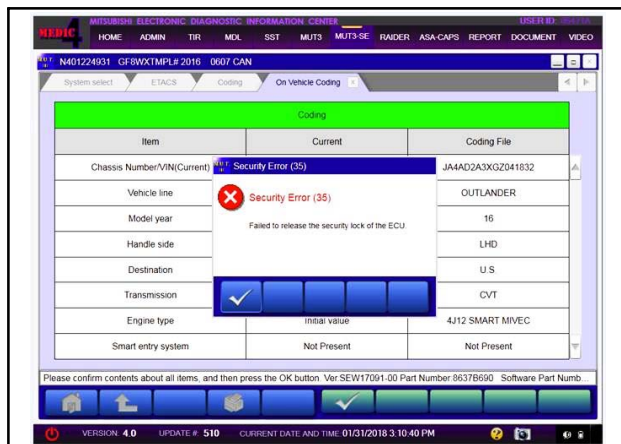
When performing ETACS coding with MUT3 SE after ETACS replacement, a “Security Error (35)” screen may be encountered. This screen (shown below) will be displayed during the coding step of the new ETACS if the items in the Loading Option fields are either not selected or selected incorrectly.

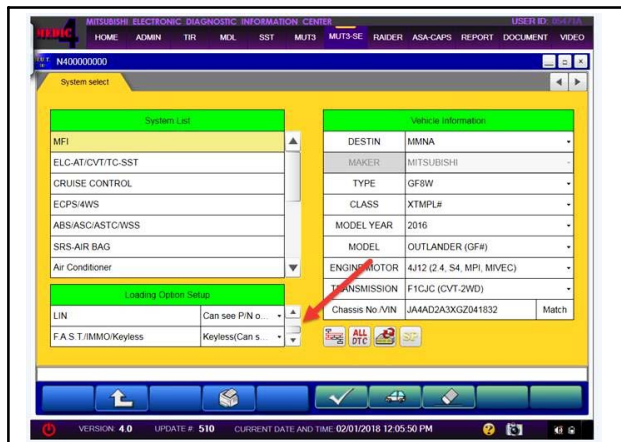
The proper key system selection must be made in the Loading Option Setup area of the MUT3 SE screen. Some techs are not aware they need to scroll down to select the additional options. If these options are NOT selected, they will run into error screens during ETACS coding.

If these error screens are encountered, go back to the System Select screen and select the correct loading options. Be sure to scroll down to see additional selections and select all those applicable to your vehicle.
