Technical Service Bulletin

SUBJECT:			No: TSB-18-54-001
COMMUNICATION MALFUNCTION OF TELEMATICS CONTROL UNIT (TCU) / MITSUBISHI CONNECT			DATE: February 2018
			MODEL: 2018 Eclipse Cross
CIRCULATE TO:	<input checked="" type="checkbox"/> GENERAL MANAGER	<input checked="" type="checkbox"/> PARTS MANAGER	<input checked="" type="checkbox"/> TECHNICIAN
<input checked="" type="checkbox"/> SERVICE ADVISOR	<input checked="" type="checkbox"/> SERVICE MANAGER	<input checked="" type="checkbox"/> WARRANTY PROCESSOR	<input checked="" type="checkbox"/> SALES MANAGER

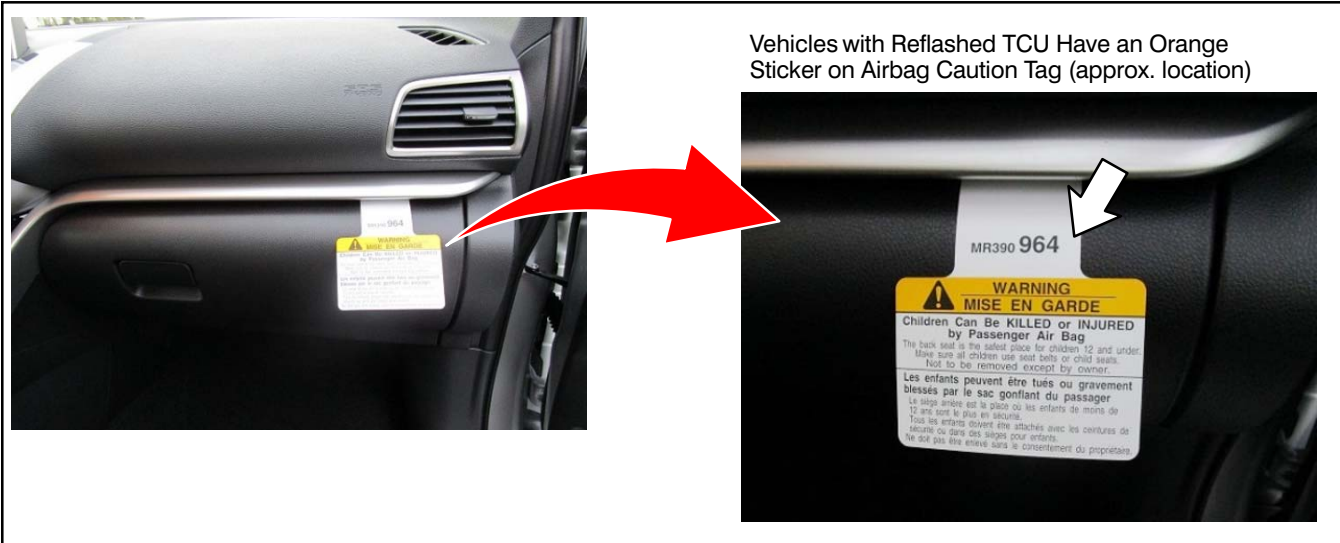
!! IMPORTANT !! Some vehicles may have already had the reflash completed at the Port. These vehicles have been marked with an 8 mm orange sticker on the Airbag Caution tag attached to the right side of the glove box, in the approximate location shown below.

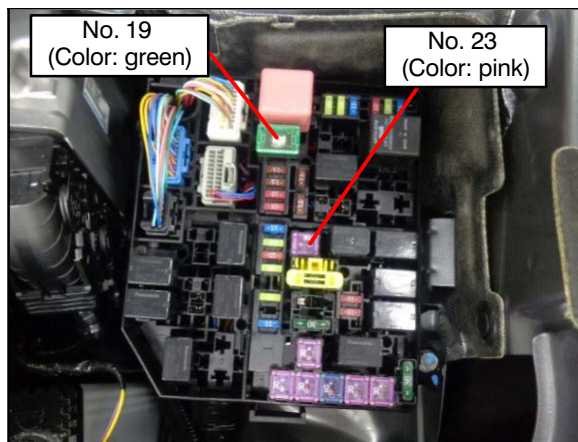
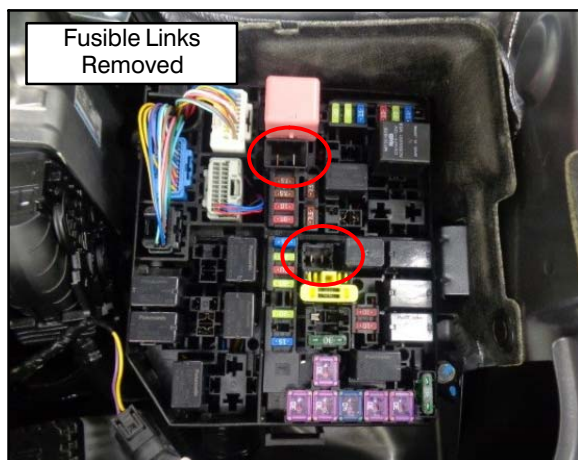
1. Locate fuse box in engine compartment.

2. Remove the following fusible links:

- No. 19 (Green)
- No. 23 (Pink)

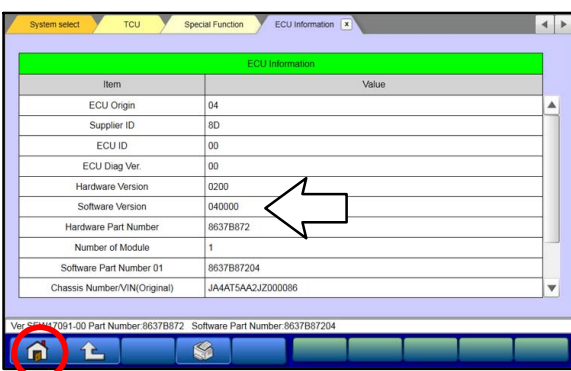
d. If "Software Version" is "060000": the TCU has already been reprogrammed.

If software version is **older** than "060000" (040000, 050000), then the TCU needs to be reprogrammed to the latest version.

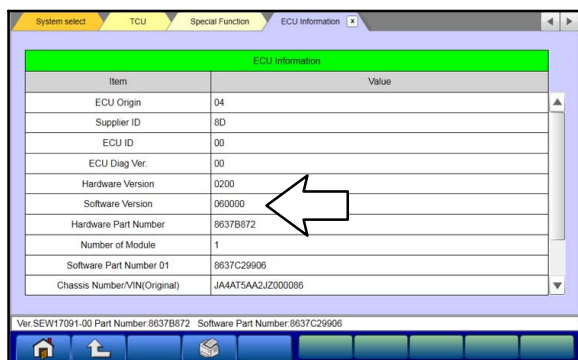
Confirm “Software Version” is now “060000.”
