BR18-003

February 14, 2018

## 2017 QX80; DTC C1116 AND VDC WARNING LAMP ON

**APPLIED VEHICLES:** 2016 – 2017 QX80 (Z62) equipped with Distance Control Assist (DCA)

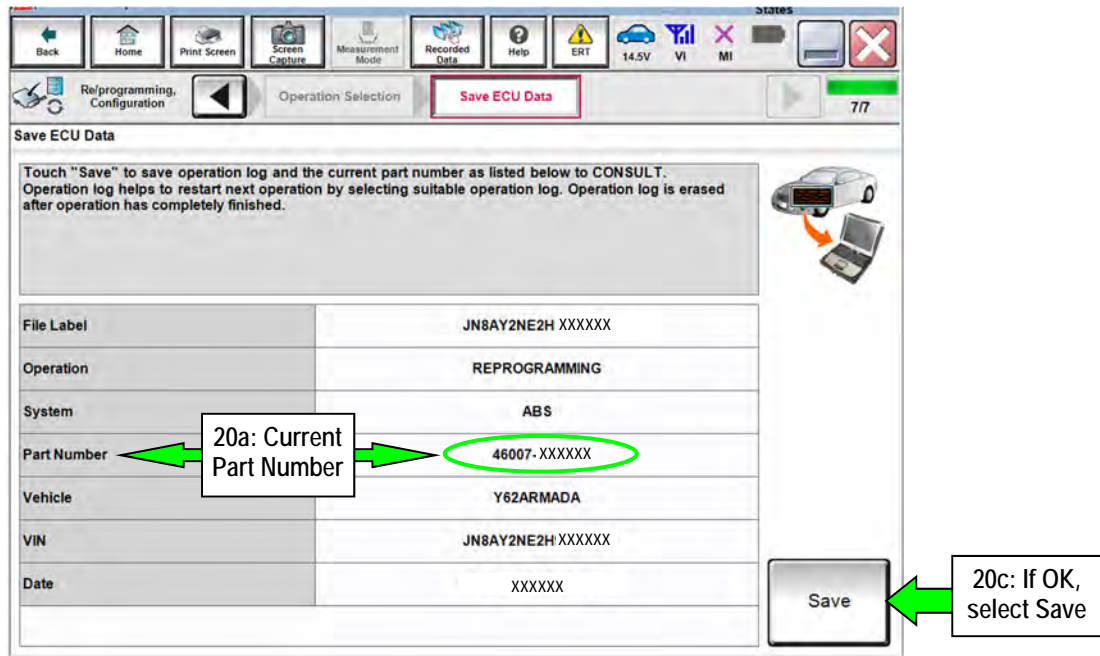
Figure 9

20. When you get to the screen shown in Figure 9, confirm reprogramming applies as follows:

a. Find the ABS Part Number and write it on the repair order.

NOTE: This is the current ABS Control Unit Part Number.

b. Compare the P/N you wrote down to the numbers in the **Current Part Number** column of **Table A** below:

- If there is a match, this bulletin applies. Continue with the reprogramming procedure on the next page.
- If there is not a match, this bulletin does not apply. Close C-III plus and check ASIST for further diagnostic and repair information.

c. If there is a part number match as specified below, select **Save** and then continue with the reprogramming procedure on the next page.

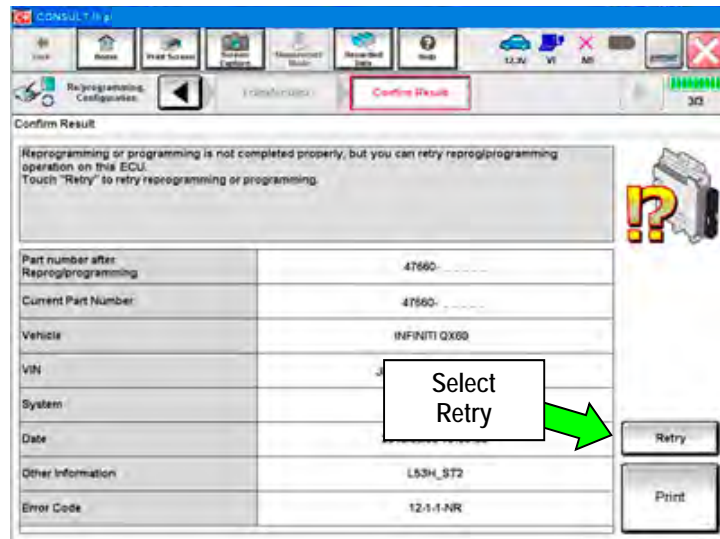
Figure 19

If reprogramming does not complete and the "!" icon displays as shown in Figure 19:

- Check battery voltage (12.0–15.5 V).
- Ignition is ON, engine OFF.
- External Bluetooth® devices are OFF.
- All electrical loads are OFF.
- **Select retry and follow the on screen instructions.**
- "Retry" may not go through on the first attempt and can be selected more than once.

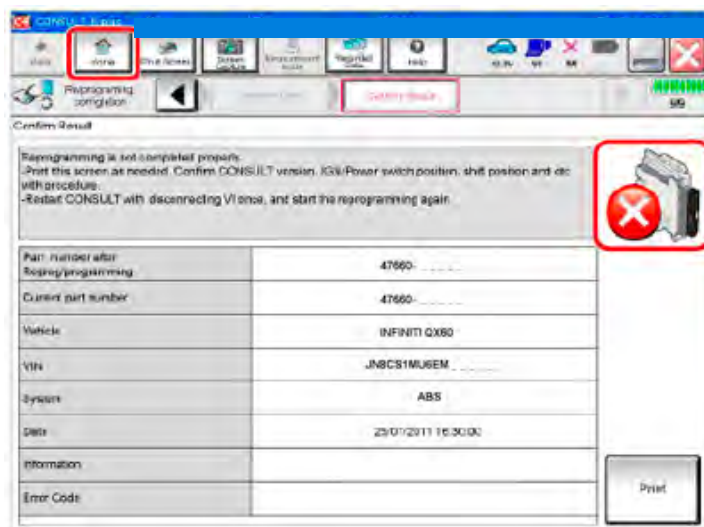
Figure 20

If reprogramming does not complete and the "X" icon displays as shown in Figure 20:

- Check battery voltage (12.0 – 15.5 V).
- CONSULT A/C adapter is plugged in.
- Ignition is ON, engine OFF.
- Transmission is in Park.
- All C-III plus / VI cables are securely connected.
- All C-III plus updates are installed.
- **Select Home, and restart the reprogram procedure from the beginning.**
