# SERVICE BULLETIN

Classification: BR18-002a	Reference: NTB18-013a	Date: February 28, 2018
------------------------------	--------------------------	----------------------------

## 2017 ARMADA; DTC C1116 AND VDC WARNING LAMP ON

**APPLIED VEHICLES:** 2016 -2017 Armada (Y62) equipped with Distance Control Assist (DCA)

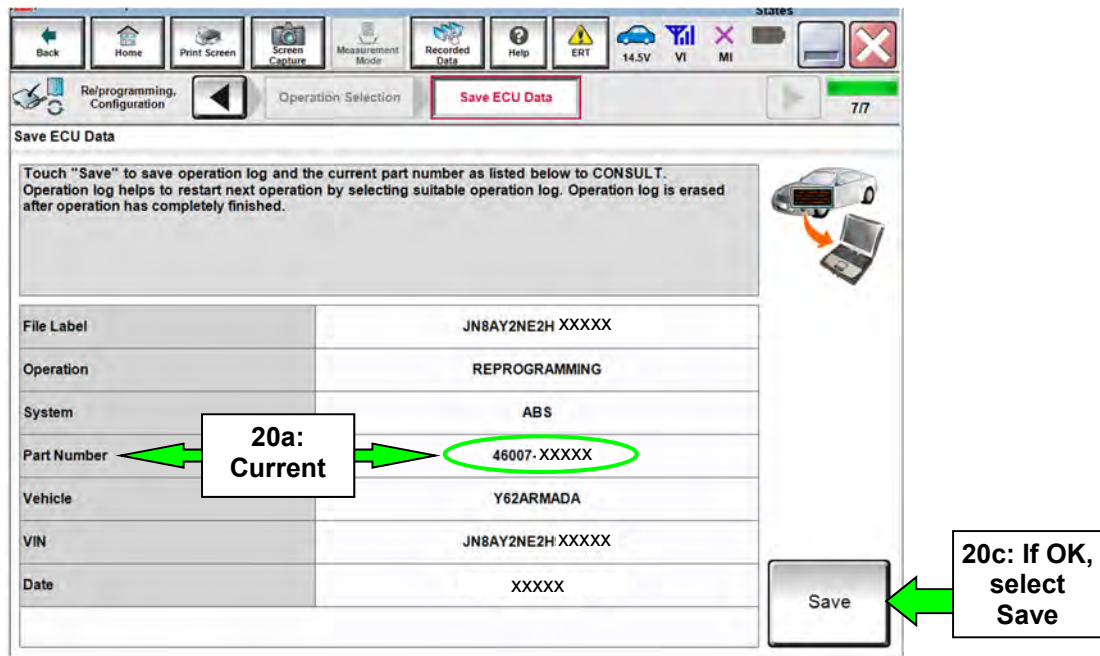
Figure 9

- a. Find the ABS Part Number and write it on the repair order.  
**NOTE:** This is the current ABS Control Unit Part Number.

- b. Compare the P/N you wrote down to the numbers in the **Current Part Number** column of **Table A** below:
  - If there is a match, this bulletin applies. Continue with the reprogramming procedure on the next page.
  - If there is not a match, this bulletin does not apply. Close C-III plus and check ASIST for further diagnostic and repair information.
- c. If there is a part number match as specified below, select **Save** and then continue with the reprogramming procedure on the next page.

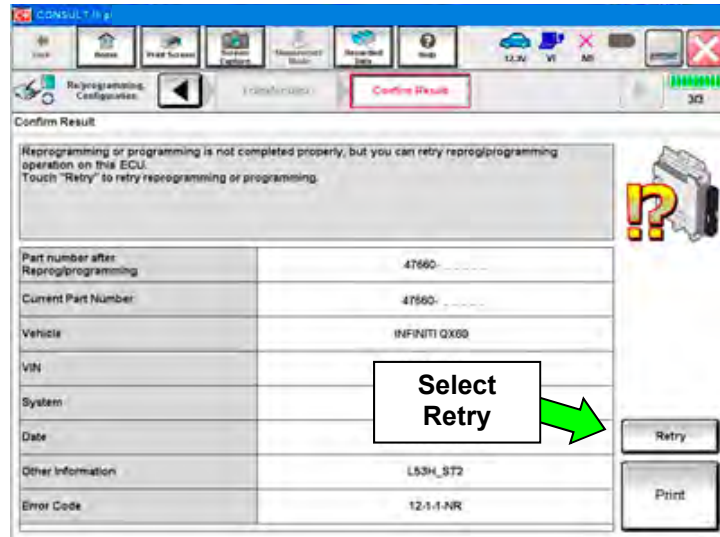
Figure 19

If reprogramming does not complete and the “!?” icon displays as shown in Figure 19:

- Check battery voltage (12.0–15.5 V).
- Ignition is ON, engine OFF.
- External Bluetooth® devices are OFF.
- All electrical loads are OFF.
- **Select retry and follow the on screen instructions.**
- “Retry” may not go through on the first attempt and can be selected more than once.

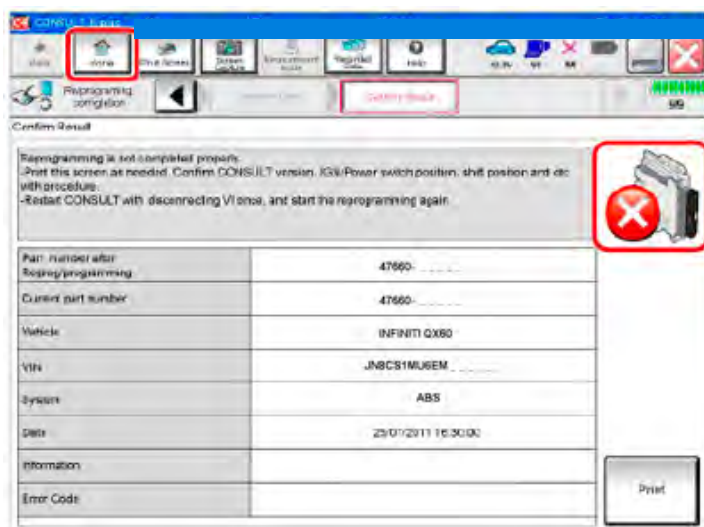
Figure 20

If reprogramming does not complete and the “X” icon displays as shown in Figure 20:

- Check battery voltage (12.0 – 15.5 V).
- CONSULT A/C adapter is plugged in.
- Ignition is ON, engine OFF.
- Transmission is in Park.
- All C-III plus / VI cables are securely connected.
- All C-III plus updates are installed.
- **Select Home, and restart the reprogram procedure from the beginning.**
