**Engine News****The Proper Torque for the Intake Valve Actuation Piston Jam Nut on Certain C15 and C18 Engines {1130}**

Media Number -M0091740-00

Publication Date -2018/02/26

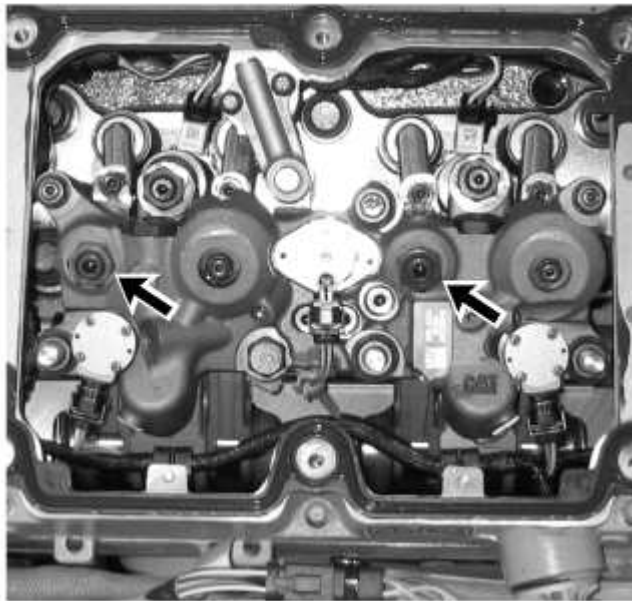
Illustration 1

The function of the Intake Valve Actuation (IVA) piston is extremely sensitive to the torque applied to the jam nut. When the torque applied to the jam nut is higher than what is recommended in the service documentation, the piston may become sticky or seize causing erratic operation. Symptoms of a sticky or seized IVA piston could be misfire, white smoke, or -7 diagnostic codes. The piston will also be sticky or seized, but will move freely when the correct torque is applied.

Torque jam nut of the IVA ...  $50 \pm 5 \text{ N}\cdot\text{m}$  ( $37 \pm 4 \text{ lb ft}$ )
