## Reman CPI Nuevo Laredo - Some Reman 3126 HEUI Injectors were Shipped with an Incorrect O-ring Seal (148-2903).

(Status Updated: 20Feb2018)

CPI Number: 400017  
 Status: Open , Active  
 6 Sigma Phase: Analyze  
 Commercial Impact:  
 Initial Project Activation Date: 30Aug2017  
 Target Completion Date: 19Aug2018

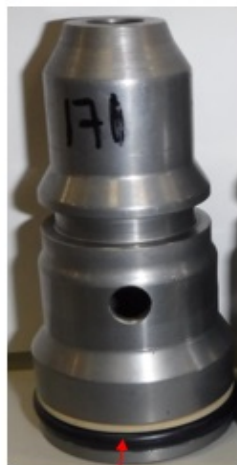
Correct

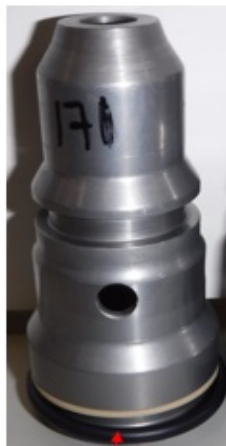
A dealer has reported that the o-ring seals, for the middle location on the injector, are too loose. From measurements, it was determined that these seals were incorrectly chosen, packaged and shipped with the injectors.

Incorrect

Some Reman 3126 HEUI Injectors were shipped with incorrect Case Orings (P/N 148-2903) These Orings are shipped in a separate kit with the Injector. Please use 148-2903 Oring from dealer stock to replace any incorrect Orings. Incorrect Oring is larger in internal diameter & thinner if installed will be loose on the nozzle case. Submit a part stock warranty claim for the incorrect O-ring. Please include injector serial number in the claim. Service Letter PI70680 Approved 9/25/2017. Root cause has been identified team working on Permanent corrective Action, PCA implementation end of March 2018

**Repair Action:** Have field update stock with correct oring seals.
