N109NAS2

TECHNICAL BULLETIN

501-12: Instrument Panel and Console

Service Action: Sliding Armrest Rattle And Excessive Free Play

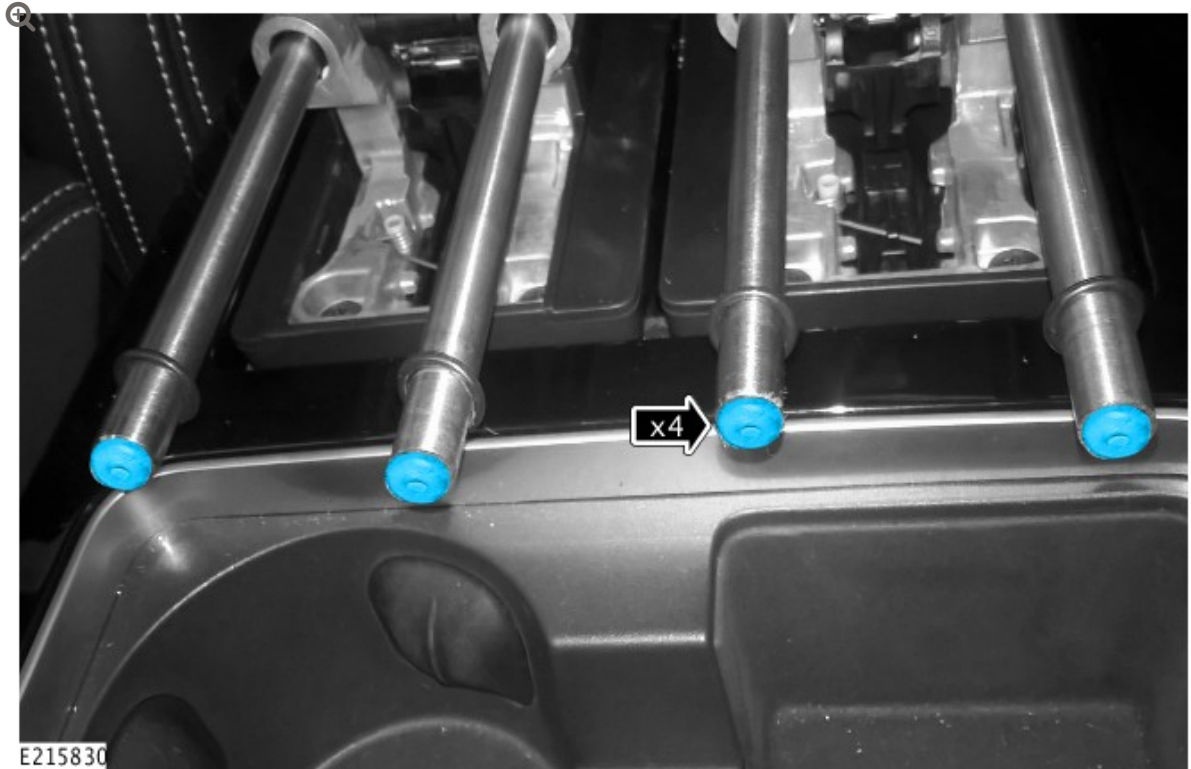
5

An issue has been identified on certain vehicles within the listed Affected Vehicle Range where the front floor console left and right sliding armrests have free play back and forth.

Install the 4 rubber buffers into the front end of the sliding arms.

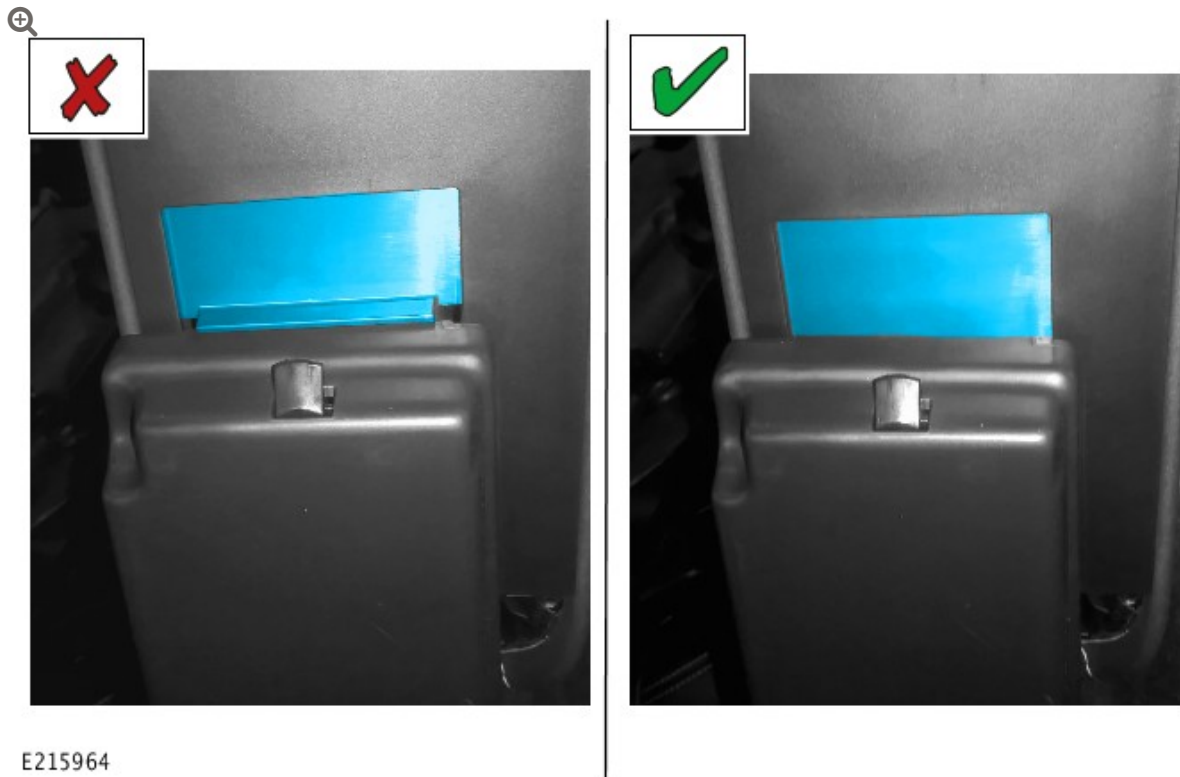
6

Visually inspect the floor console storage compartment lids.

- If the gap hider is installed correctly (✓), go to Step 7.
- If the gap hider is not installed correctly (✗), push the gap hider into its correct location.
 - Once the gap hider is installed correctly (✓), go to Step 7.
