LTB01034NAS2

TECHNICAL BULLETIN

303-05: Accessory Drive

Engine Accessory Drive Idler Pulley and Belt Failure

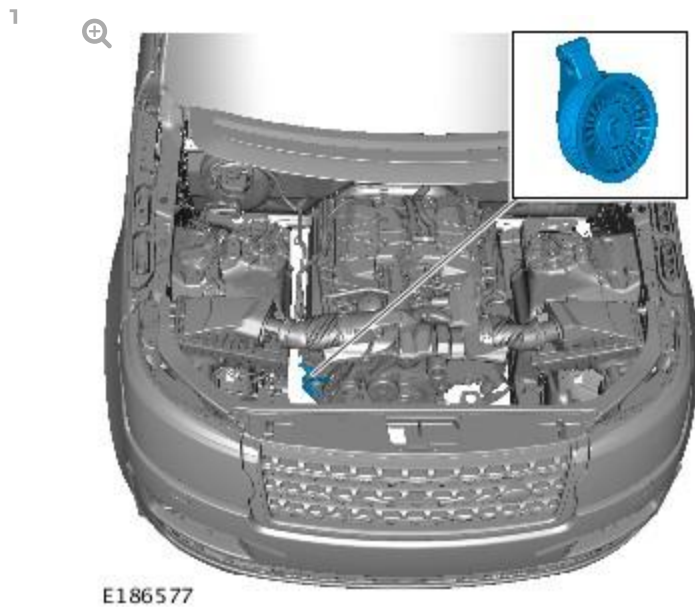
COMPONENT LOCATION

A rubbing type noise from the engine compartment may be evident; the coolant temperature gauge may display a high temperature reading; and/or the battery warning light may be illuminated.

This may be caused by the engine accessory drive belt becoming damaged due to engine accessory drive primary right-hand idler pulley failure.

Component location.
