**Title:** IC Bus with ISB Frequent Regeneration

**Applies To:** IC Bus ISB

This document will guide the user through resolving Frequent Regen issues on IC Bus with ISB 6.7.

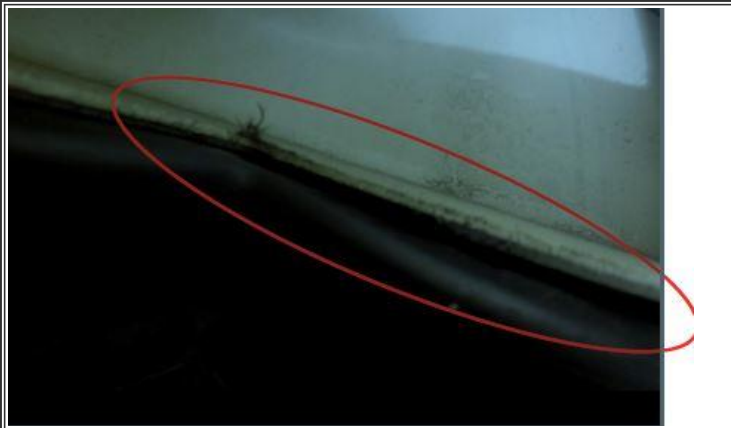
1. Airbox boot seal to the hood compromised. Middle section may appear bent or folded in. The seal position looks off-centered from the hood.

**Figure 1: Gap between Boot seal and Hood**

Step	Action	Decision
3	<p><b>DIAGNOSTIC:</b></p> <p>With the hood in the fully latched position, inspect the accordion boot seal to hood.  <b>See Figure 1 and 2</b></p> <p>Is a gap present between the seal and hood?</p>	<p><b>Yes.</b>                      Replace the cover assembly.</p>
		<p><b>No.</b> Return to Fault Code Diagnostics</p>

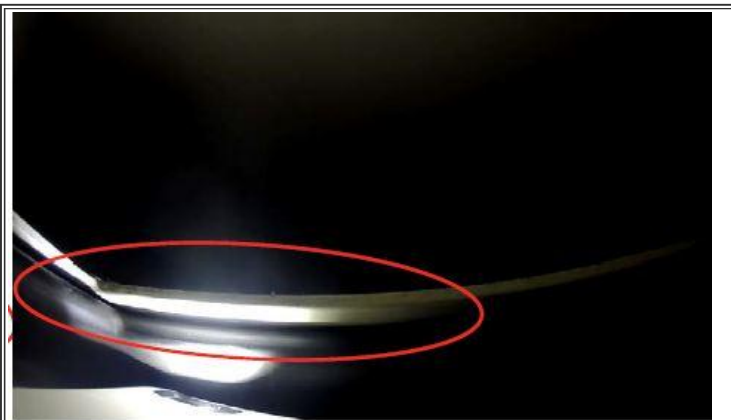
**Figure 2: Hood misaligned with respect to Boot seal**
