Title: Cab Water Leak Troubleshooting Tips

Applies To: This primarily refers to LT, RH, ProStar, and Lonestar sleeper cabs. However some aspects may also apply to all cabs in the High Performance Vehicle family - LT, RH, ProStar, LoneStar, TransStar, WorkStar(HV), DuraStar(MV), and TerraStar. 9000i, PayStar(HX), CityStar are not covered in this document.

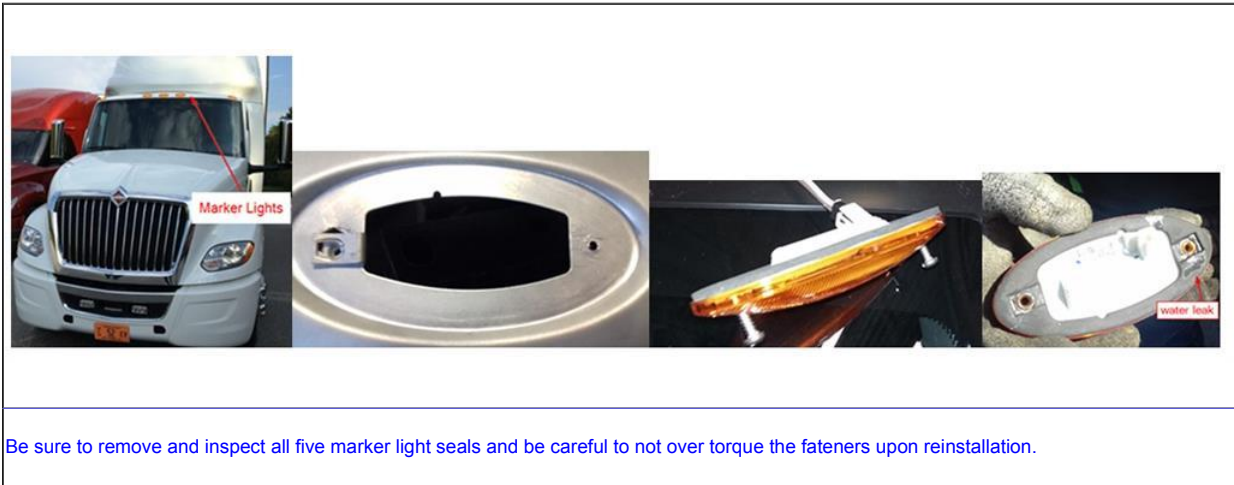
3. Roof marker lights

- Each marker light is held in place with two #8 SS sheetmetal screws. One goes directly into the cab roof and the other goes into a U-nut clip. Sometimes the U-nut tears the foam gasket. Sometimes the screw that goes directly into the cab roof strips and causes the gasket not to compress and seal.

- Remove each marker light to inspect and verify seal integrity. (See attached photos for example of defective seal.)
- Check all five marker lights as more than one could be leaking.

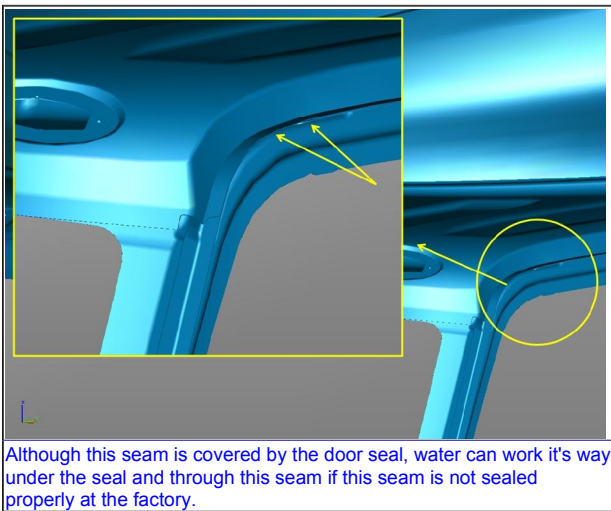
1. Door Seam

- Water typically presents itself during or shortly after driving through inclement weather or when subjected to a truck wash.
- Water drips from above the driver or passenger side door.
- Water drips from the top of the windshield on the outboard driver or passenger side (approximately below where the outboard sunshade mounting points are located).

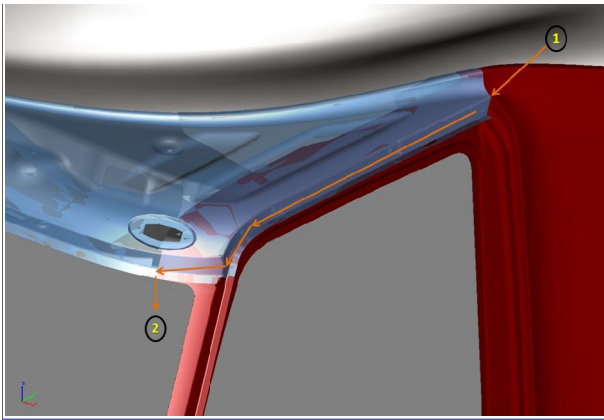
1. Cab seam above the rear corner of the door

- Water typically presents itself during or shortly after driving through inclement weather or when subjected to a truck wash.
- Water drips from above the driver or passenger side door.
- Water drips from the top of the windshield on the outboard driver or passenger side (approximately below where the outboard sunshade mounting points are located).

1. Water enters here.
2. Water exits here and drips down the inside of the windshield.

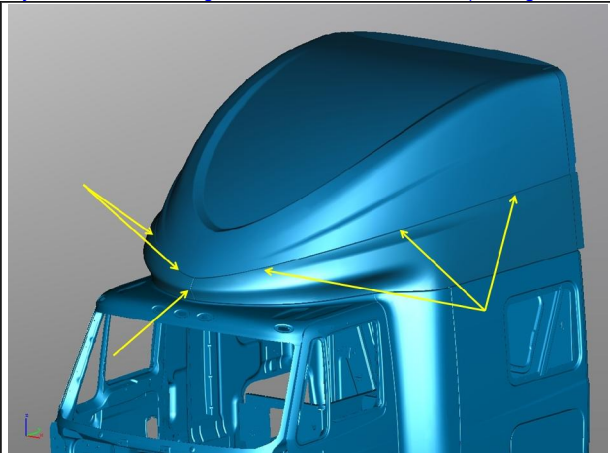
All roof seams should be checked for cracks or voids in the sealer.

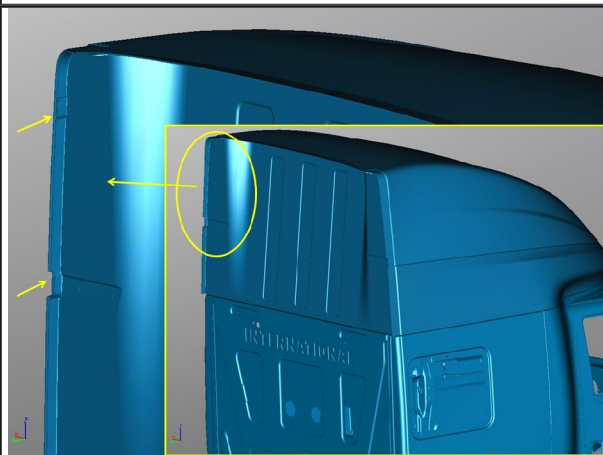
Seams at the rear corners of the Skyrise cab should be checked for voids.

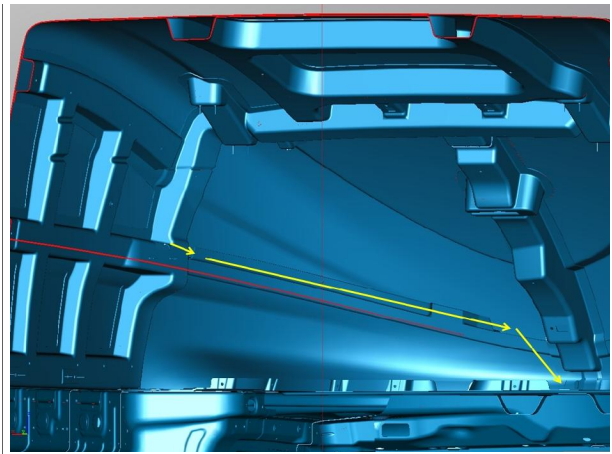
After penetrating the outer seams, water can travel along internal reinforcement bond lines, ultimately draining into the trough formed by the lower roof panel and dumping near the front center of the driver compartment.

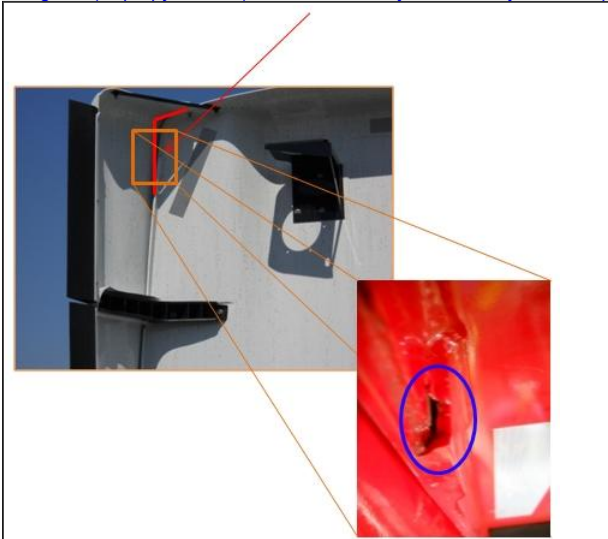
• **Roof Seam Leaks (SkyRise only)**

Driver side shown, passenger side symmetrically opposite.
This area is illustrated due to its obscurity as a water entry point.
These instructions can be used on any roof seam that exhibits a void or inconsistency in sealer.

1. Using IPA (isopropyl alcohol) clean the seams/joints and any other suspect locations (visible voids/gaps) in the immediate area.

2. Allow the surfaces to dry.
3. Apply Dow® BETASEAL™ (2611723c1) to the same areas cleaned in Step 1.
4. Immediately wipe off the surfaces (prolonged exposure to the Dow® primer could damage the paint). These surfaces are now prepped for good adhesion to the sealer.
5. Apply Bostik® SuperTrans™ (2611726c1) to the prepped surfaces. Force material into the joint where possible. For best results, apply sealer into the seam wiping in both directions.
6. Allow material to dry.
