Bulletin #: HTB2018-01.18

RE: All Horton Models fitted with Data-Panel Cool-Tech controllers

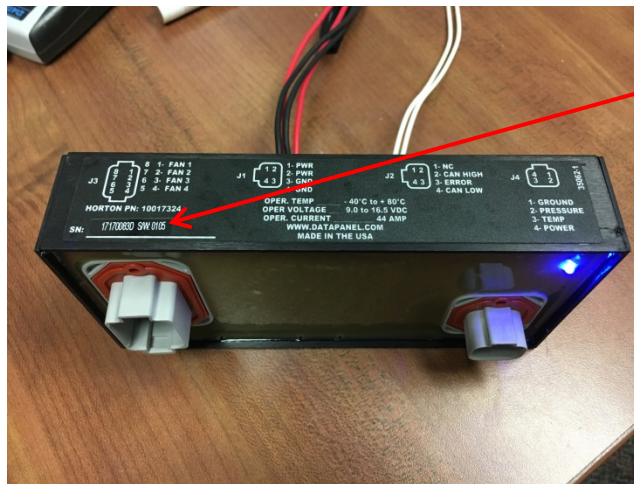
The arrow shows the label containing the serial number and software version.
