**MODEL:** Karma Revero**DATE:** November 2017**TITLE:** Audio Amplifier Replacement**Revised:** February 2018**APPLICABILITY:** MY17 and MY18 Revero (See attached VIN List)**MARKET REGION:** North America**PURPOSE:** Replacement of central channel audio amplifier

CC-17-94-24

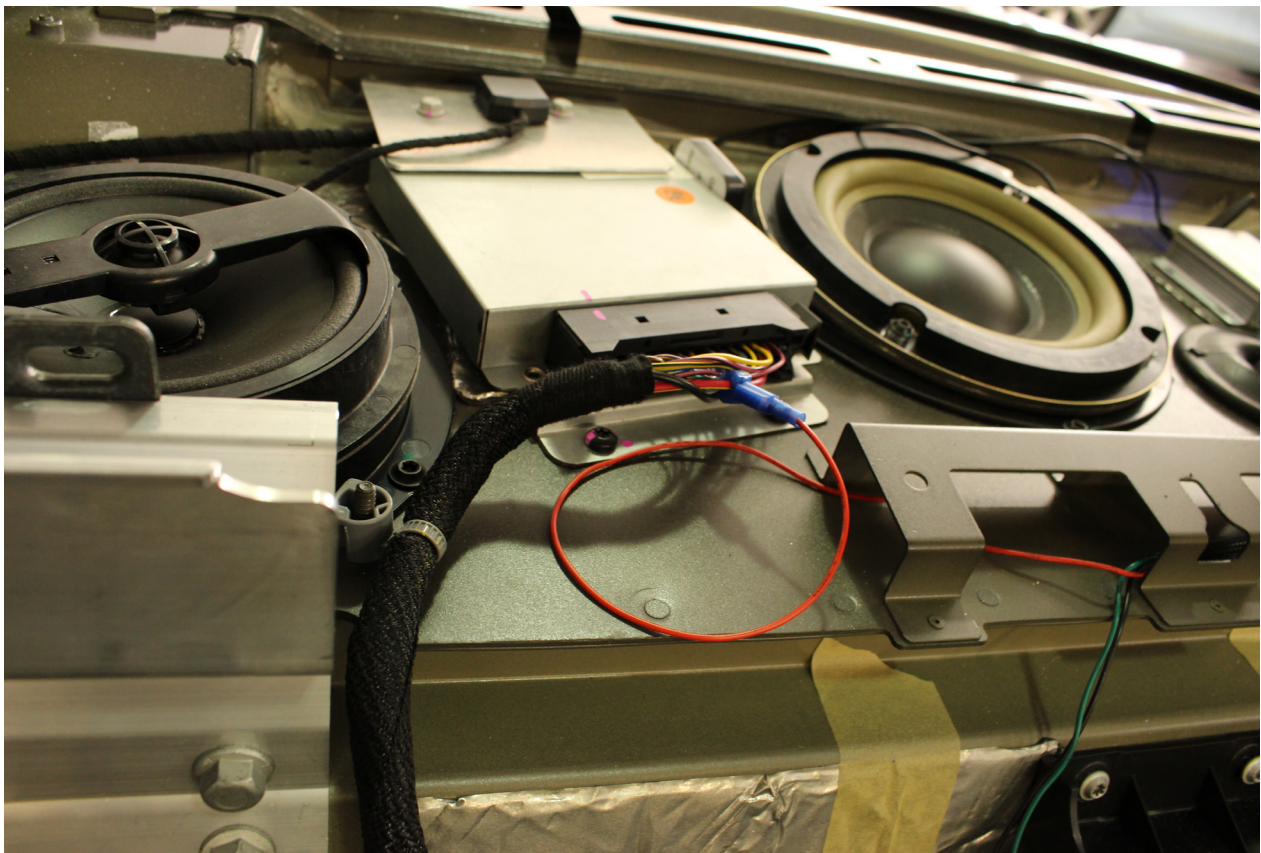
**fig.1a**

Located on the rear shelf, under the package tray, the central amplifier should be replaced with the latest version C131181200303 (fig 1a). A VIN list is provided on next page.

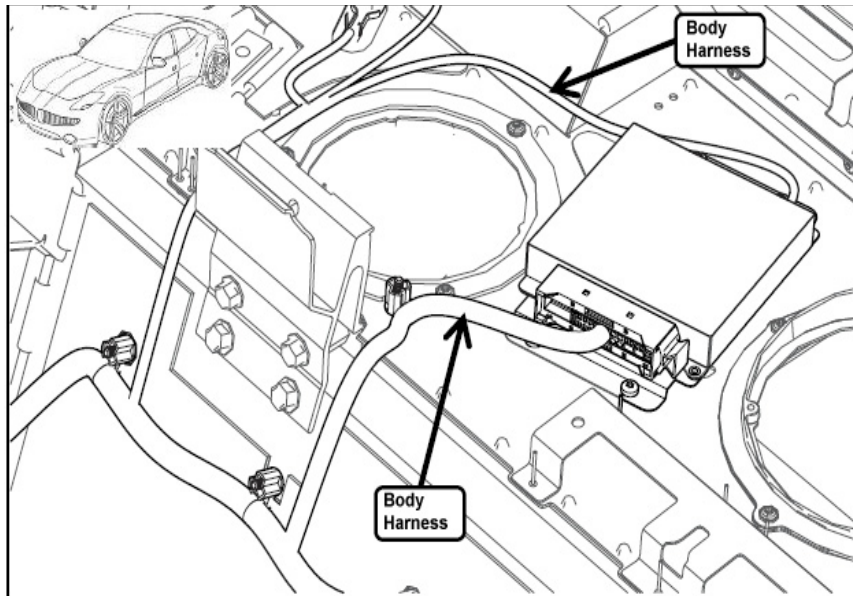
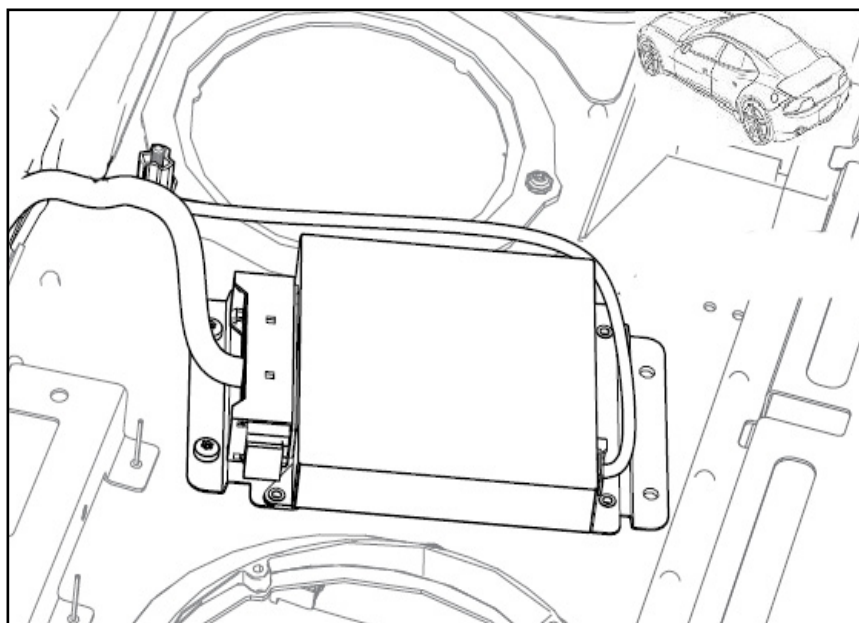
Note the body harness routing to avoid pinching or damaging it on reinstallation (Fig 2a and 2b).

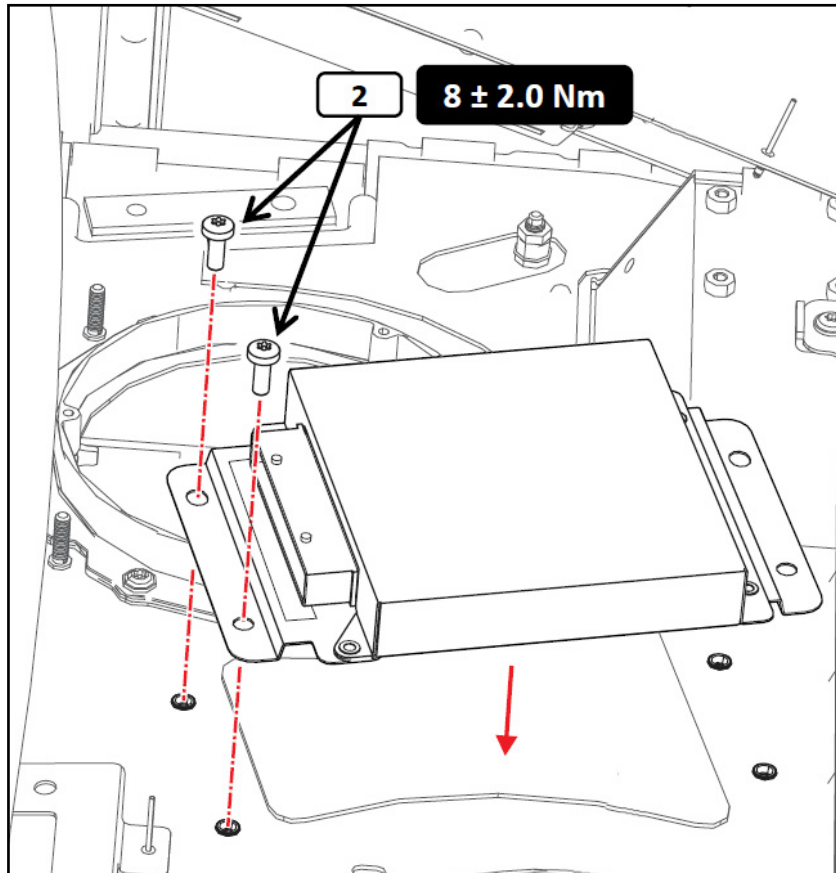
There is two sided tape on the enclosure, pry this up carefully with the appropriate tool.

7.) Install torque as below  $8 \pm 2.0\text{Nm}$  (Fig 8).
