MODEL: Karma Revero**DATE:** February 2018**First Release****TITLE:** Steer Column Telescope Actuator Nut, Bolt Torque Increase**PRIORITY:** On Complaint**APPLICABILITY:** MY17 and MY18 Revero**MARKET REGION:** North America**PURPOSE:** Remedy a “Lash” or “Knocking Noise” when pulling and pushing the steering wheel in and out of dash.

TITLE: Steer Column Telescope Actuator Nut, Bolt Torque Increase

TB-18-44-01

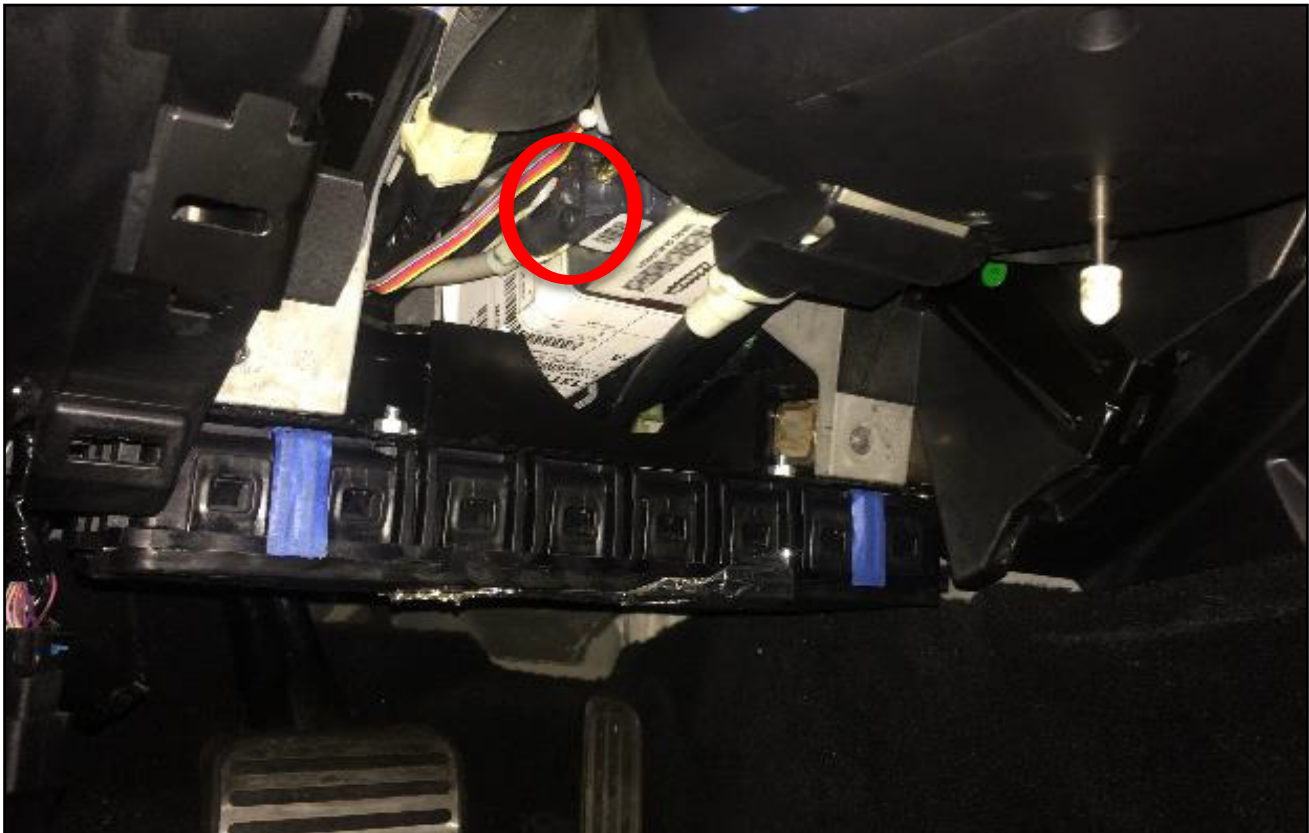
fig. 1

The knee bolster will need to be removed to access the bolts. Follow the service manual procedure if required. two bolts will be reveal as indicate (fig. 1).
