MODEL: Karma Revero**DATE:** February 2018**TITLE:** AC Line Inspection**First Release****PRIORITY:** As Indicated (see list)**APPLICABILITY:** MY17-MY18 Karma Revero**MARKET REGION:** North America**PURPOSE:** Inspect AC Line Interference

CC-18-30-01

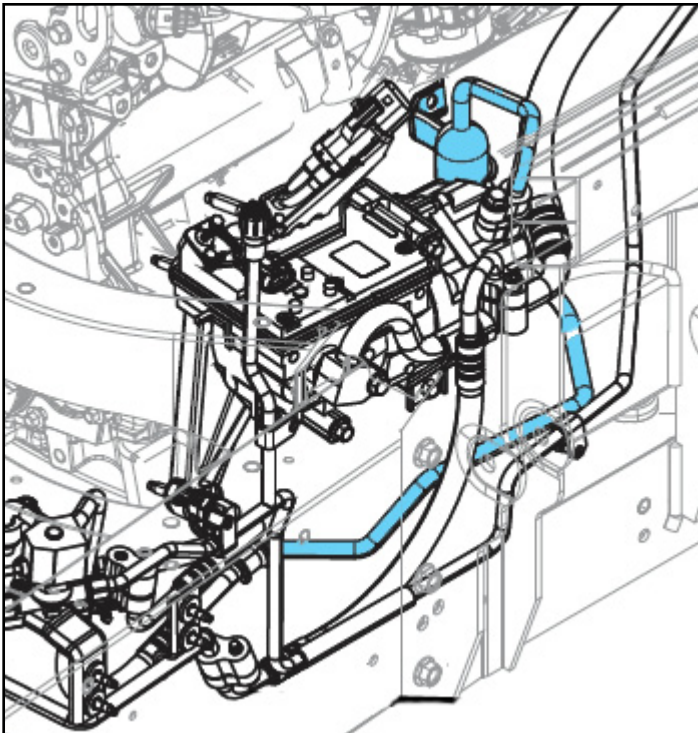
fig 1

Just above the driver side motor mount the high pressure line is visible (blue line fig 1).

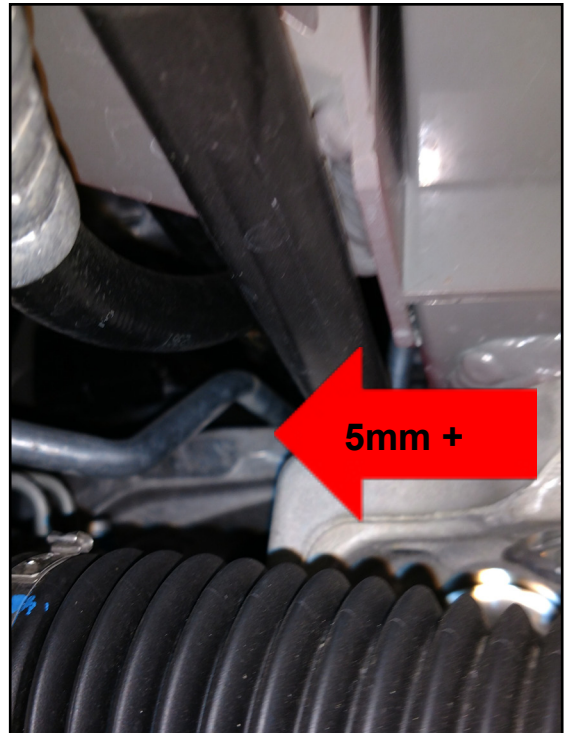
fig 2

Verify there is a clearance of 5mm or more as shown in the images (fig 2)

If clearance is not met, the front bracket can be loosened to provide some movement to slide the 19 x 140 Sleeve (C14100200100) on the line. This will eliminate metal to metal contact of the line on the motor mount. The sleeve is shown in fig 4 on a free line for illustration purposes. Secure bracket by Torquing fastener to 20 +/- 4Nm.
