**MODEL:** Karma Revero**DATE:** September 2017**TITLE:** Intercooler Charge Air Pipe Inspection**Revised** February 2018**PRIORITY:** On Complaint**APPLICABILITY:** MY17 and MY18 Revero**MARKET REGION:** North America**PURPOSE:** Inspect the intercooler hose clamp for proper alignment

**TB-17-12-19**

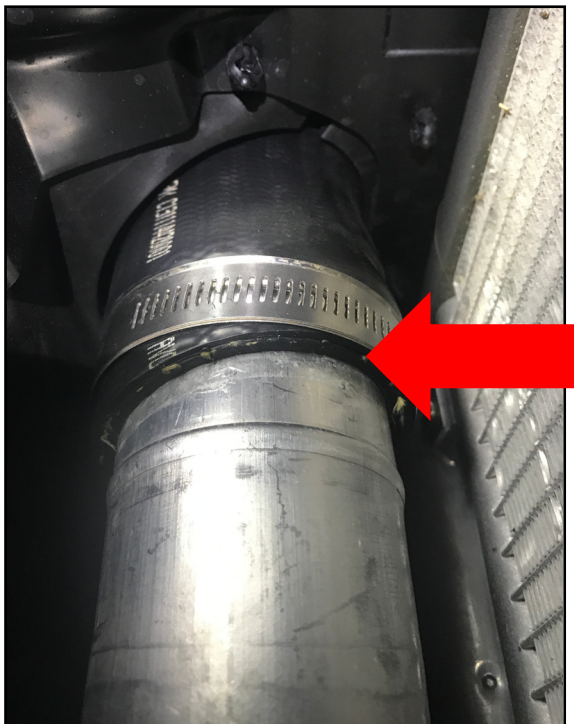
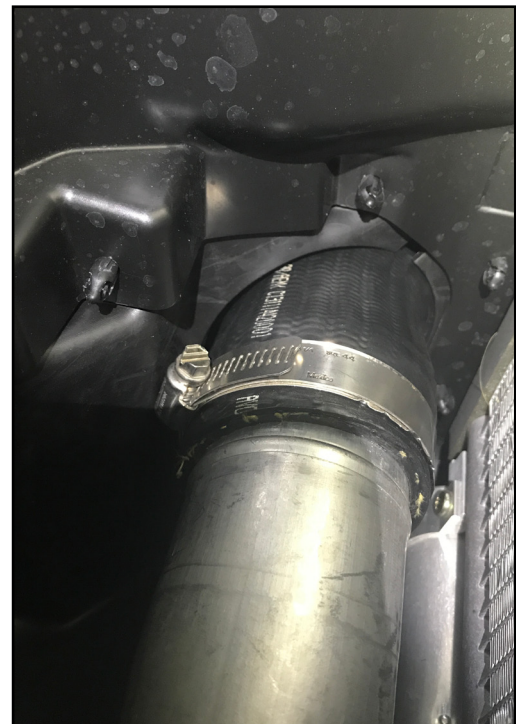
A visual inspection may show a misaligned clamp and hose immediately, this will require action (fig.1a and 1b).

**NOTE:** This is from the underside of the vehicle. The other clamps are accessible from the top

The complaint will vary in presentation through diagnostic trouble codes related to air/fuel ratio imbalance or underboost condition. Inspect the hose clamps for the intake system and ensure they are lined up correctly and all hoses are located properly. Loosening of the clamp to adjust the hose may be required. Reinstall to the specified torque value (8.5 +/- 0.5Nm).

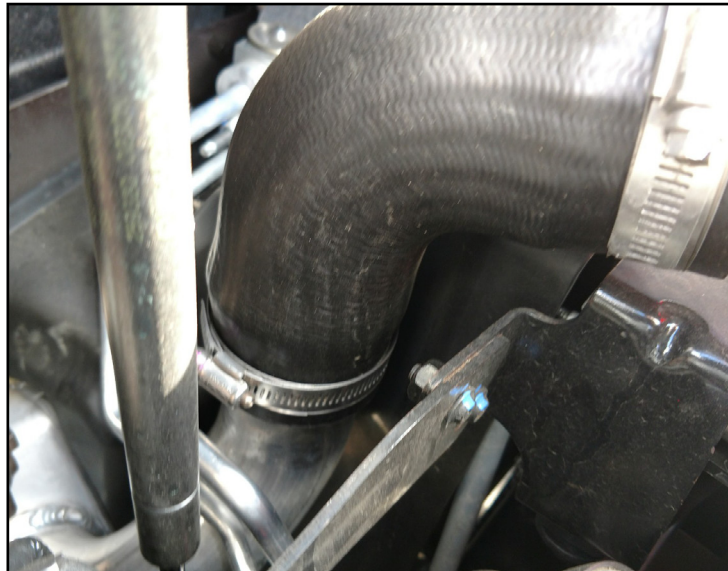
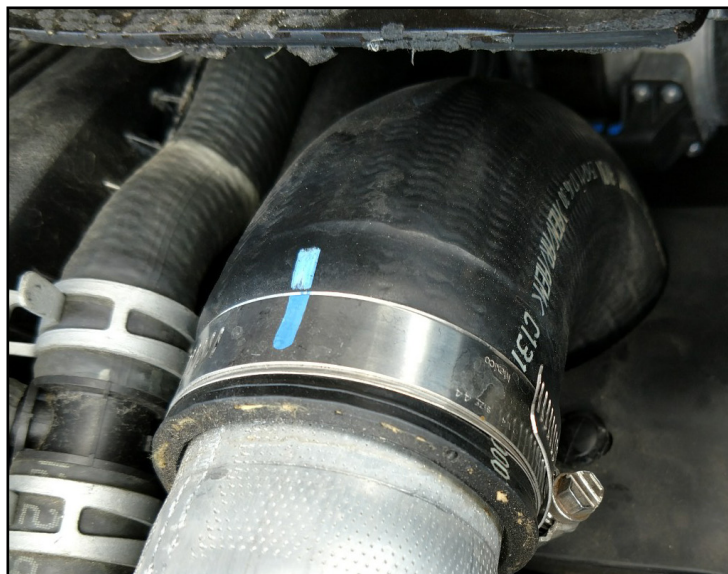
These clamps are shown correctly installed (fig. 2a and 2b).

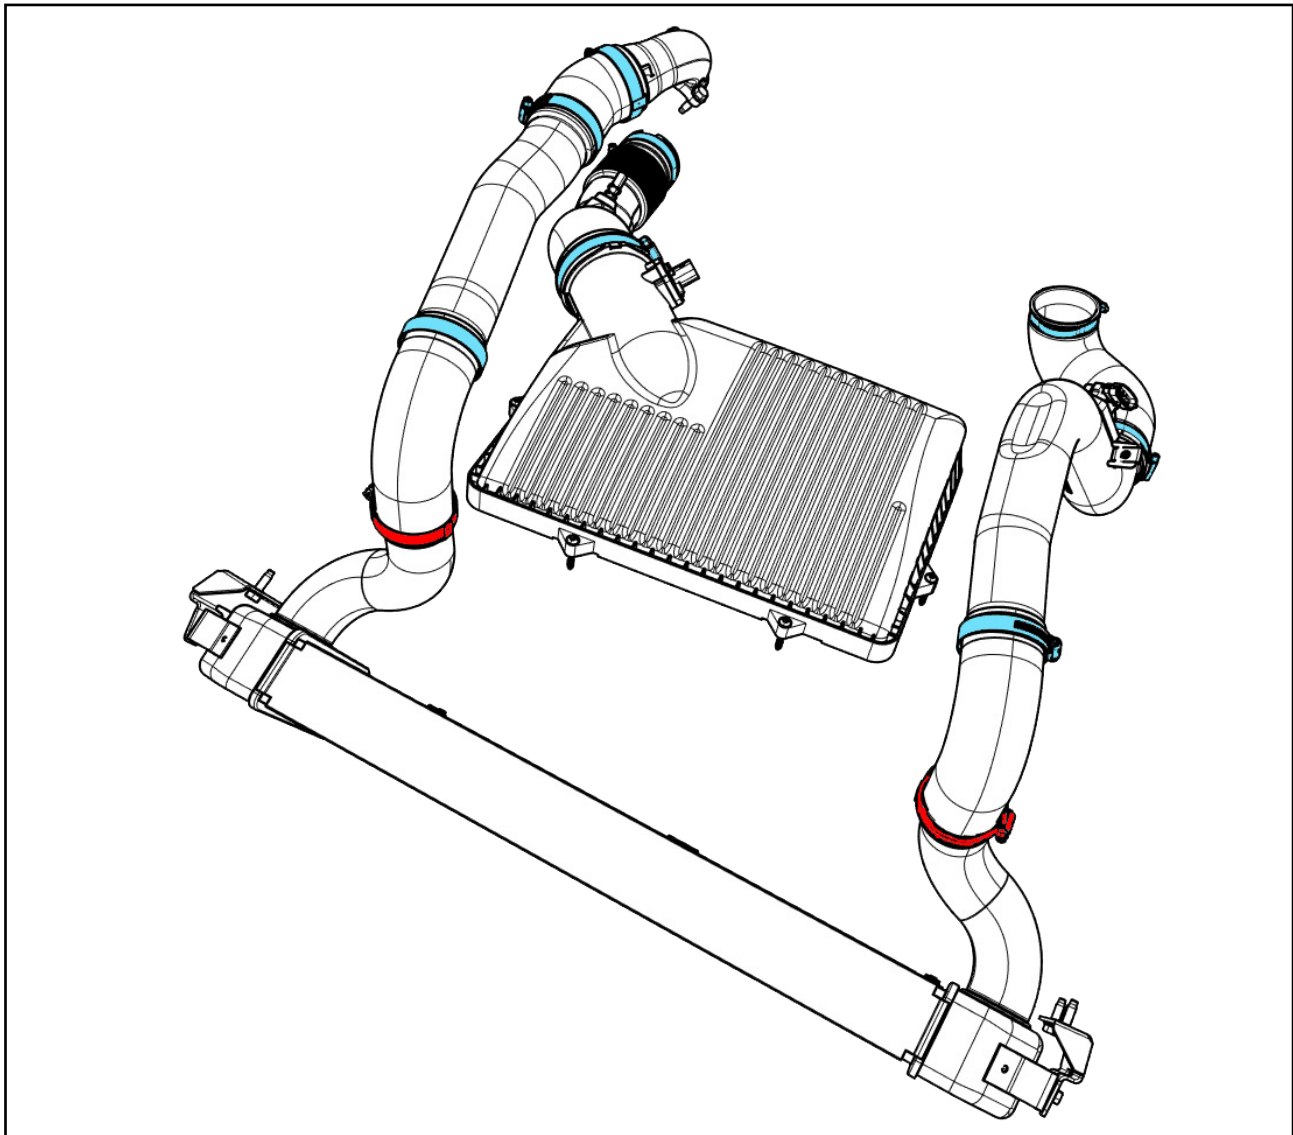
fig.3

For guidance: the hose clamps to be first considered are the red indicated clamps at the intercooler in the image (fig 3). Any additionally clamps found to be misaligned will required images and a TSS case submission.
