**MODEL:** Karma Revero**Date:** October 2017**TITLE:** Dash Stitch Impression Remedy**Revised:** February 2018**PRIORITY:** On Complaint**APPLICABILITY:** MY17 and MY18 Revero**MARKET REGION:** North America**PURPOSE:** Remedy for the dash pad stitch impression on the door panel.

# Technical Service Bulletin

**TB-17-82-26**

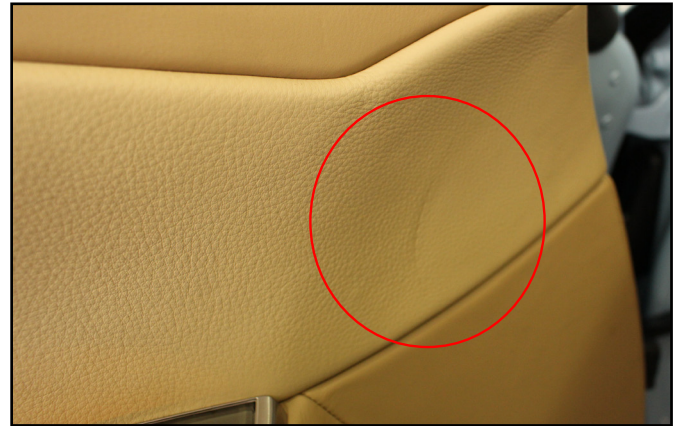
fig.1

The door panel impression is shown when the door is open, driver door shown (fig.1a).

This *may* be found on both doors, in which case the procedure will involve both sides of the dash pad.

This condition is often only seen on one door panel.
