# Entune Audio Head Unit Software Update (Denso)

YEAR(S)	MODEL(S)	ADDITIONAL INFORMATION
2017 - 2018	Prius Prime

Some 2017 – 2018 model year Prius Prime vehicles equipped with Entune™ Premium Audio (R10A5430) or earlier may exhibit one or more of the following conditions. Updated multimedia software is now available to address these conditions. Follow the Multimedia Software Update Procedure in this bulletin to install the latest software version.

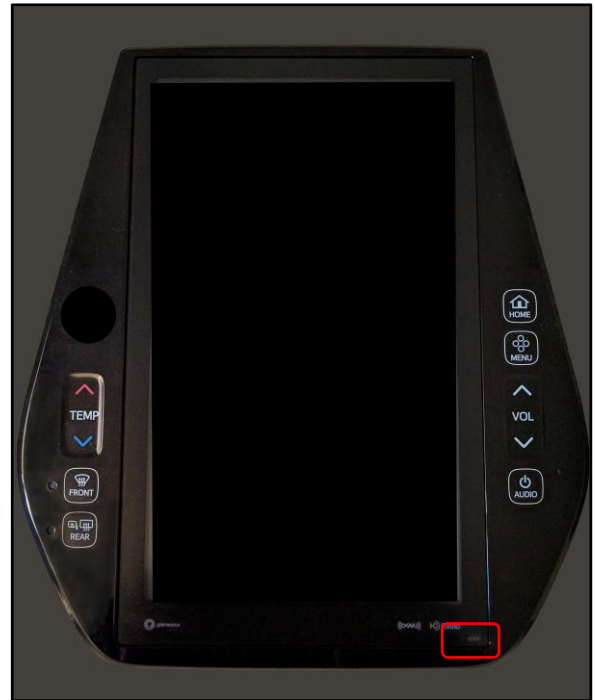
**Figure 1.**

1. Confirm the audio system type by checking the panel ID printed on the bottom of the head unit.

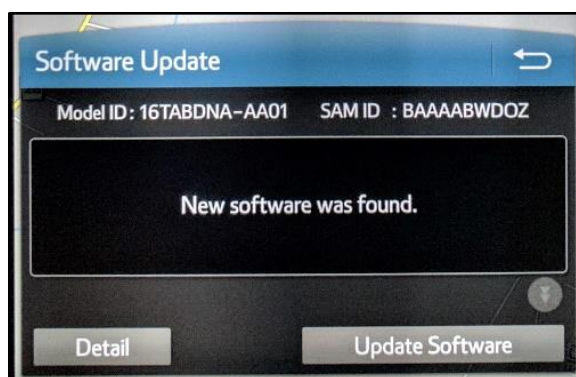
Figure 7.

If the software is detected properly, a "New software was found" pop-up will display.

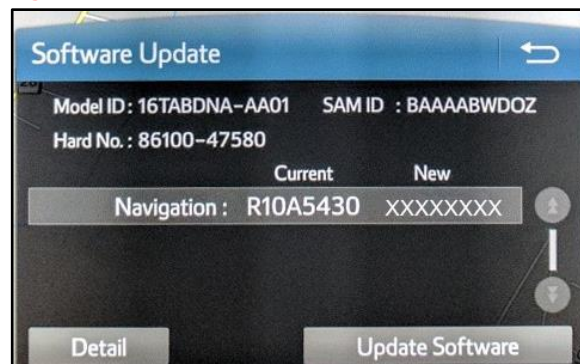
Figure 8.

11. Verify that the NEW software is the most up to date by referring to the Software Version Information table below.

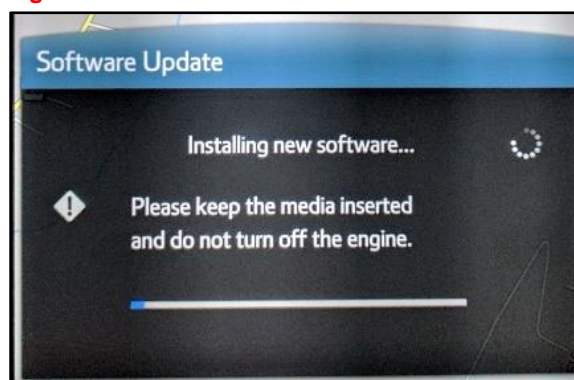
Figure 11.

14. Once the head unit begins the installation, the update will take about 10 minutes to complete.

- Do NOT turn off the ignition or Ready "OFF" the vehicle before the software is ready for updating.
- Do NOT pull the USB flash drive out of the vehicle's USB port.

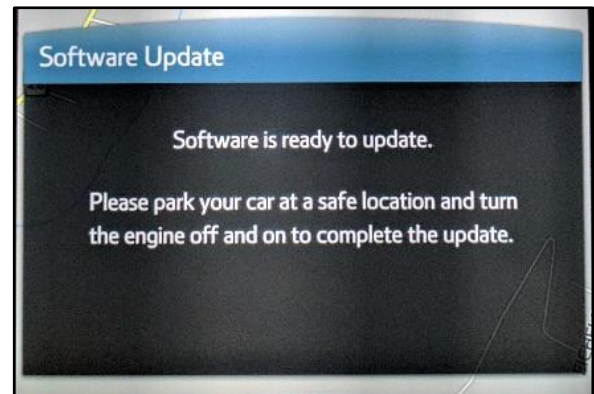
**Figure 12.**

15. When the “Software is ready to update” screen displays, Ready “OFF” and “ON” the vehicle.

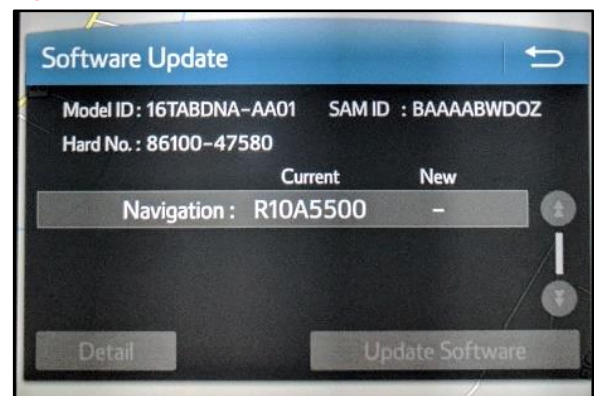
**Figure 13.**

1. Perform steps 6 – 11 of the Multimedia Software Update Procedure to reenter the Software Update screen.
2. Verify that the multimedia software information is updated on the Software Update screen.
