# Wind (Reed/Buzz) Noise From Front Doors - Cross-Wind Conditions

YEAR(S)	MODEL(S)	ADDITIONAL INFORMATION
2012 - 2017	Tacoma

January 22, 2018 Rev1:

Some 2012 – 2017 model year Tacoma vehicles may exhibit a reed/buzz type wind noise from the LH and/or RH front door when driving in high cross-wind areas. Follow the Repair Procedure in this bulletin to address this condition.

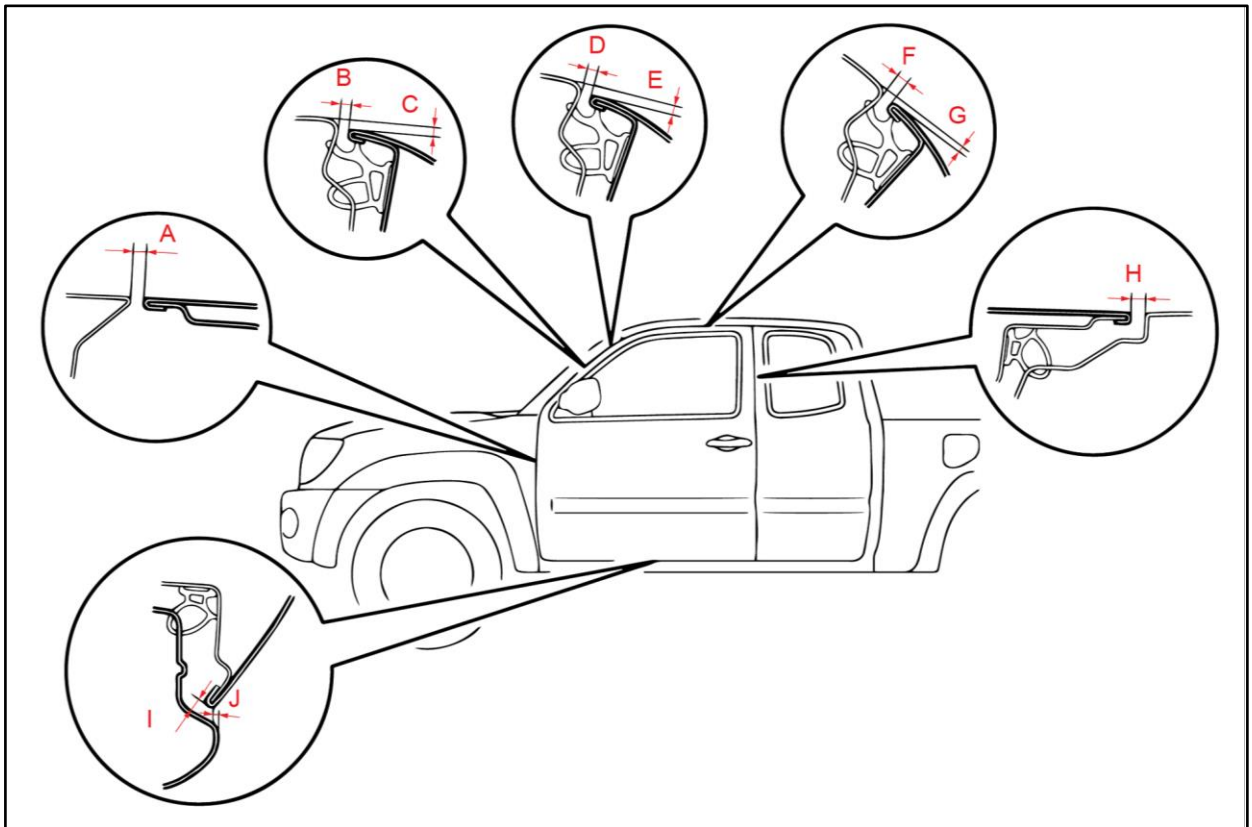
**Figure 6. Clearance Measurements for Access Cab**

<b>A</b>	3.2 to 6.2 mm (0.126 to 0.244 in.)
<b>B</b>	3.4 to 6.4 mm (0.134 to 0.252 in.)
<b>C</b>	1.1 to 4.1 mm (0.043 to 0.161 in.)
<b>D</b>	3.3 to 6.3 mm (0.130 to 0.248 in.)
<b>E</b>	1.1 to 4.1 mm (0.043 to 0.161 in.)

<b>F</b>	3.3 to 6.3 mm (0.130 to 0.248 in.)
<b>G</b>	0.7 to 3.7 mm (0.028 to 0.146 in.)
<b>H</b>	2012 – 2015: 3.5 to 6.5 mm (0.138 to 0.256 in.) 2016 – 2017: 4.5 to 7.5 mm (0.177 to 0.295 in.)
<b>I</b>	3.5 to 6.5 mm (0.138 to 0.256 in.)
<b>J</b>	0.5 to 3.5 mm (0.020 to 0.138 in.)

7. Check door fitting for gap/levelness to be within allowable specification (see below). If gap/levelness is outside of specification, the door MUST be refit to specification.

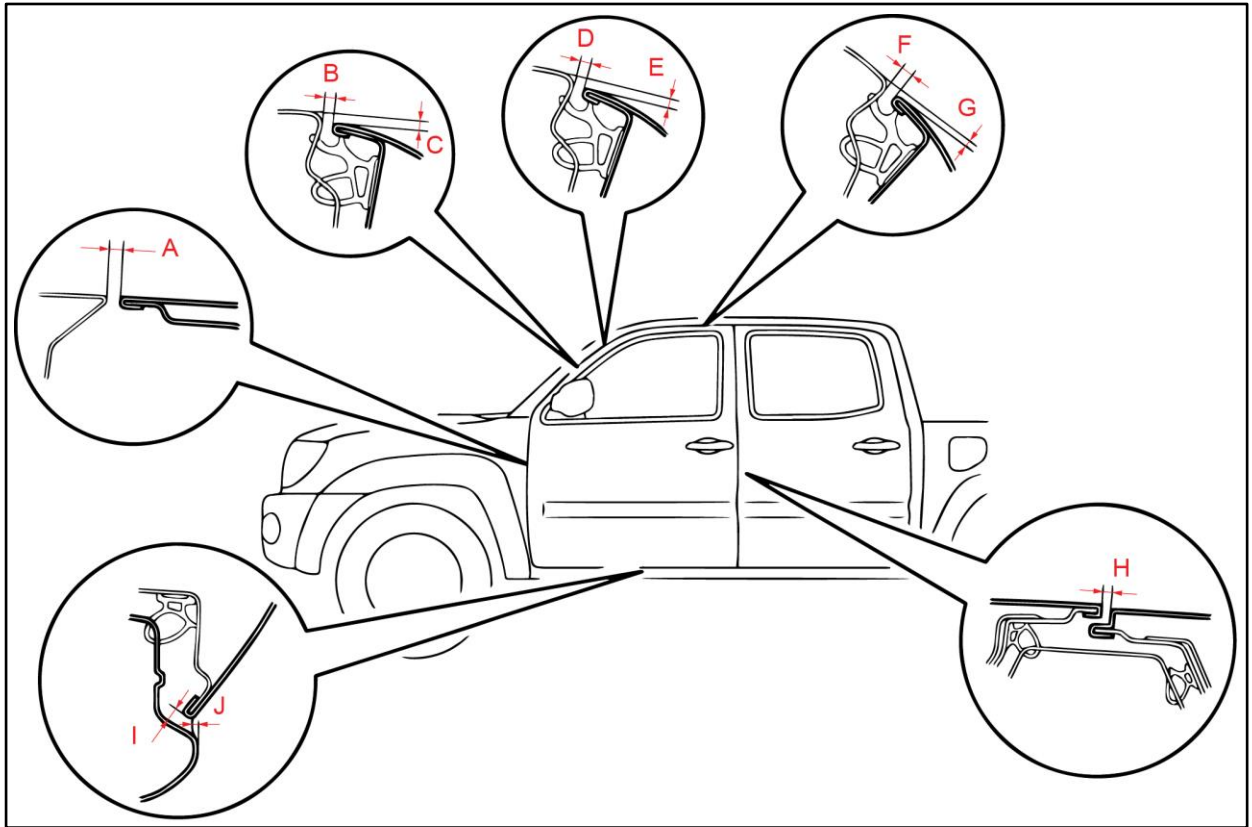
**Figure 7. Clearance Measurements for Double Cab**

<b>A</b>	3.2 to 6.2 mm (0.126 to 0.244 in.)
<b>B</b>	3.4 to 6.4 mm (0.134 to 0.252 in.)
<b>C</b>	1.1 to 4.1 mm (0.043 to 0.161 in.)
<b>D</b>	3.3 to 6.3 mm (0.130 to 0.248 in.)
<b>E</b>	1.1 to 4.1 mm (0.043 to 0.161 in.)

<b>F</b>	3.3 to 6.3 mm (0.130 to 0.248 in.)
<b>G</b>	0.7 to 3.7 mm (0.028 to 0.146 in.)
<b>H</b>	3.5 to 6.5 mm (0.138 to 0.256 in.)
<b>I</b>	3.5 to 6.5 mm (0.138 to .256 in.)
<b>J</b>	0.5 to 3.5 mm (0.020 to 0.138 in.)
