VSC System DTC C1234: Yaw Rate Sensor

Service Category Brake

Section Brake Control/Dynamic Control System

YEAR(S)	MODEL(S)	ADDITIONAL INFORMATION
2001 - 2002	Sequoia

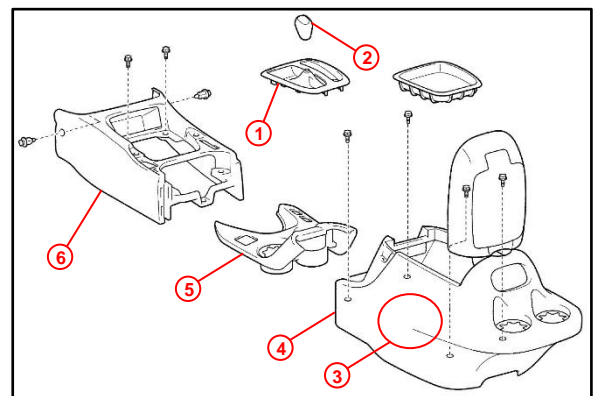
Figure 1.

1	4WD: Shifting Hole Cover
2	4WD: Shifting Lever Knob
3	Yaw Rate Sensor Location
4	Rear Console Box
5	Upper Console Panel
6	Front Console Box

3. Remove the console box.
Refer to TIS, applicable model and model year Repair Manual:
