TT8136EN  
March, 2018  
Page 1 of 2

**SUBJECT:** Preventing Cat-eyes when Reprogramming TCM in PACCAR Kenworth and Peterbilt Trucks using Allison DOC® and Allison TCM Reflash™

**MODELS AFFECTED:** 1000, 2000, 3000, 4000 Series 5th Generation Product Family Transmissions

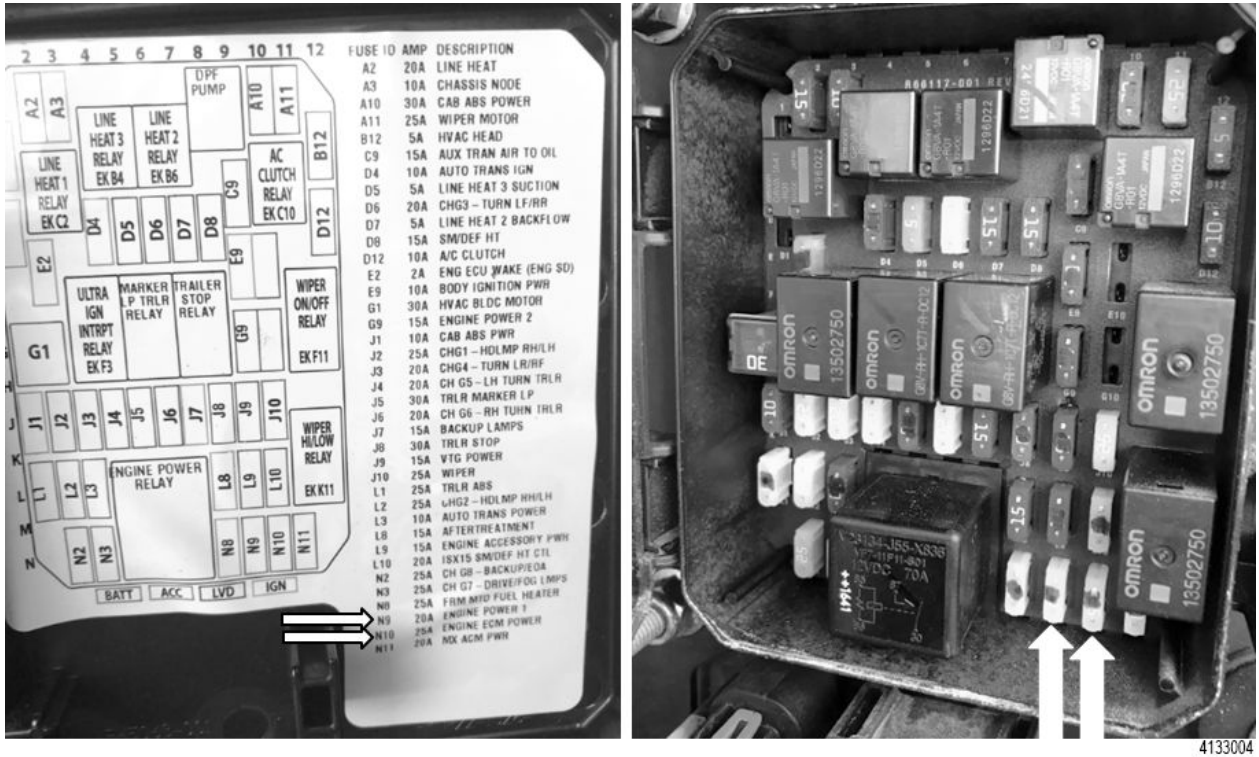
Figure 1. Location of Fuses

Cat-eyes may occur after reprogramming 2013 and later PACCAR Kenworth and Peterbilt trucks using Allison DOC® and Allison TCM Reflash™ service tools. The problem is caused by a conflict with the vehicle engine controller.

With the key cycled to “OFF” in the ignition, disable power to the engine controller by temporarily removing fuses from the fuse box. Cycle key to “ON” while reprogramming the TCM. When reprogramming is complete, cycle key to “OFF” and reinstall removed fuses. Refer to [Figure 1](#) for fuse identification and location. May not be representative of all vehicles.
