### Service Letter

#### PRODUCT IMPROVEMENT PROGRAM FOR INSPECTING AND POSSIBLY REPLACING LINERS IN CERTAIN REMAN C18 AND C32 CYLINDER PACKS IN DEALER PARTS STOCK

Media Number -TEBE7405-00

Publication Date -2018/03/19

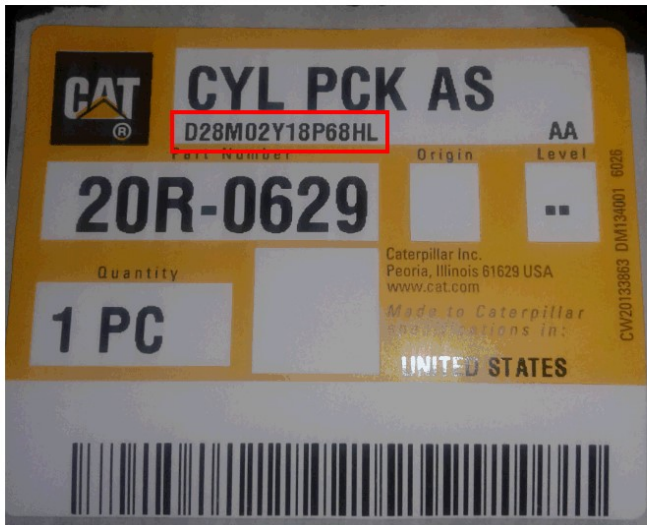
Image1.1.1

Inspect the packaging label date code. If it is from D23M03Y17P68HL (March 23, 2017) through D16M11Y17P68HL (November 16, 2017), open box and inspect liner part number. Reference Image1.1.1.

If the cylinder liner is 322-1126 or 556-0701, seal cylinder pack box and write "INSP" on the packaging label and place the cylinder pack back into dealer parts stock.

If the cylinder liner is 516-9693, replace liner with 556-0701.

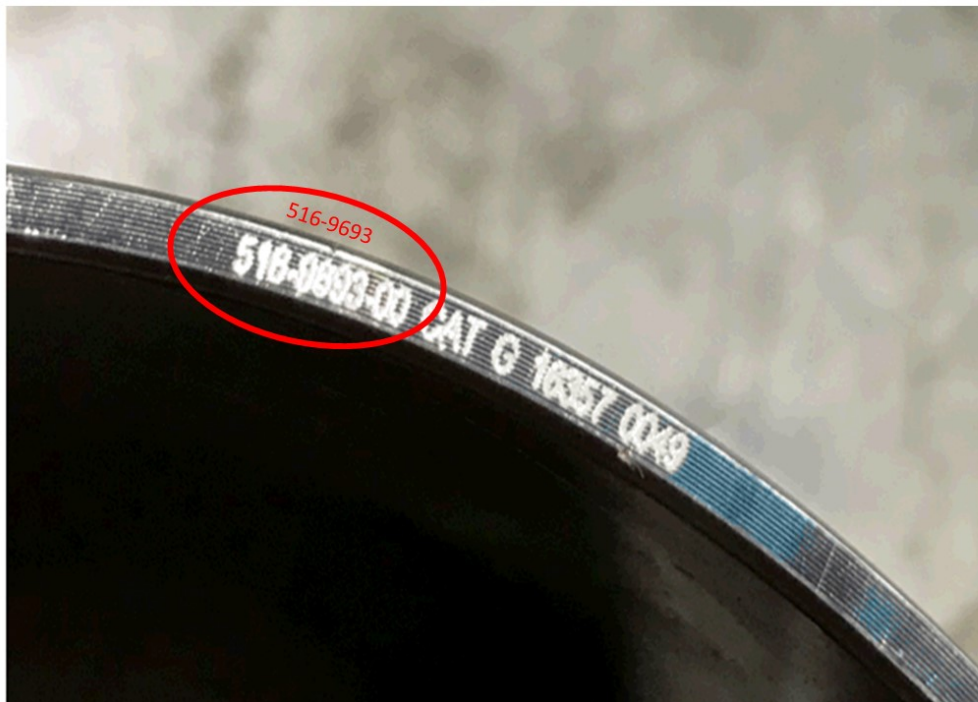
Inspect bottom of the liner for part number. Reference Image1.1.2
