# **L9 – Jake Brake**

## **#5 Intake rocker pedestal cap screw not fully torqued**

March 26, 2018

# Navistar SAP found ESN 74273427 was running rough and had high smoke

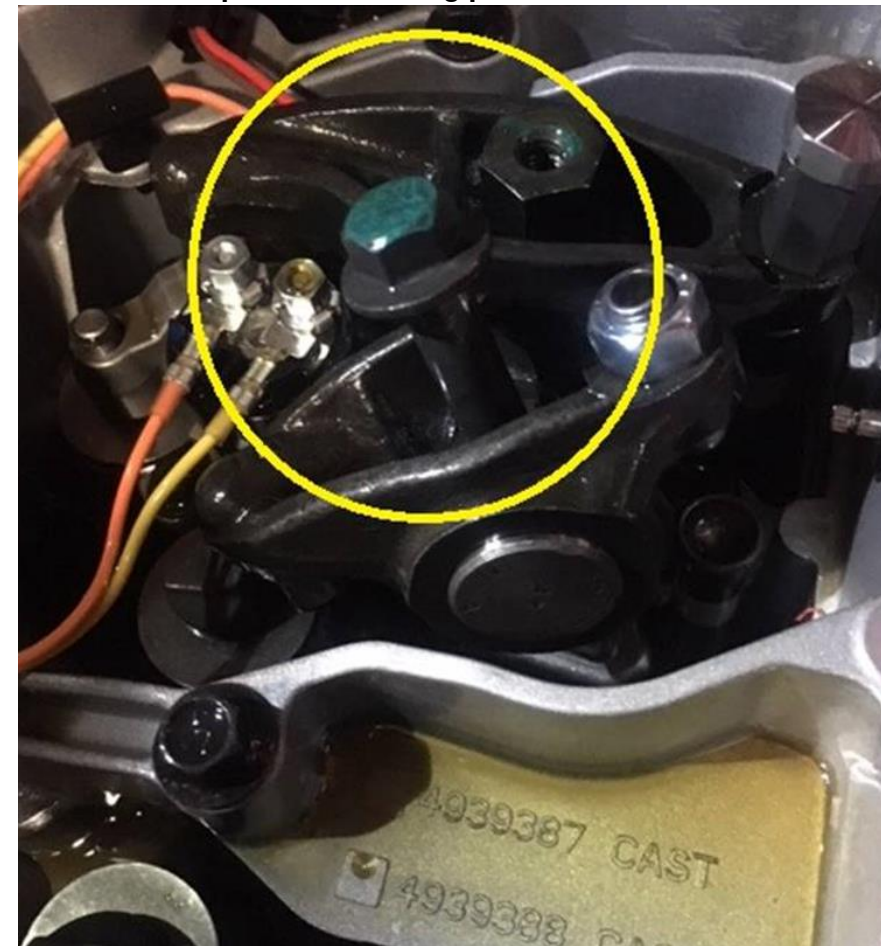
- ESN: 74273427
- OEM: Navistar SAP
- Model: L9 370 Hp with Jake brake
- Lineset: 2/16
- Defect reported: 3/13
- Hours/Miles: 2.2hrs / 2 miles
- Troubleshooting:
  - The Cummins Service Technician performed a cylinder cutout test with Insite to identify Cylinder 5 had an issue
  - After removing the valve cover, the #5 Intake rocker pedestal cap screw was found standing proud
- Repair:
  - Torqued the cap screw to 65Nm and the issue was resolved

74273427 – Cap screw standing proud

- Dock closure 5439 on all Jake brake engines – (3/23)
  - Verify the #5 intake rocker pedestal cap screw is torqued to 65Nm
- Reteach #5 intake on the Jake brake program – (3/23)
  - Quality verified the proper torque was applied after the change
  - ESNf **74291280**

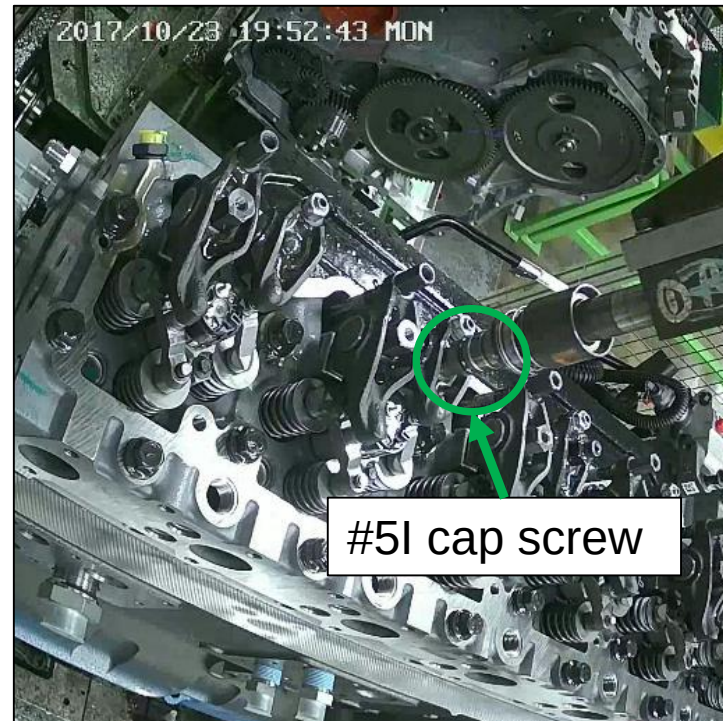
- On 3/23, maintenance reviewed a Jake brake engine run through the cycle
  - It was noted that robot 1 was torquing cylinder #6 intake twice instead of moving to next step which is cylinder #5 intake
  - The engine received a pass status
- Reviewed video footage of the torque robot
  - October 23<sup>rd</sup> shows the 5l cap screw receiving torque
  - November 11<sup>th</sup> shows the 6l cap screw being torqued twice
  - 5l does not receive torque
- There is a maintenance work order from October 25<sup>th</sup> that modified the Jake brake torque program due to high rejects for mislocations

Video from 10/23 shows the c/s receiving torque

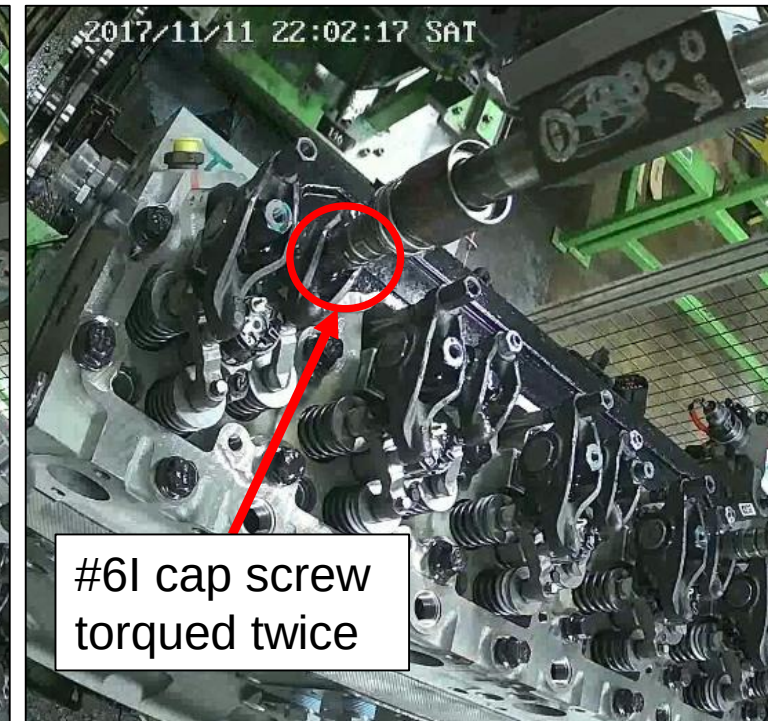
Video from 11/11 shows the c/s not receiving torque

- Station 445 runs down the cap screws to 15Nm so #5I appeared tight and was able to pass hot test
- Toolsnet data for the engines all passed
  - The rocker pedestal cap screw program loosens the cap screw and performs a burnished step before applying the 65Nm torque

| No. | Description | Target Date | Status |
|---|---|---|---|
| 1 | Implement a quality alert regarding MCR requirement for re-teaching torque related program changes | 3/23 | Complete |
| 2 | Establish quality verification process for any changes made #449 robot and torque programming (Standard QSI procedure, check list for product verification and notification/signoff(s)) | 3/26 | In process |
