| <b>Technical Service Bulletin:</b><br>TSB180032 | <b>Released Date:</b> 20-Mar-2018 |

## Air Compressor Hose Rupture: Navistar®

- Navistar
  - IC Bus
  - Durastar

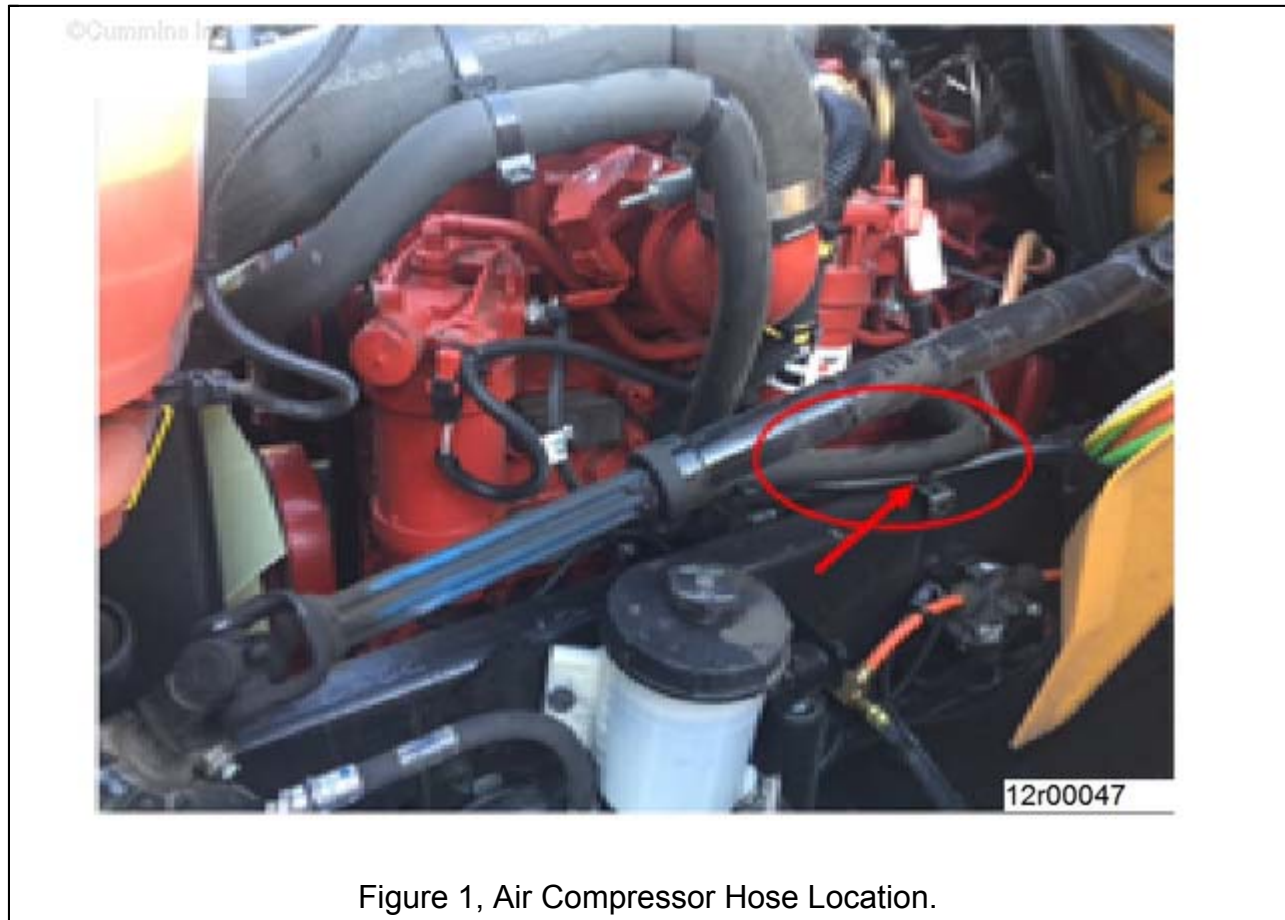
Figure 1, Air Compressor Hose Location.

- Zip tie retaining air governor lines is rupturing inlet hose of air compressor. (Navistar Part Number 6132813c1)

- Verify ruptured air compressor hose is 6132813c1.
- Verify there are no signs of oil leakage from turbocharger compressor oil seal.
- Reference Navistar iKnow article IK1900254.
- See Figure 1, 2, and 3 for location of ziptie and example of ruptured air compressor hose.

- Reference Navistar iKnow article IK900254 for further instructions.
