HYUNDAI Technical Service Bulletin	GROUP CAMPAIGN	NUMBER 18-01-014
	DATE MARCH, 2018	MODEL(S) SONATA (LFa)
SUBJECT: 2018 SONATA D-AUDIO SOFTWARE UPDATE FOR LCD OVERLAY (SERVICE CAMPAIGN T2W)

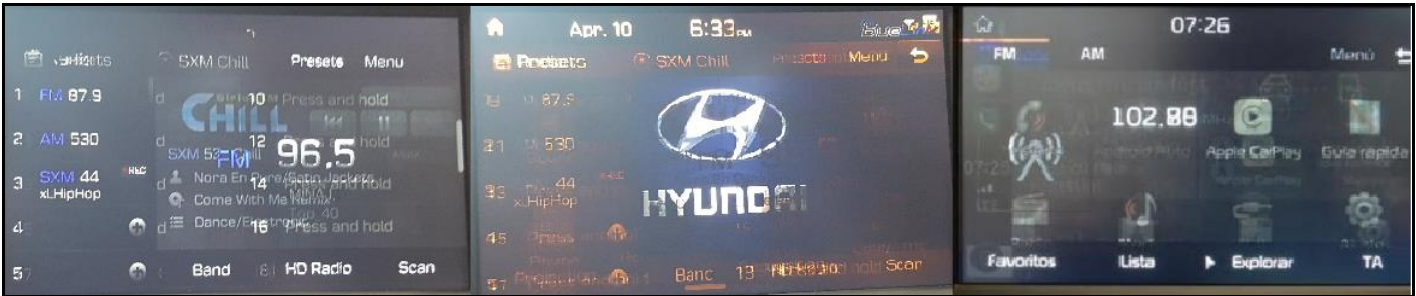
[LCD Overlay / Display Overlapping Symptom]

Description: This bulletin describes the procedure for updating the Display Audio (D-Audio) System Software for the 2018 Model Year Sonata (LFa). This update prevents the LCD Overlay/Display overlapping condition (previous screen images/icons showing on current screen).

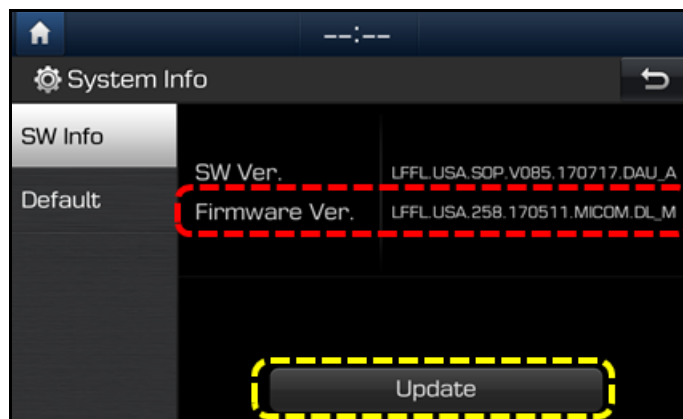
4. In the SW Info screen, check the **FIRMWARE Version:**

Proceed with update if the OLD/Original FIRMWARE Version is earlier than the NEW Firmware Version provided in the table below:

- If the version is equal to or later than the NEW FIRMWARE version above, then no update is needed.
- Otherwise, if the Firmware Version is earlier (less than) the NEW Firmware Version in the table above, proceed to step 5.
