GROUP <b>BOD</b>	MODEL <b>2018MY Optima (JFa)</b>
	NUMBER <b>182 (Rev 3, 03/21/2018)</b>	DATE <b>January 2018</b>

## TECHNICAL SERVICE BULLETIN

**SUBJECT:** SERVICE ACTION: FLOOR CONSOLE INNER PANEL  
INSPECTION & CORRECTION/REPLACEMENT (SA328)

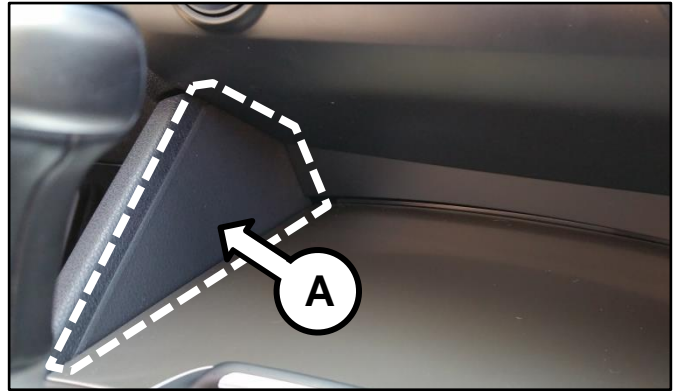
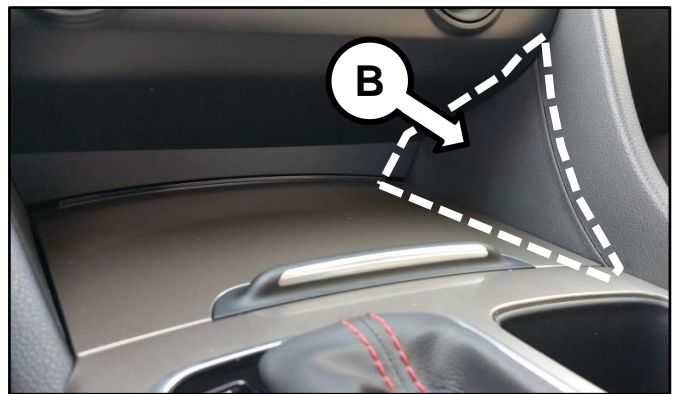
1. Inspect both left and right inner side panels (A) & (B) of the floor console for any sign of surface peeling.
  - If neither left nor right panels are peeling, proceed to Solution Application Procedure below to apply a corrective spray solution.
  - If one or both panels is/are peeling, proceed to the Replacement Procedure on page 3 of this bulletin.
