GROUP <b>ENG</b>	MODEL <b>2016-2017MY Optima (JF, JFa), Sorento (UMa) 2017MY Sportage (QL)</b>
	NUMBER <b>175 (Rev 3, 03/20/2018)</b>	DATE <b>August 2017</b>
<b>TECHNICAL SERVICE BULLETIN</b>		
SUBJECT: <b>SERVICE ACTION: E-CVVT COVER INSPECTION AND MOTOR PLUG REPLACEMENT (SA305)</b>

**This issue number is SA305.**

## SERVICE ACTION: E-CVVT COVER INSPECTION AND MOTOR PLUG REPLACEMENT (SA305)

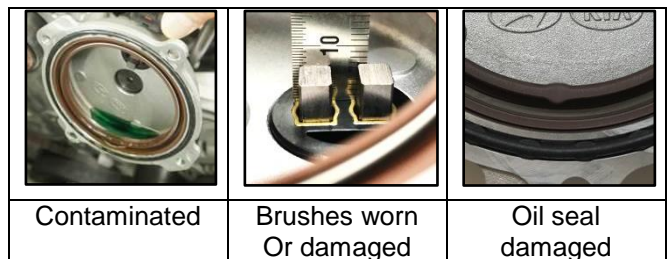
10. Inspect the E-CVVT cover.

- If there is no sign of oil leakage, contamination, and/or damage, replace only the cover O-ring.
- If there is an oil leak, contamination, and/or damage, replace the cover.

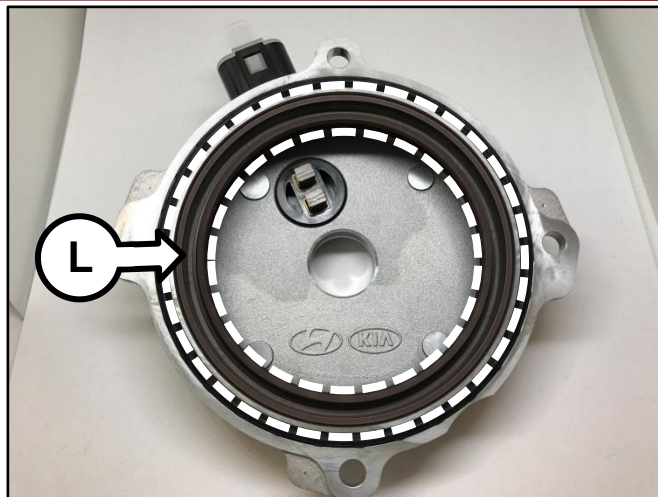
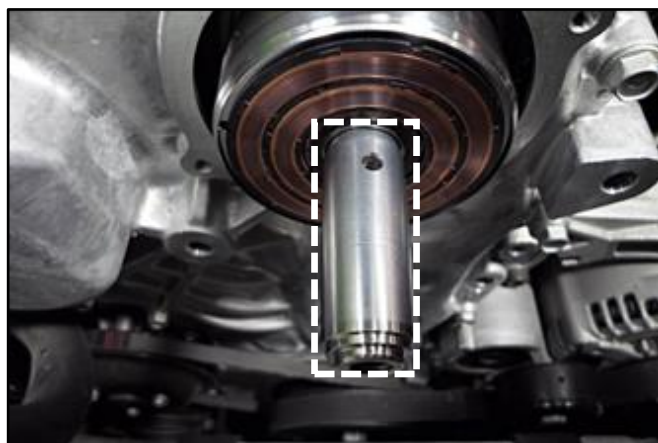
**SST INSERTED INCORRECTLY**

**SST INSERTED CORRECTLY**

- Apply oil to the oil seal lip (L) of the E-CVVT cover and install the SST "B" to the E-CVVT motor as shown.

When installing the cover, correctly insert the end of the SST to the motor shaft as shown below. Ensure that the SST hole faces towards the motor shaft.

Use caution not to fold the oil seal when installing the cover.
