# SERVICE BULLETIN

Classification: EC18-008	Reference: NTB18-026	Date: March 22, 2018
-----------------------------	-------------------------	-------------------------

## 2017-2018 PATHFINDER; MIL ON WITH DTC P219F

**APPLIED VEHICLES:** 2017-2018 Pathfinder (R52)  
**APPLIED ENGINE:** VQ35DD (direct injection)

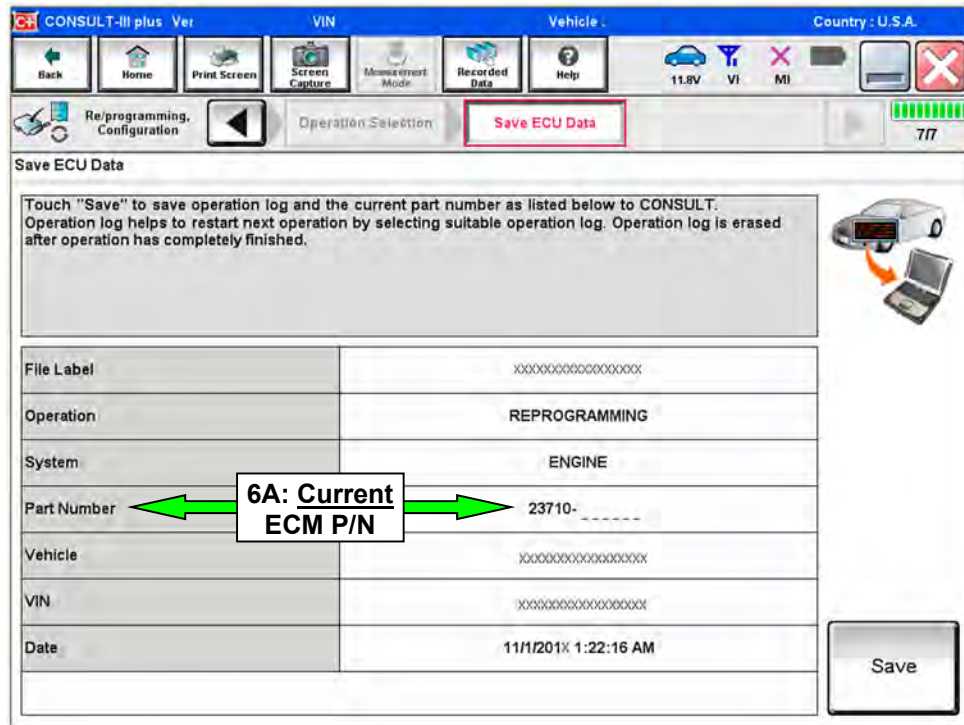
Figure 2

A. Find the ECM **Part Number** and write it on the repair order.

B. Compare the P/N you wrote down to the numbers in the **CURRENT ECM PART NUMBER** column in **Table A** below.

- If there is a match, this bulletin applies. Continue with the reprogramming procedure.
- If there is not a match, this bulletin does not apply. Close C-III plus and refer to ASIST for further diagnostic information.

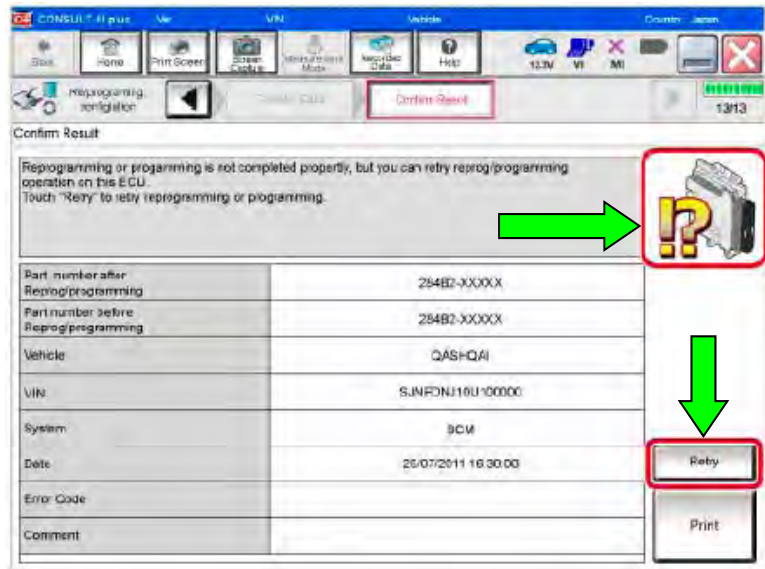
Figure 6

If reprogramming does not complete and the “!?” icon displays as shown in Figure 6:

- Check battery voltage (12.0–15.5 V).
- Ignition is ON, engine OFF.
- External Bluetooth® devices are OFF.
- All electrical loads are OFF.
- **Select retry and follow the on screen instructions.**
- “Retry” may not go through on first attempt and can be selected more than once.

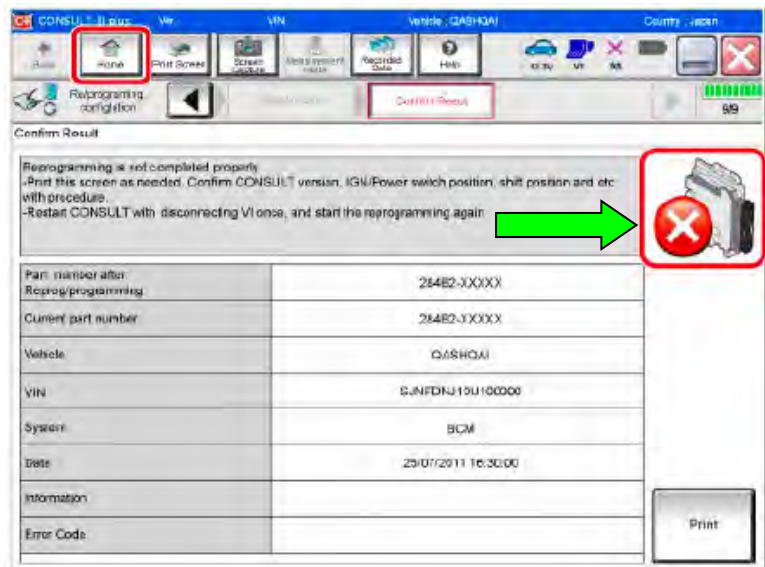
Figure 7

If reprogramming does not complete and the “X” icon displays as shown in Figure 7:

- Check battery voltage (12.0 – 15.5 V).
- CONSULT A/C adapter is plugged in.
- Ignition is ON, engine OFF.
- Transmission is in Park.
- All C-III plus / VI cables are securely connected.
- All C-III plus updates are installed.
- **Select Home, and restart the reprogram procedure from the beginning.**
