Service Campaign Bulletin SC-75

## **CUSTOMER SERVICE CAMPAIGNS 4003 AND 4004 Equator Airbag Control Unit (ACU) Reprogramming**

**Affected Models:** 2009 - 2012 Equator

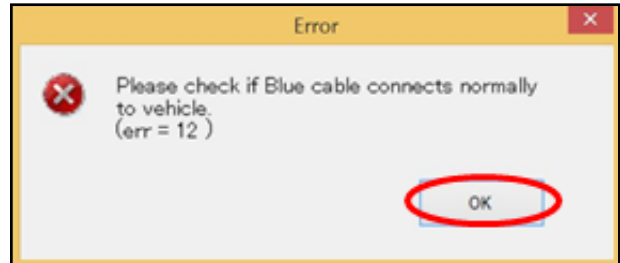
11) If you see this error (err=12), one of two conditions are present:

- A) The vehicle has already been programmed with the latest software – check the warranty system to confirm this.
- B) You are trying to program an FA6 vehicle with the FA9 cable. Stop here and select **OK**. Close the software and start again using the FA6 cable and software. See Section 4 for FA9 programming process.

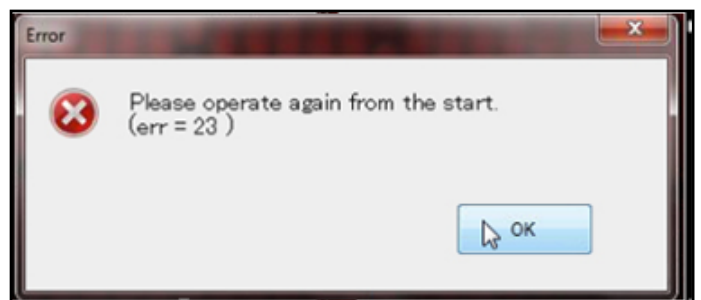
13) If the software fails during reprogramming and you see an error code 22 or 23, turn off the reprogramming software and unplug the USB cable from the PC. Wait 30 seconds and reinsert the cable into a different USB port and retry programming the ACU.

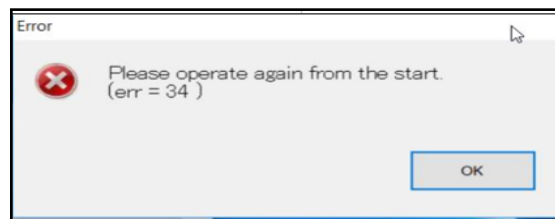
17) If the software fails during reprogramming and you see **error code 34**, select **OK**, turn off the reprogramming software and unplug the cable from the vehicle and the PC.

Turn the ignition OFF, wait 30 seconds, then ignition ON (engine OFF, not running). The supplemental airbag warning light (shown to the right) should illuminate for approximately 7 seconds before turning off. **Stop there and call Suzuki Tech-Line for further assistance.**

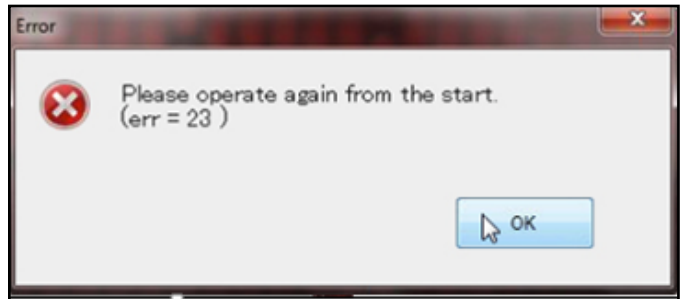
- 6) If the software fails during reprogramming and you see an **error code 22 or 23**, turn off the reprogramming software and unplug the USB cable from the PC. Wait 30 seconds, then re-insert the cable into a different USB port and retry programming the ACU.

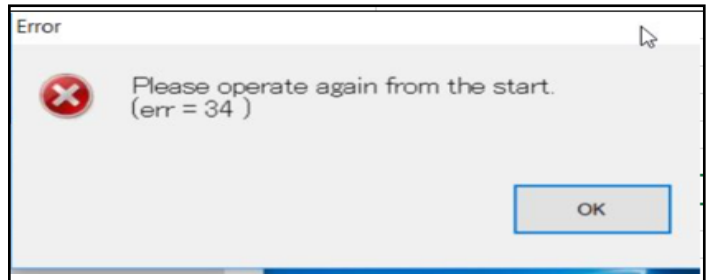
- 7) If the software fails during reprogramming and you see **error code 34**, select **OK**, turn off the reprogramming software and unplug the cable from the vehicle and the PC. Turn the ignition OFF, wait for 30 seconds, then turn the ignition ON (engine OFF, not running).

The supplemental airbag warning light (shown to the right) should illuminate for approximately 7 seconds before turning off. Stop there and call Suzuki Tech-Line for further assistance.
