SC-18-01-03

MODEL: 2017 - 2018 Model Year Karma Revero

**TITLE: Repair of Fastener Location****PRIORITY:** All**MARKET REGIONS:** All

**PURPOSE:** This document is to provide for approved and known methods to repair locations where a fastener has failed to achieve the required torque

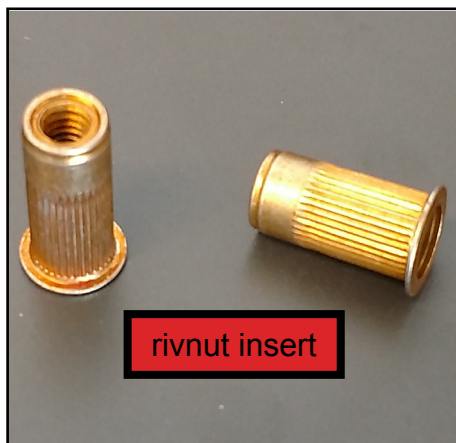
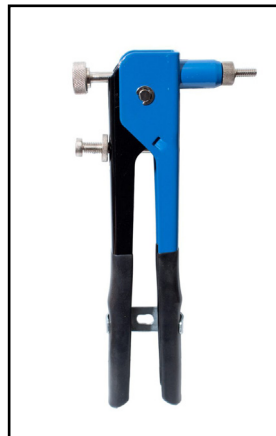
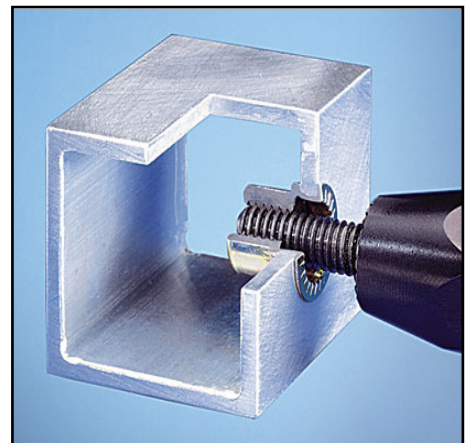
When repairing a location that fails to achieve torque (or is “stripped”) use the following pairing of Rivet nut (or “rivnut”) and appropriate size fasteners with adhesive. This is the preferred method of repair. Take care and use the appropriate torque wrench to torque the fasteners as indicated.

Rivnut installation should follow the install instructions provided with your rivnut install tool. Install tools are available locally.

**For 6mm the torque specification would be 8Nm +/-1Nm.**

When complete with install **Thread in fasteners by hand initially at least 3 - 4 threads.**
